The breakaway torque of the KW

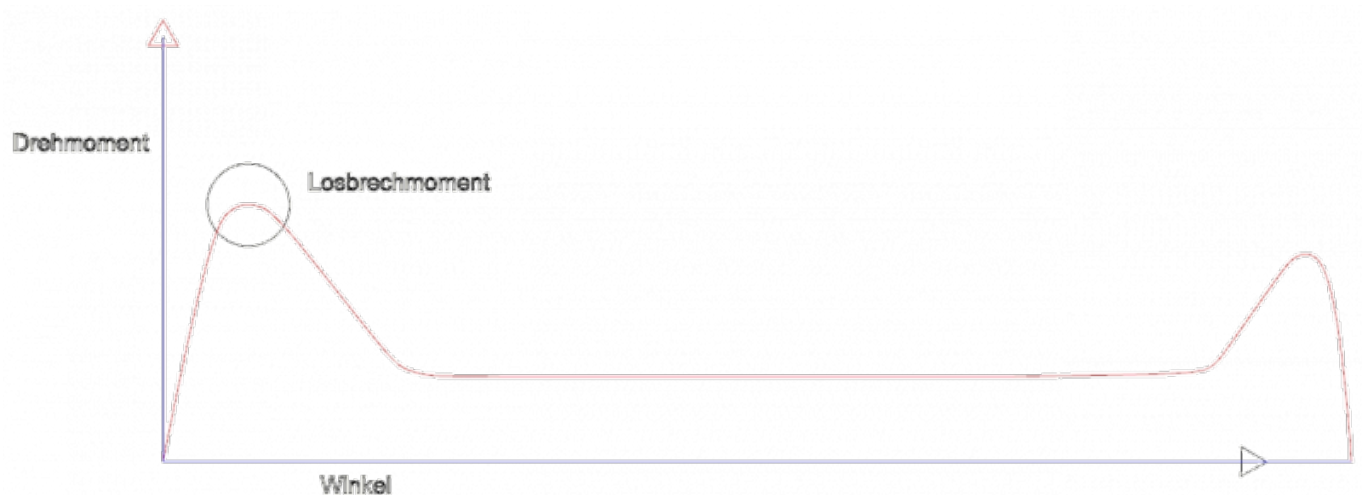
When you turn the propeller, the following behavior is observed:

Initially, the breakaway torque is manifested by increased resistance when you try to turn the propeller. If it rotates, we feel a lower and more even effort. If you now stop the rotation, you will notice a jerky stop of the propeller. This is roughly illustrated by the following curve.

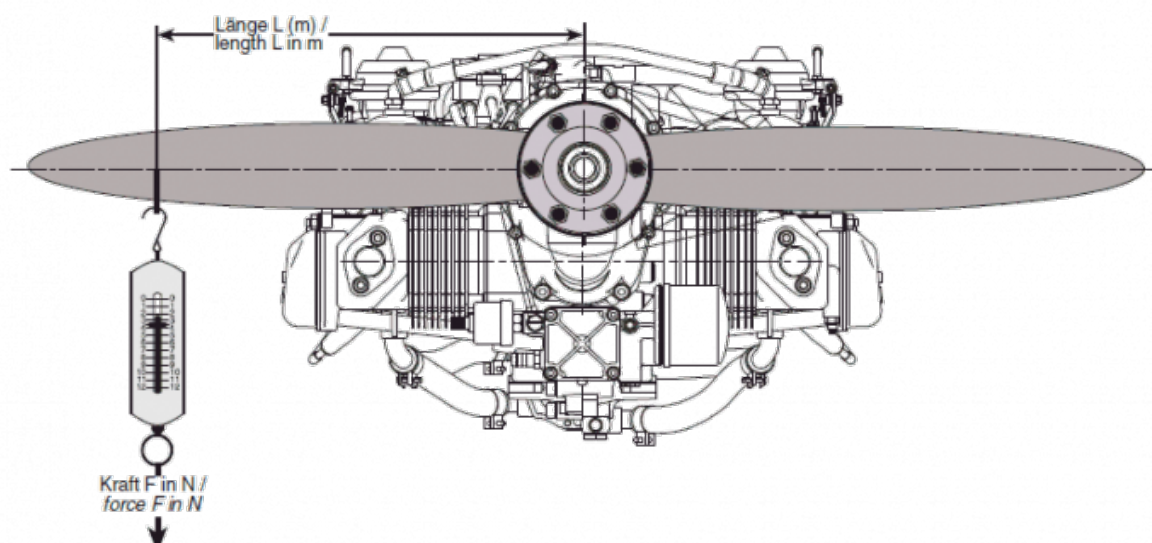
Measuring torque required to turn crank drive

150 Nm

If we take into account the gear ratio of 2.43:1 for the 912 S/ULS, this means a **breakaway torque of 61.73 Nm at the crankshaft.**

If a breakaway torque of over 15 Nm is detected on the crankshaft of an engine during maintenance and it is subsequently disassembled, the typical rough, gray discolored areas can be seen in the area of the main bearings on the housing interfaces.

Measurements of the remaining crankshaft bearing play would show **a play of 0 (ZERO) or less.**

Engine runs sluggishly	
Step	Procedure
1	Remove spark plug connector and remove 1 spark plug from each cylinder.
2	<p>Torque must be determined with a suitable jig.</p> <p>To do this, determine the maximum occurring torque on the propeller shaft necessary to move the whole crank drive.</p> <p>The torque must be max. 150 Nm (110.64 ft.lb).</p> <p>If the max. permissible torque is exceeded, following inspections are to be performed:</p> <ul style="list-style-type: none"> - Carry out detailed inspection of the affected gearbox components - Carry out detailed inspection of crank drive
