# The breakaway torque of the KW

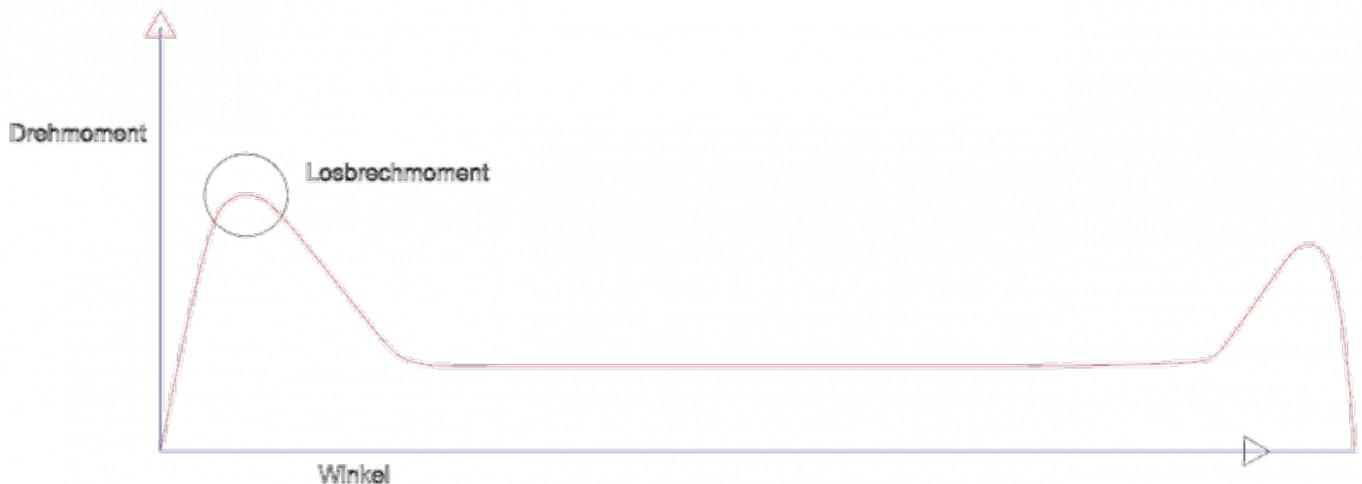
Initially, the breakaway torque is manifested by increased resistance when you try to turn the propeller. If it rotates, we feel a lower and more even effort. If you now stop the rotation, you will notice a jerky stop of the propeller. This is roughly illustrated by the following curve.

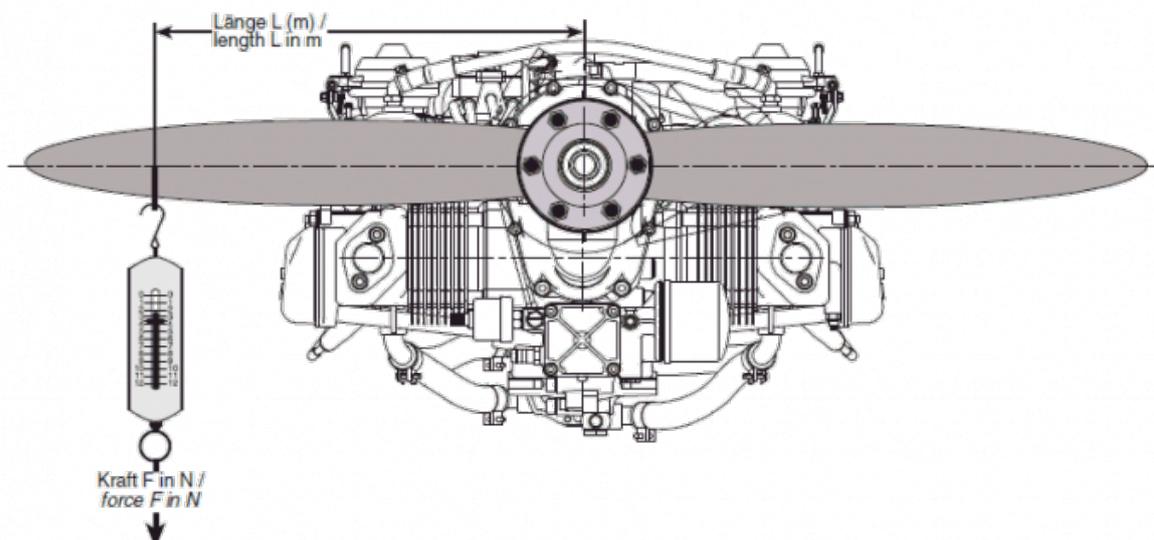
### Measuring torque required to turn crank drive

Engine runs sluggishly	
Step	Procedure
1	Remove spark plug connector and remove 1 spark plug from each cylinder.
2	Torque must be determined with a suitable jig. To do this, determine the maximum occurring torque on the propeller shaft necessary to move the whole crank drive. The torque must be max. 150 Nm (110.64 ft.lb). If the max. permissible torque is exceeded, following inspections are to be performed: - Carry out detailed inspection of the affected gearbox components - Carry out detailed inspection of crank driv

If we take into account the gear ratio of 2.43:1 for the 912 S/ULS, this means a **breakaway torque of 61.73 Nm at the crankshaft.**

If a breakaway torque of over 15 Nm is detected on the crankshaft of an engine during maintenance and it is subsequently disassembled, the typical rough, gray discolored areas can be seen in the area of the main bearings on the housing interfaces.

Measurements of the remaining crankshaft bearing play would show a **play of 0 (ZERO) or less.**
