The breakaway torque of the KW

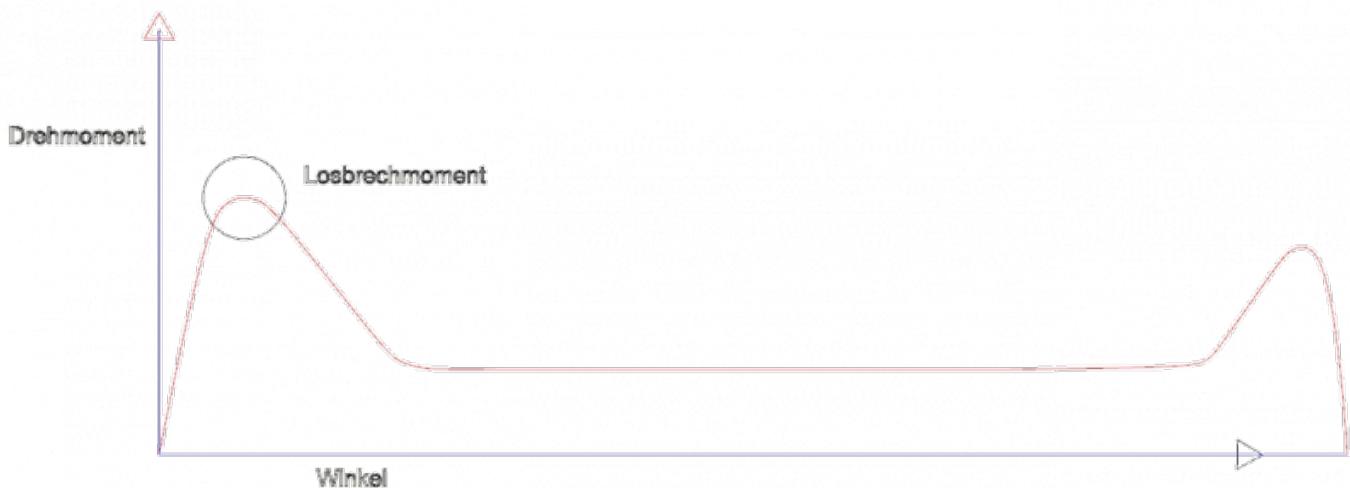
Initially, the breakaway torque is manifested by increased resistance when you try to turn the propeller. If it rotates, we feel a lower and more even effort. If you now stop the rotation, you will notice a jerky stop of the propeller. This is roughly illustrated by the following curve.

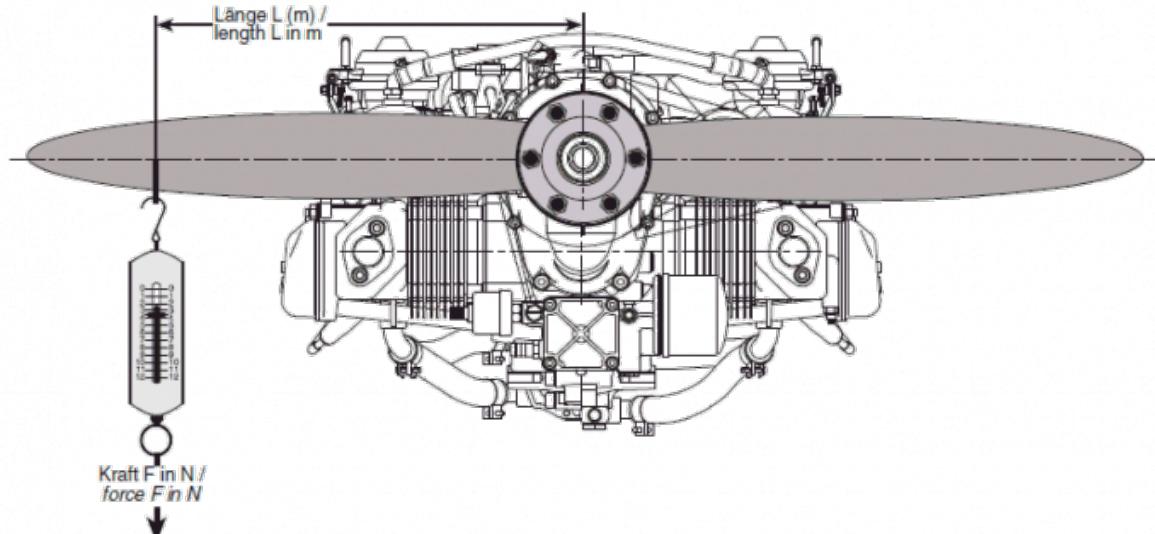
Measuring torque required to turn crank drive

Engine runs sluggishly	
Step	Procedure
1	Remove spark plug connector and remove 1 spark plug from each cylinder.
2	<p>Torque must be determined with a suitable jig. To do this, determine the maximum occurring torque on the propeller shaft necessary to move the whole crank drive. The torque must be max. 150 Nm (110.64 ft.lb).</p> <p>If the max. permissible torque is exceeded, following inspections are to be performed:</p> <ul style="list-style-type: none"> - Carry out detailed inspection of the affected gearbox components - Carry out detailed inspection of crank driv

150 Nm

If we take into account the gear ratio of 2.43:1 for the 912 S/ULS, this means a **breakaway torque of 61.73 Nm at the crankshaft**.

If a breakaway torque of over 15 Nm is detected on the crankshaft of an engine during maintenance and it is subsequently disassembled, the typical rough, gray discolored areas can be seen in the area of the main bearings on the housing interfaces.

Measurements of the remaining crankshaft bearing play would show a **play of 0 (ZERO) or less**.
