## darker spark plugs on one side

... or what strange causes there are.

I examined carburetors from a 914,

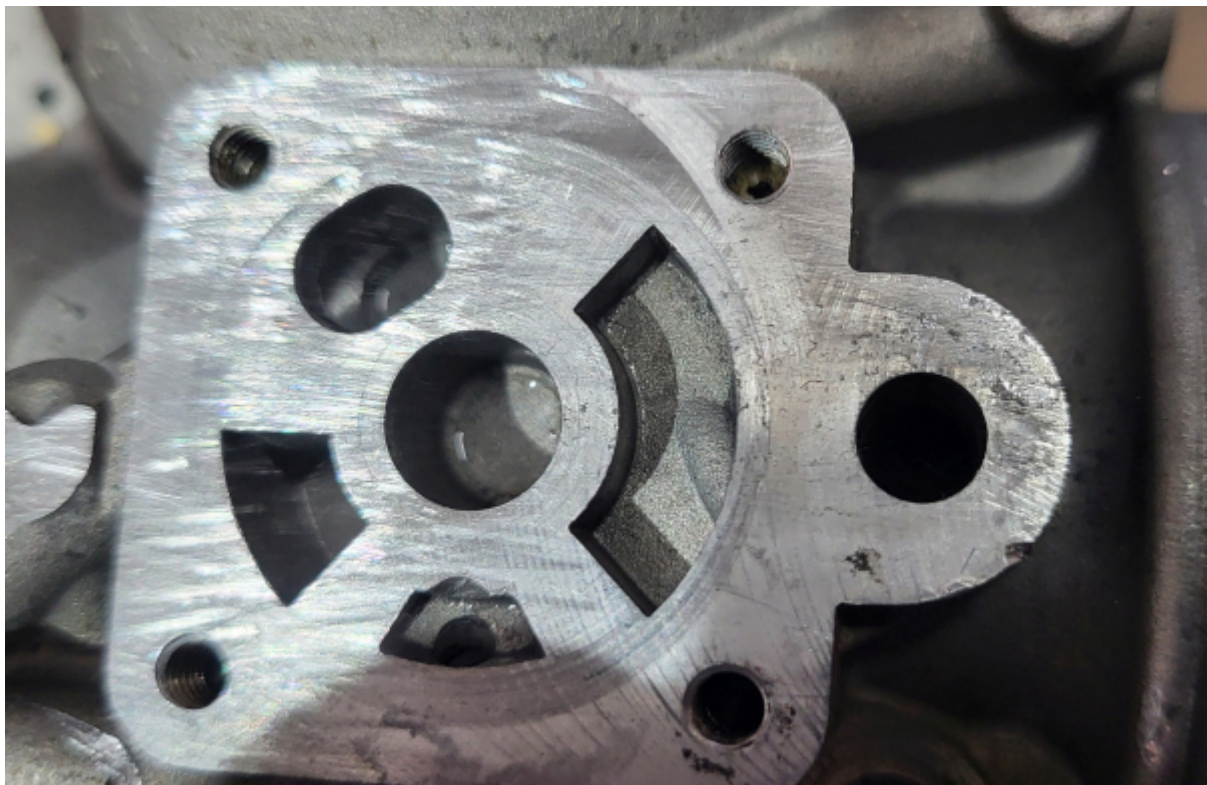
Now I was amazed when I removed 1/3 of the choke housing from the carburetor.

You can clearly see a milled edge that extends into the area of the rotary choke piston.

During operation, however, the edge was worn away by the rotary piston, so that the choke was tight after the 800 h mentioned.

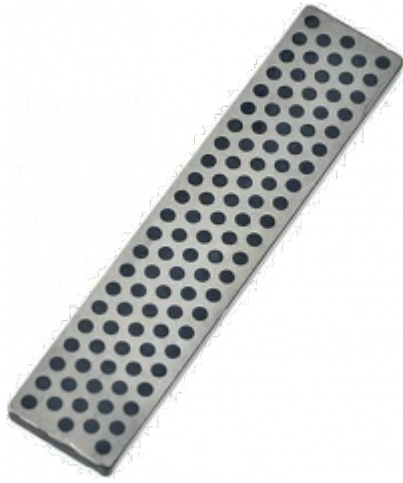
A milled edge on the carburetor housing reached into the area of the choke plunger where it is supposed to seal. As the rotary piston cannot fully rest and seal here, it is not possible to achieve good engine running with the leaking choke.

Whenever you get Bing's to check, it is advisable to disassemble and check the choke housing.  
Make sure that the choke is 100% tight.

Over time, I have gotten into the habit of grinding the sealing surface of the choke on the carburetor housing flat with a diamond tightening stone. This was also urgently needed here.
