darker spark plugs on one side

... or what strange causes there are.

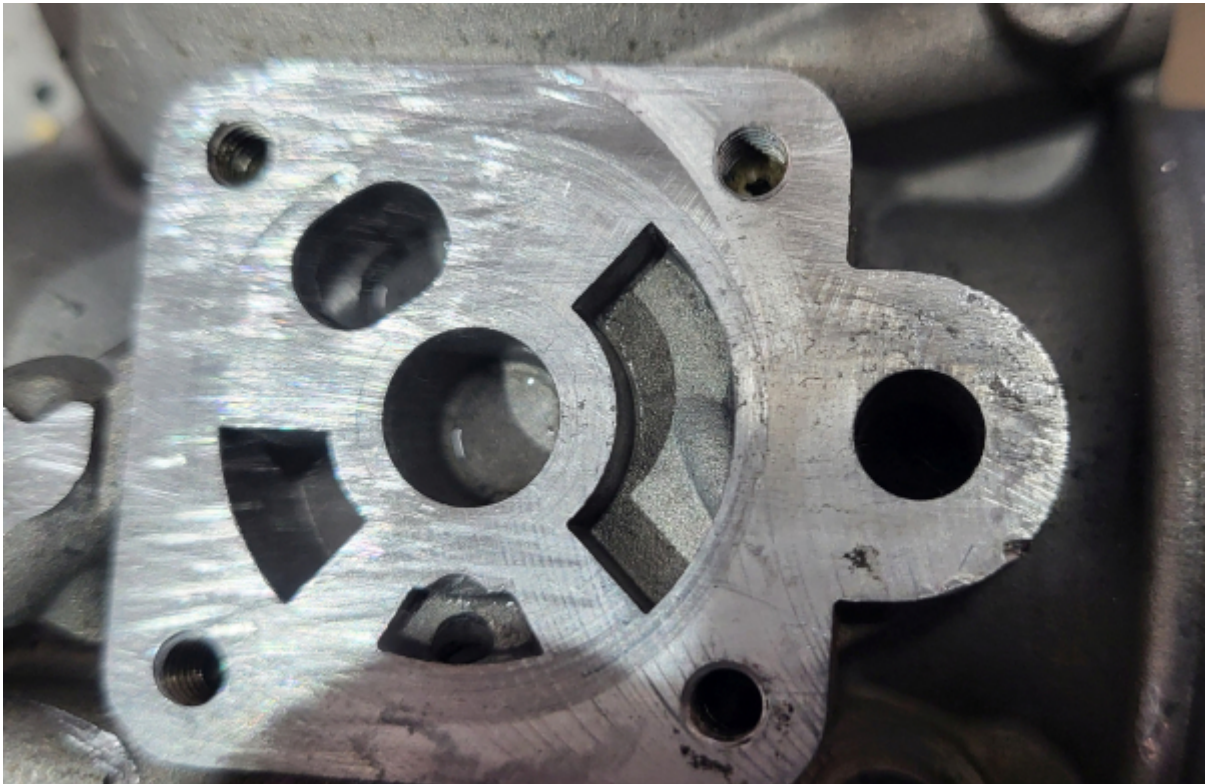
The owner of the plane had been complaining about darker plugs on the right side (1/3) and not particularly nice engine running since the first day.

Now I was amazed when I removed 1/3 of the choke housing from the carburetor.

You can clearly see a milled edge that extends into the area of the rotary choke piston.

During operation, however, the edge was worn away by the rotary piston, so that the choke was tight after the 800 h mentioned.

Whenever you get Bing's to check, it is advisable to disassemble and check the choke housing.
Make sure that the choke is 100% tight.

Over time, I have gotten into the habit of grinding the sealing surface of the choke on the carburetor housing flat with a diamond tightening stone. This was also urgently needed here.
