darker spark plugs on one side

I examined carburetors from a 914,

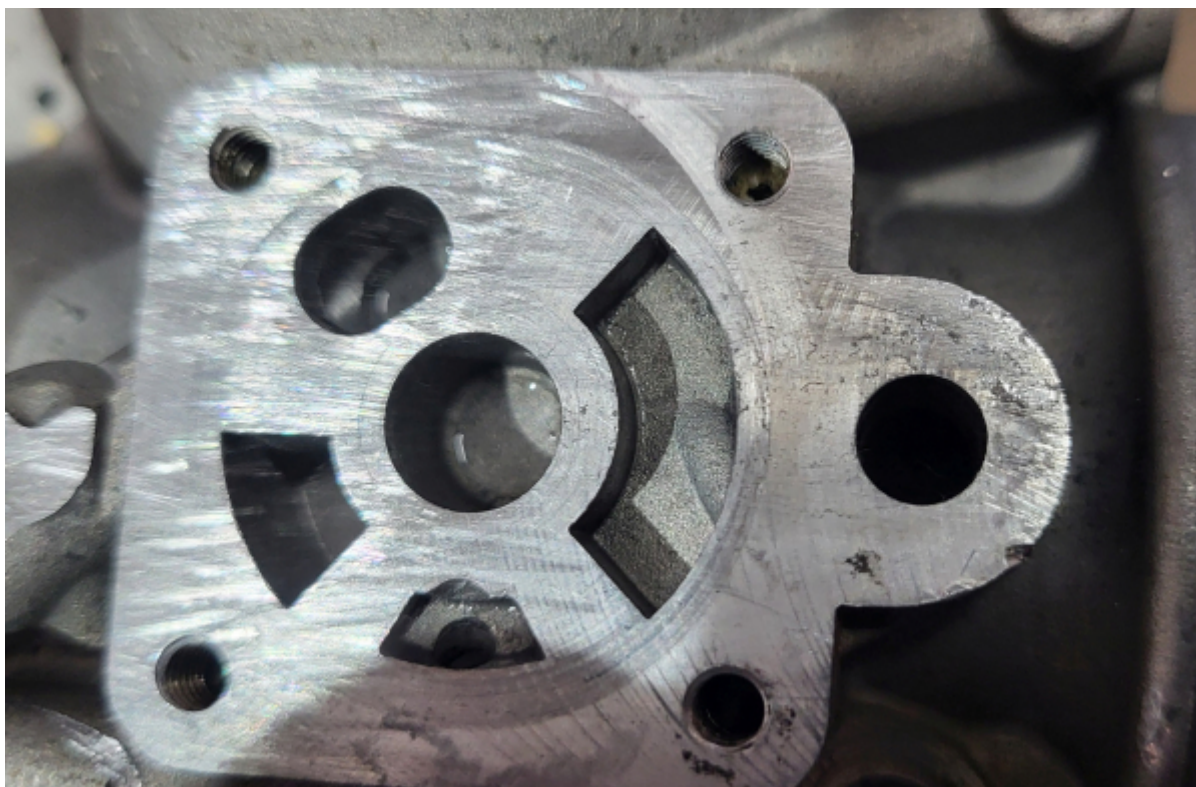
The owner of the plane had been complaining about darker plugs on the right side (1/3) and not particularly nice engine running since the first day.

Now I was amazed when I removed 1/3 of the choke housing from the carburetor.

You can clearly see a milled edge that extends into the area of the rotary choke piston.

During operation, however, the edge was worn away by the rotary piston, so that the choke was tight after the 800 h mentioned.

Whenever you get Bing's to check, it is advisable to disassemble and check the choke housing.
Make sure that the choke is 100% tight.

Over time, I have gotten into the habit of grinding the sealing surface of the choke on the carburetor housing flat with a diamond tightening stone. This was also urgently needed here.
