## darker spark plugs on one side

... or what strange causes there are.

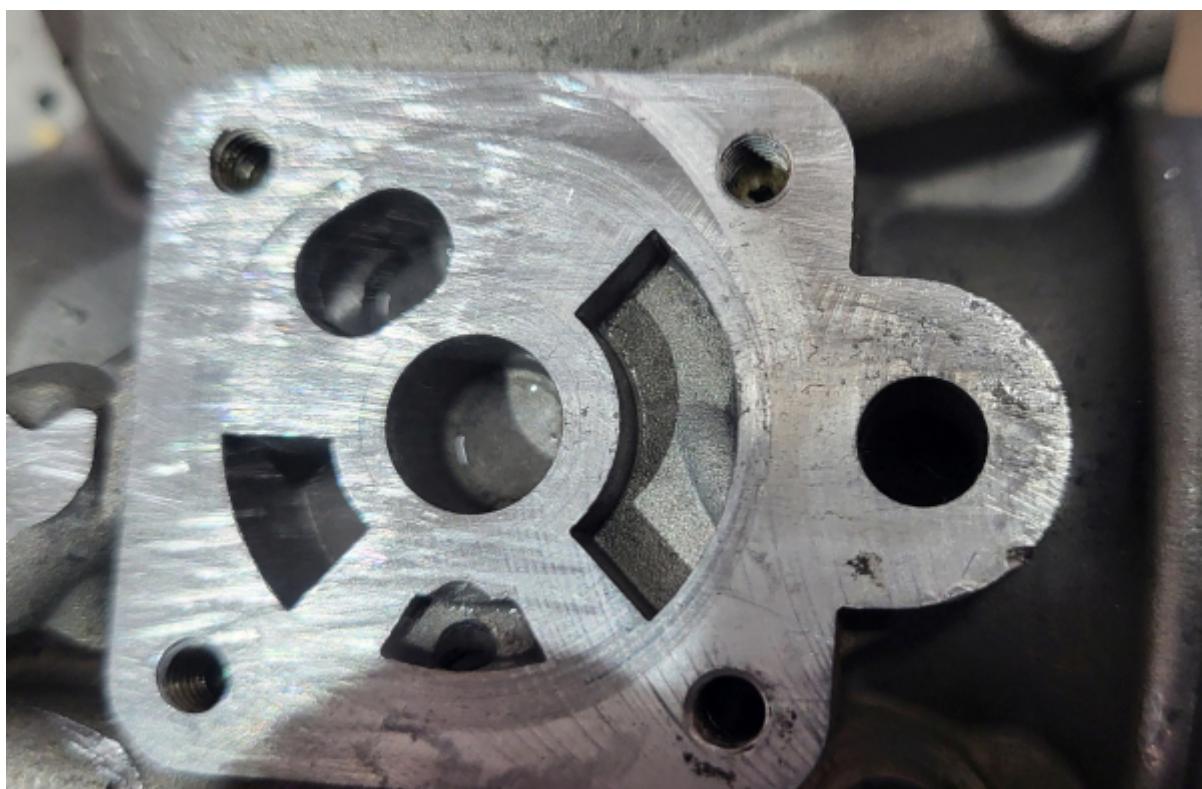
Now I was amazed when I removed 1/3 of the choke housing from the carburetor.

You can clearly see a milled edge that extends into the area of the rotary choke piston.

During operation, however, the edge was worn away by the rotary piston, so that the choke was tight after the 800 h mentioned.

Whenever you get Bing's to check, it is advisable to disassemble and check the choke housing.  
Make sure that the choke is 100% tight.

Over time, I have gotten into the habit of grinding the sealing surface of the choke on the carburetor housing flat with a diamond tightening stone. This was also urgently needed here.
