... what can happen with a defective wastegate flap servo

... the TCU warning lights indicate a possible defect in the wastegate flap servo and what the consequences can be.

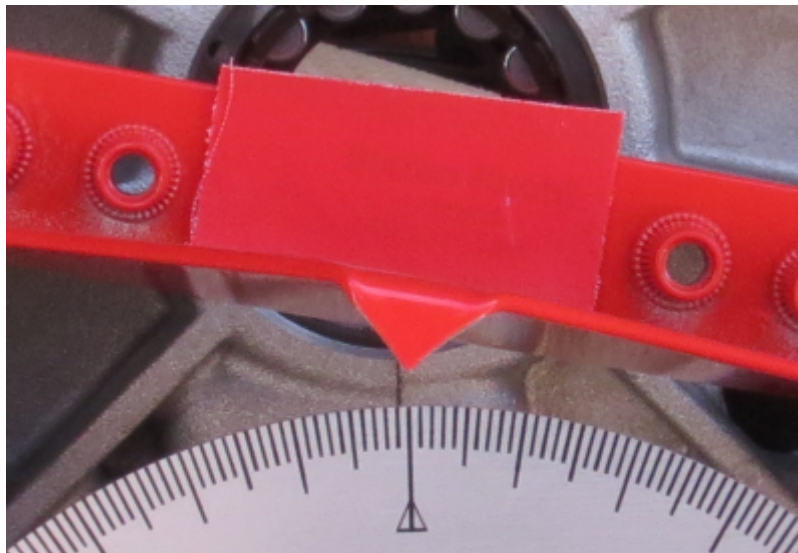
Piston turned to the piston stopper at cylinder 1 and the degree disk set to 0°.

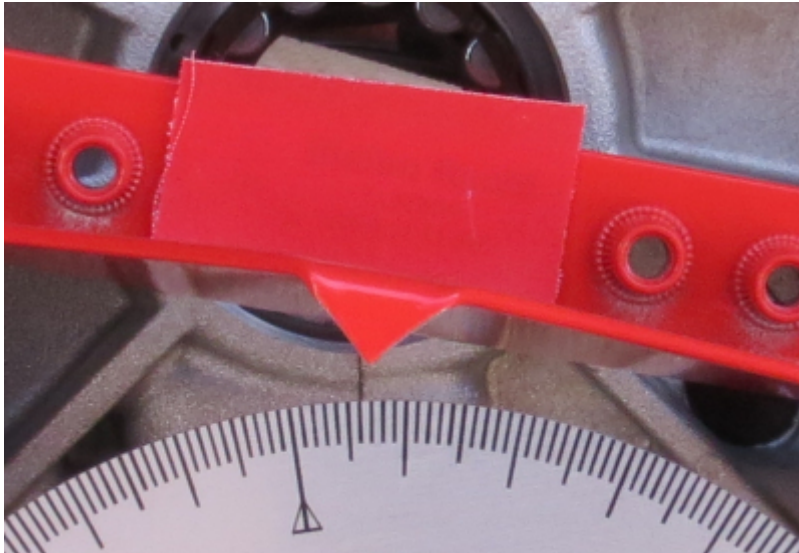
Turn the piston to the piston stopper at cylinder 2 and read the position on the degree disk.

Here you can clearly see that the crankshaft is rotated by approx. 6° between the two measured cylinders, in this case between cylinders 1 and 2. The measured value for cylinders 3 and 4 was also 6°.

This means that the crankshaft is only twisted between cylinders 1 and 2.

For cylinder 1, the piston is therefore advancing by 6°.

As you can imagine, there was a hard lump in Gustav's face - **the crankshaft needs to be replaced.**
