... what can happen with a defective wastegate flap servo

... the TCU warning lights indicate a possible defect in the wastegate flap servo and what the consequences can be.

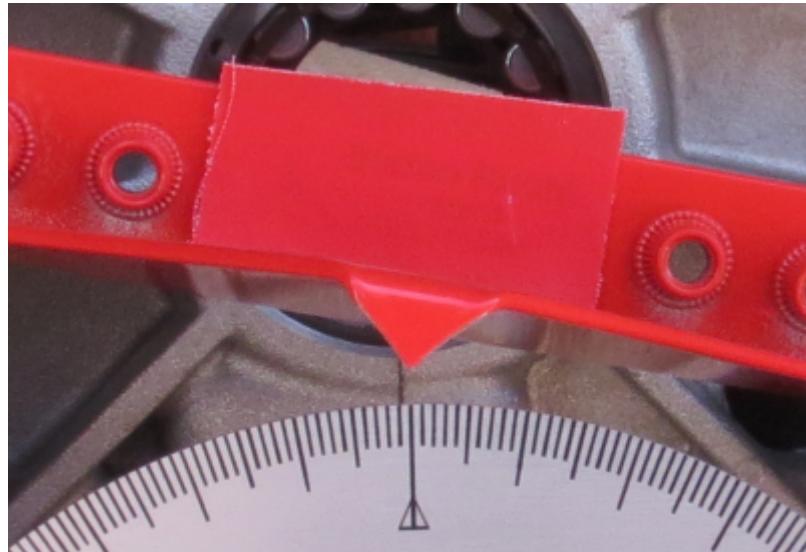
Piston turned to the piston stopper at cylinder 1 and the degree disk set to 0°.
