... what can happen with a defective wastegate flap servo

... the TCU warning lights indicate a possible defect in the wastegate flap servo and what the consequences can be.

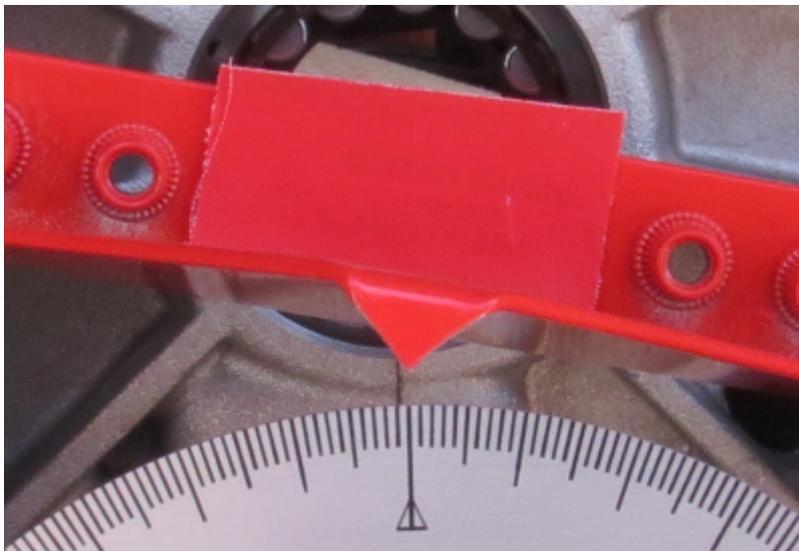
Piston turned to the piston stopper at cylinder 1 and the degree disk set to 0°.

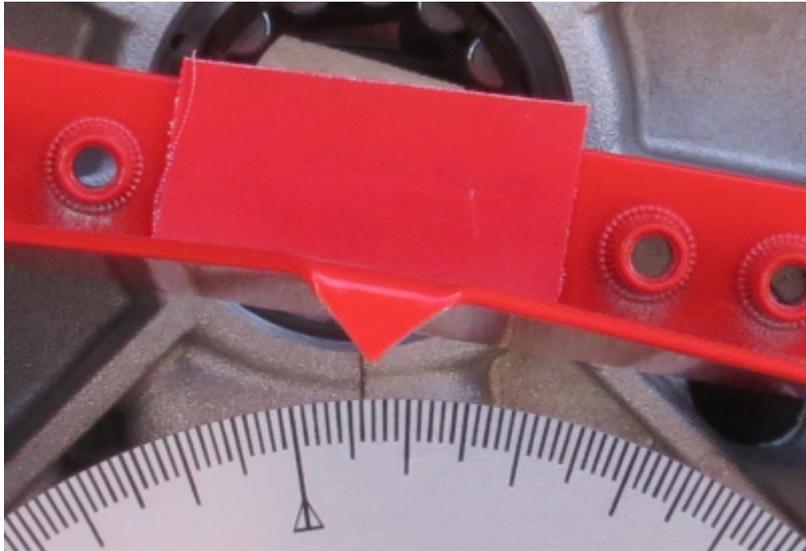
The event occurred before 30:76 h. The wastegate flap was not open wide enough according to the specified parameters, so we had an overboost of 2366 mbar.

Experience has shown that a boost pressure of over 1800 mbar is dangerous for the interference fit of the crankshaft.

This can then twist or elongate.

If the crankshaft elongates, the crank webs in the area of the main bearings grind against the walls of the crankcase, causing the crankshaft to jam or become stiff.

Turn the piston to the piston stopper at cylinder 2 and read the position on the degree disk.

Here you can clearly see that the crankshaft is rotated by approx. 6° between the two measured cylinders, in this case between cylinders 1 and 2. The measured value for cylinders 3 and 4 was also 6°.

This means that the crankshaft is only twisted between cylinders 1 and 2.

For cylinder 1, the piston is therefore advancing by 6°.

As you can imagine, there was a hard lump in Gustav's face - **the crankshaft needs to be replaced.**
