# The cooling run of the turbocharger

.... and what happens if you don't comply with it

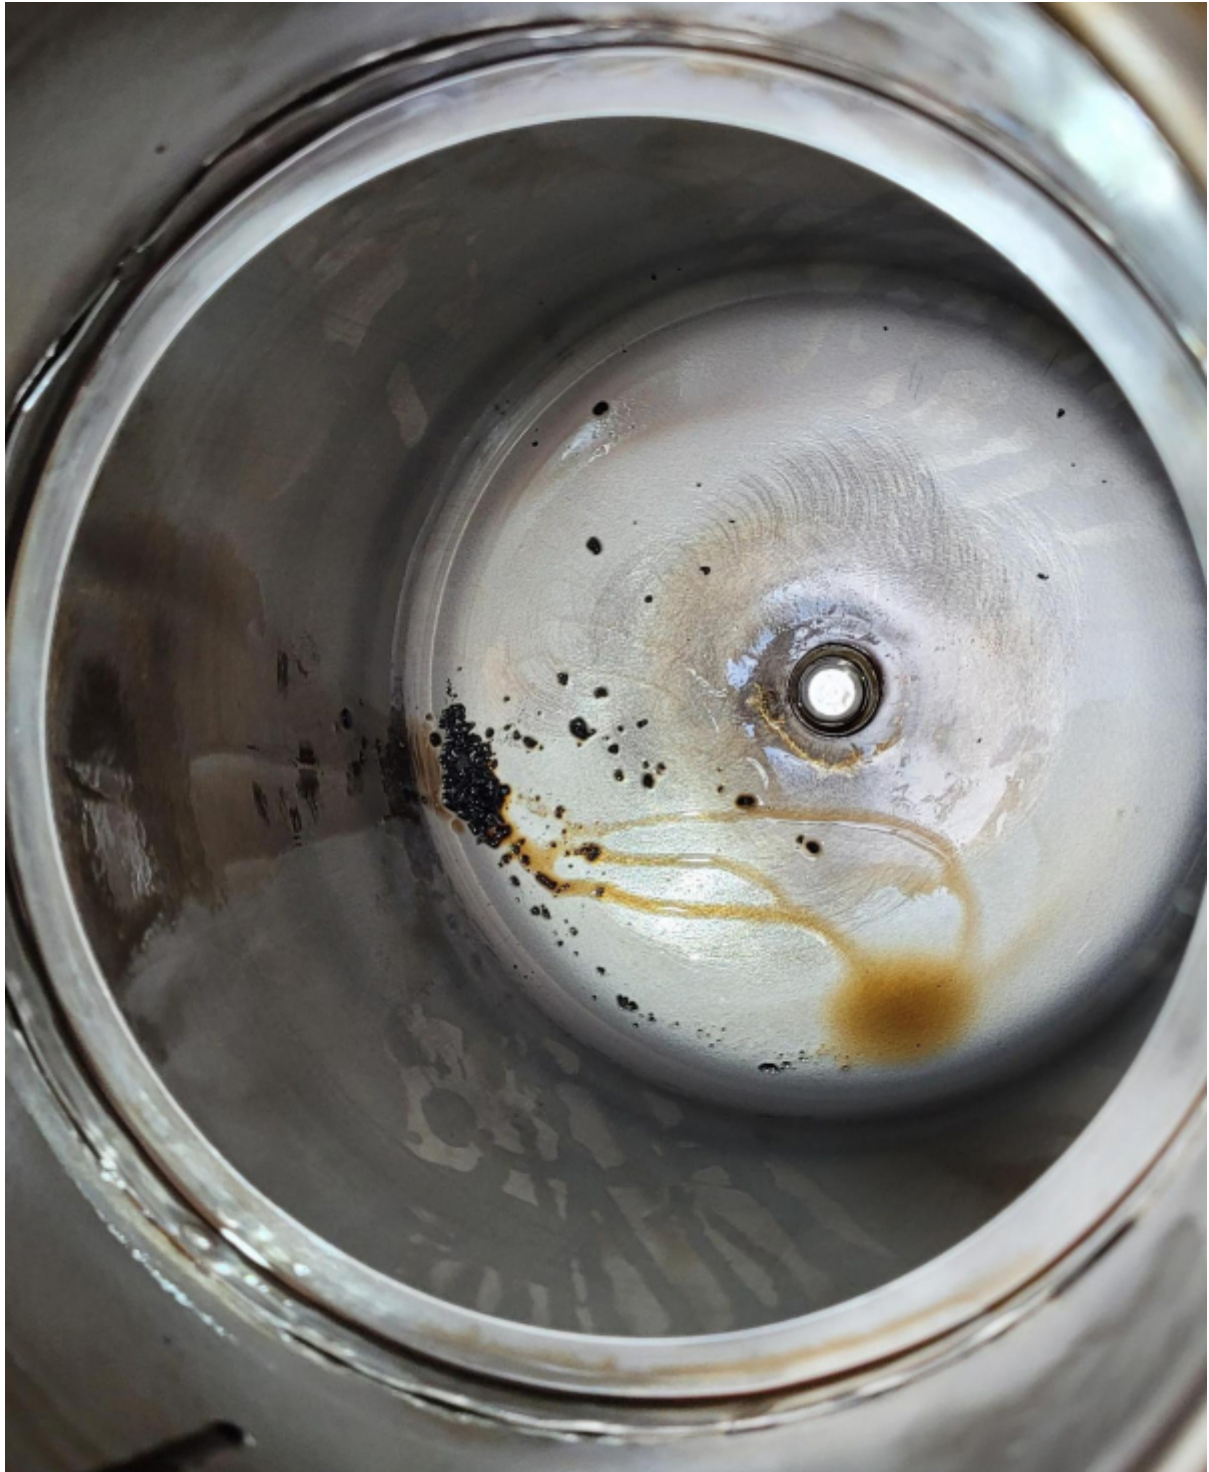
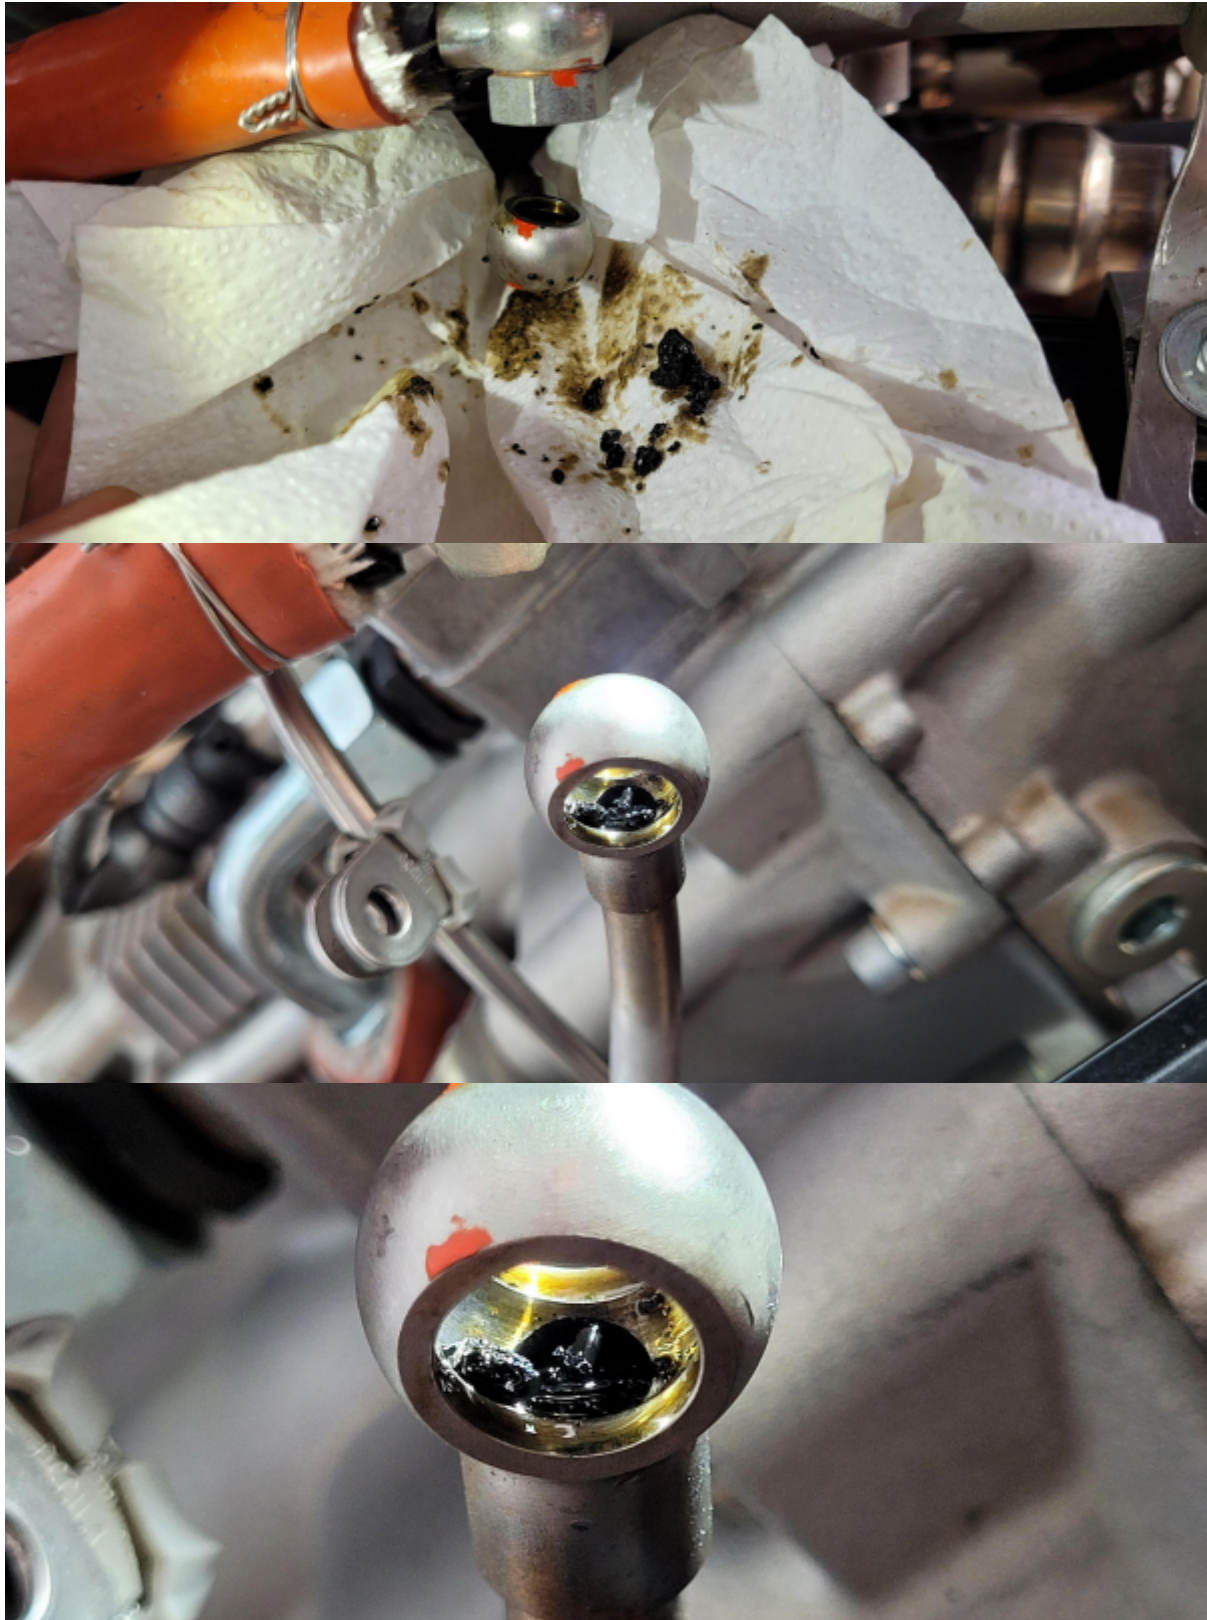
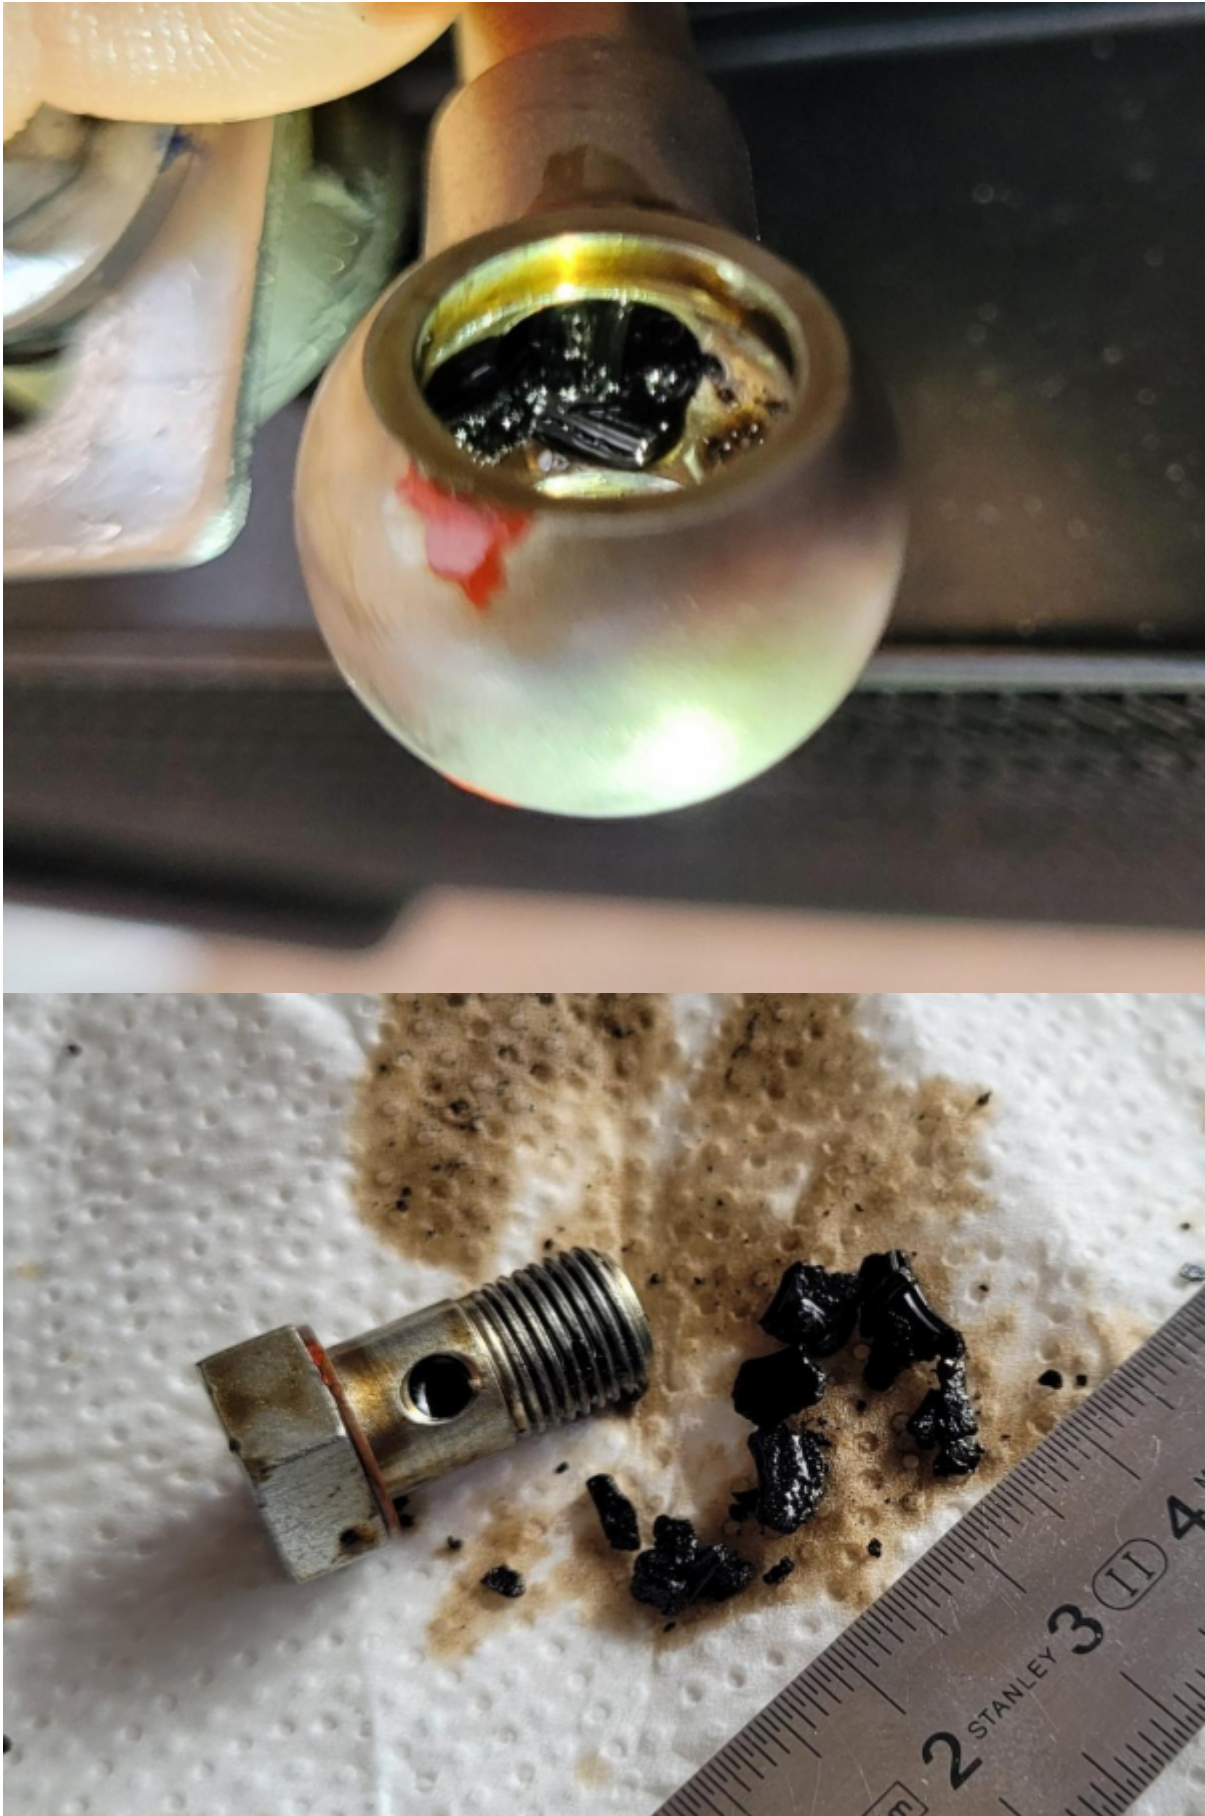
1)

- no leak was detected on the engine
- there was always oil pressure in flight
- the oil level on the dipstick is just below minimum

Of course, this was also the case here, which is why I was so surprised to find such lumps.

Unfortunately, the question could not be clearly answered, but it is reasonable to assume that the times of the cooling run were too short at some point.

However, it is quite clear that the „good outcome“ of the story is due to the fact that the banjo bolt in front of the oil pump was not yet completely blocked. The amount of oil that could still pass through here was apparently just under the amount that was pumped to the center section to lubricate the turbocharger. The quantity that was not returned caused the oil to overflow at the points where the turbocharger shaft was positioned. As a result, the oil was forced out on both sides of the turbo, some of which ended up in the exhaust and some in the airbox, causing the oil plume.

they are caused by coking of the engine oil on the shaft, mainly in the area of the bearing at the turbine wheel (the side that is driven by the exhaust gases). When the engine is running, the engine oil cannot coke here, as there is always a certain amount of cooling due to the lubrication process. If the oil is not pumped and the shaft is not yet cold enough, the oil that has come to rest boils away and forms nice lumps of carbon. These then eventually fall into the oil sump, are sucked towards the oil pump by the suction line and possibly clog the banjo bolt in front of the oil pump.

### The moral of the story, don't shorten the cooling run!

I keep preaching that the cooling run should be about 5 minutes **if at all possible**

This is another reason why I always recommend removing the oil reservoir and checking for carbon crumbs when changing the oil. Small black crumbs in the oil filter mat are another warning sign!

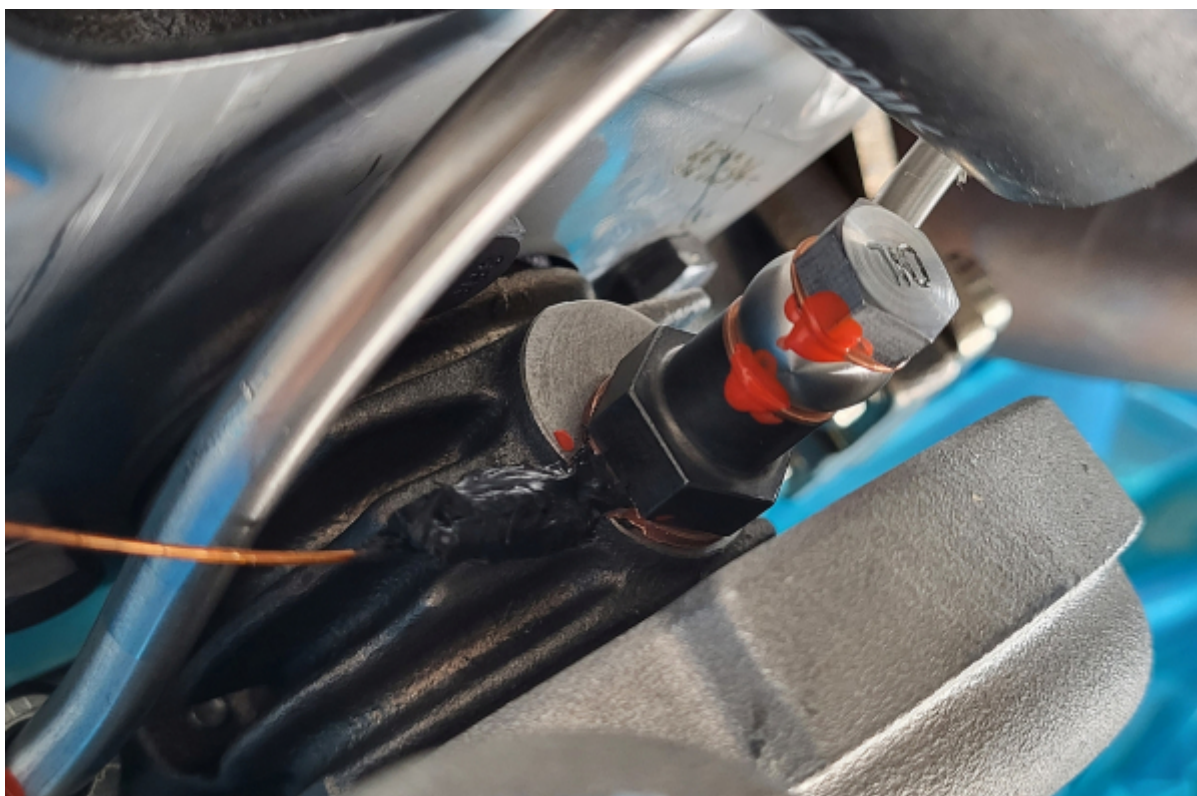
We fitted the sensor to the oil inlet of the center section of a Turbo-Dimona as a replacement for the copper seal that is fitted under the valve housing.

We had just 120°C in flight after 5 minutes of take-off power. After landing and the cooling run approx. 100°C .

The temperature rose to approx. 130°C after parking.

However, these are temperatures that do not lead to carbonization.

Consequently, carbon formation only takes place on the shaft in the area of the turbine wheel.

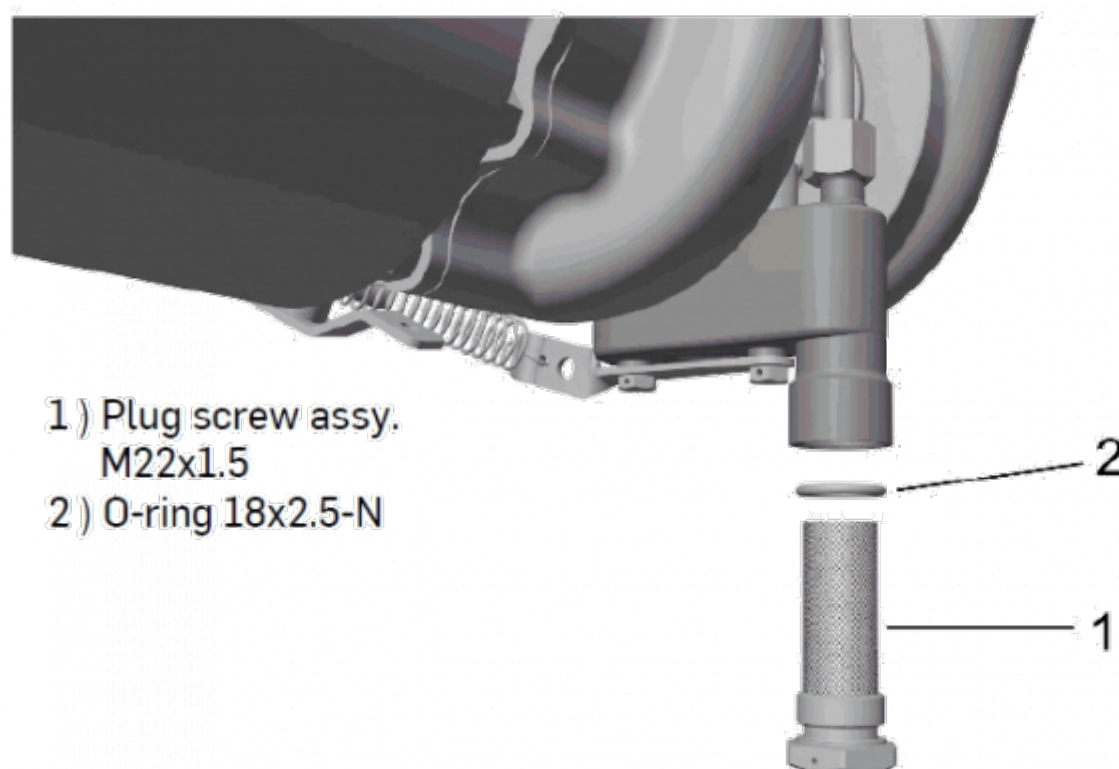
**[SI-914-039](#) Introduction of a new oil sump assy for ROTAX Engine Type 914 (Series) from 20.02.2023**

A strainer is integrated into the oil sump vessel here, which prevents carbon crumbs of one size from reaching the banjo bolt of the return line, which can clog it.

I recommend everyone to install this unfortunately not quite cheap part.
