Leak at the cylinder base

http://www.kleijung.de/rotax/doku.php?id=en:leaking_cylinder_foot

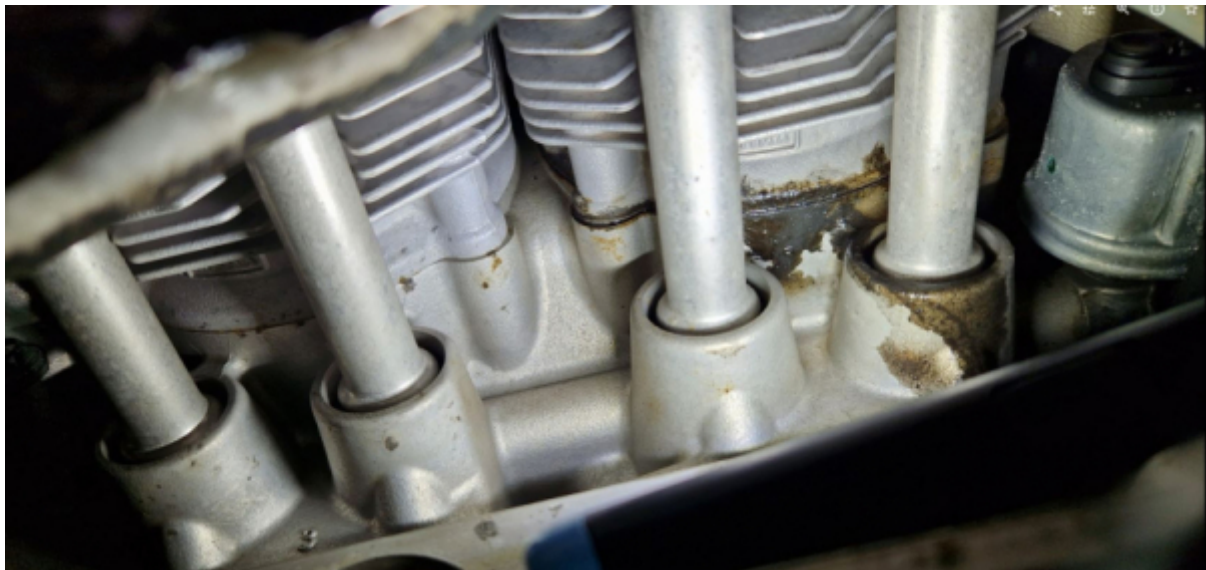
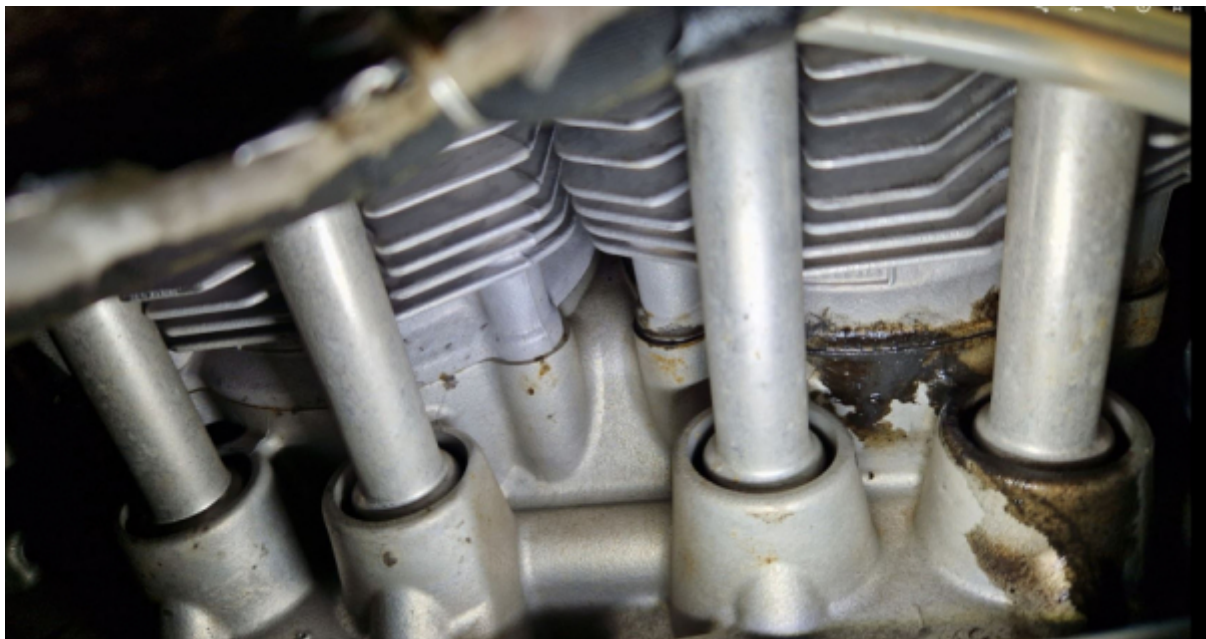
Oil where it doesn't belong.¹⁾

thanks, Ingo B. for the 2 damage pictures

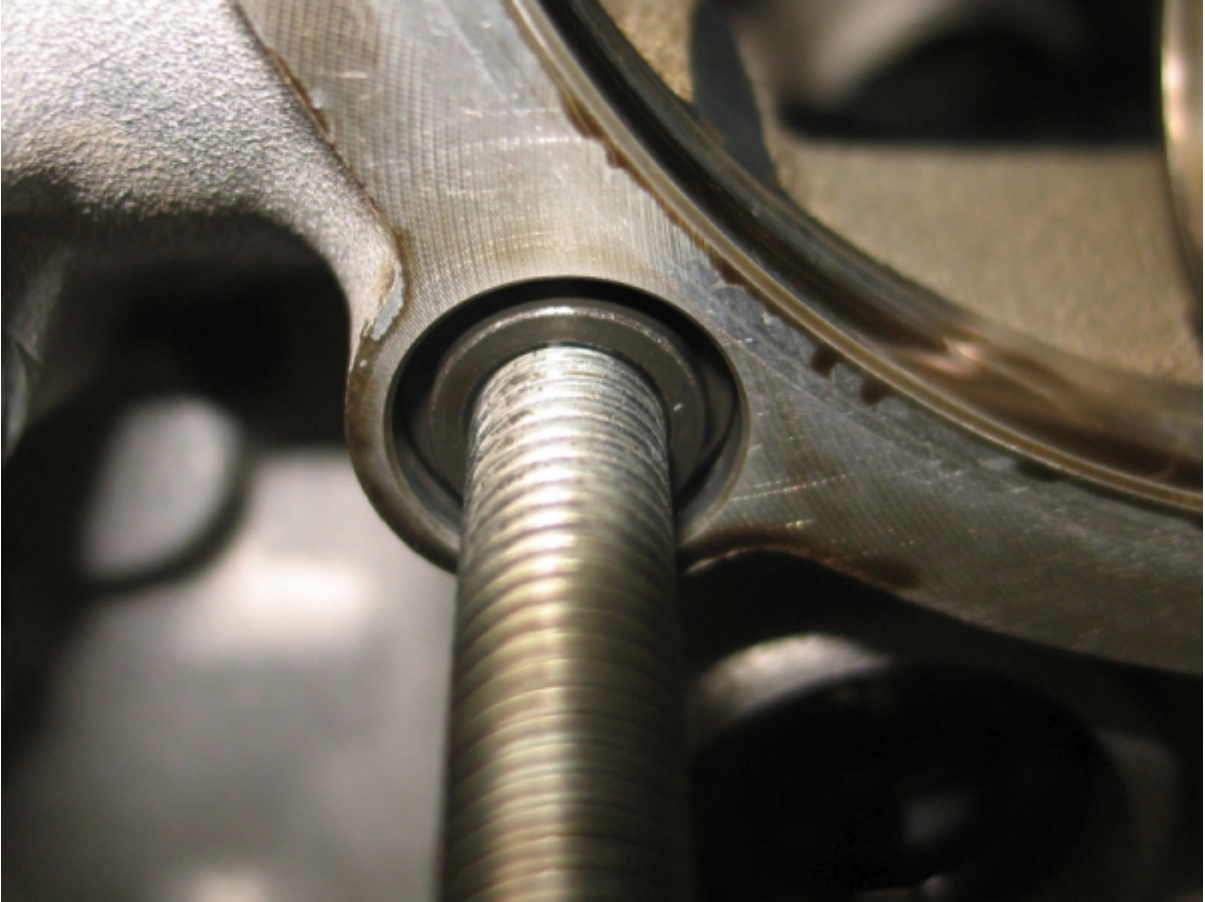
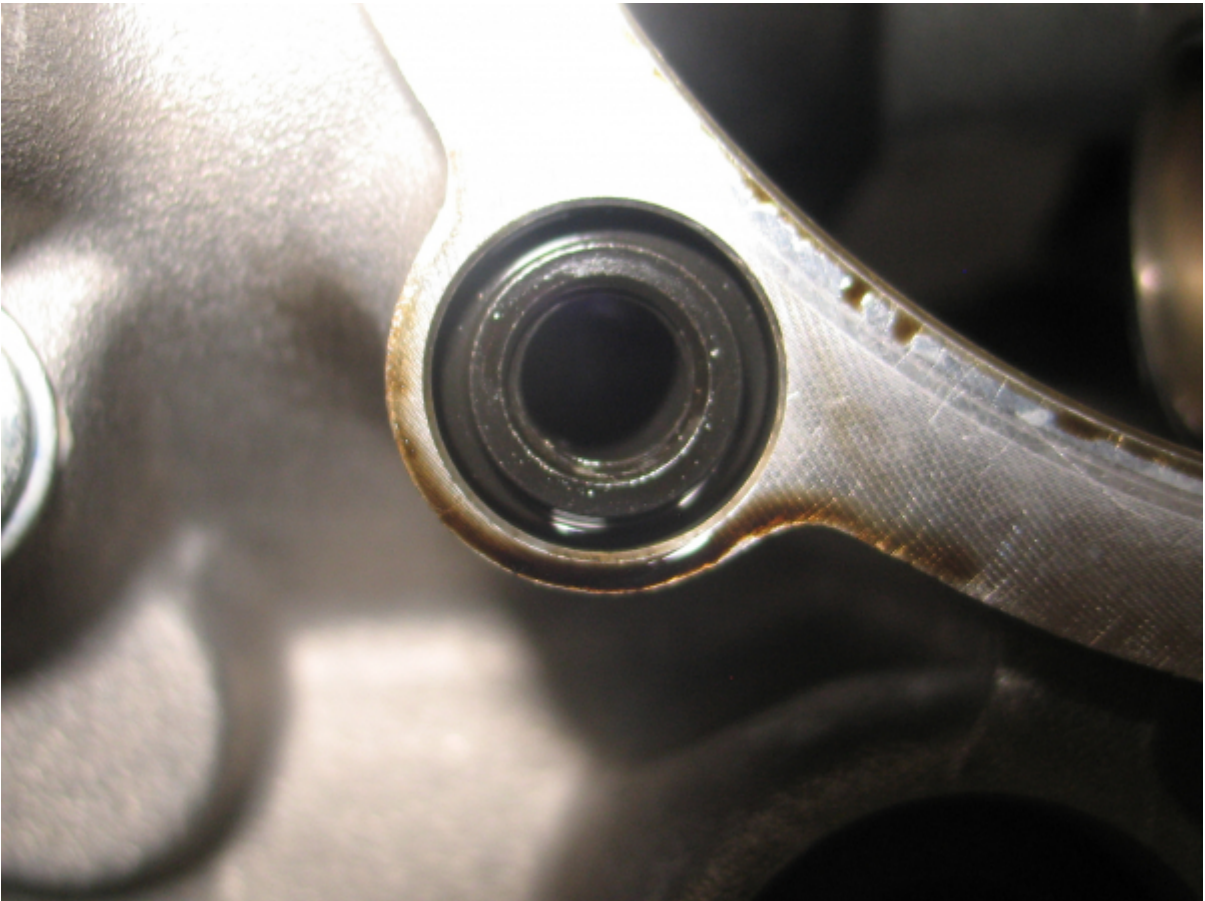
[After the cylinder has been removed, it looks like this:](#)

Quite simply: after a modification to the crankcase, no O-rings were installed here.

Order and install the O-rings.

[Read in the SI-912 i-006 R1 / SI-912-019 R3 / SI-914-021 R3](#)
