# The check valve on the 914 turbocharger

... or why there is a pool of oil under the 914

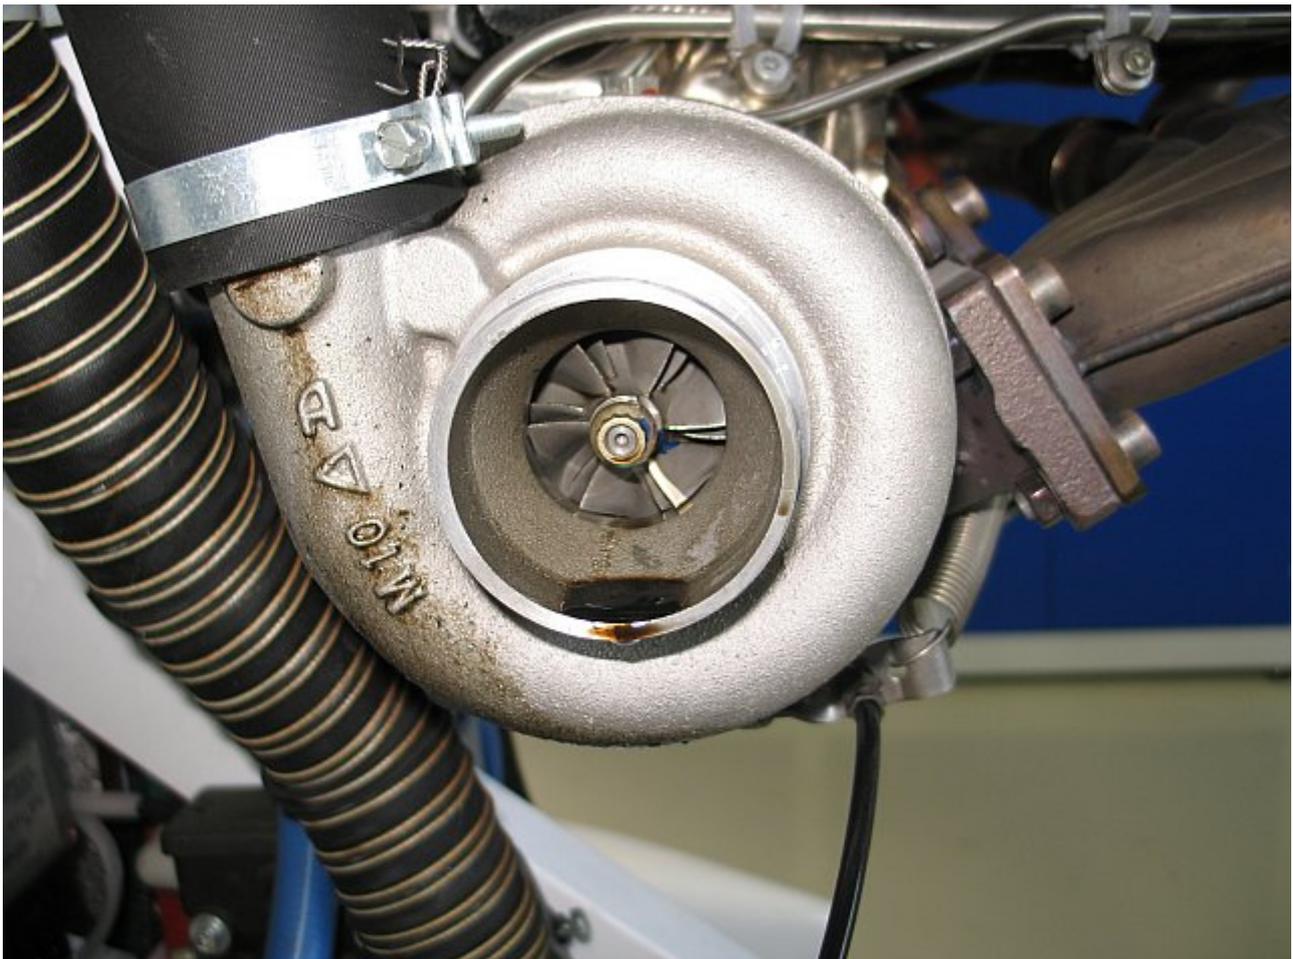
Now the hose is removed from the turbine housing and **you can see the following picture:**

A pool of oil that shouldn't be there is smiling at you in the turbocharger.

If the non-return valve in the valve housing is not tight, the oil sump will fill up and then the turbine and compressor housing will also fill up.

If this is also full, the oil continues to run into the exhaust and into the compressor housing inlet. Here you can see the oil loss when oil drips from the intake hose.

1. During the warranty period, get on your contractual partner's nerves until they have rectified the problem
  2. Fit a new banjo bolt (or have one fitted)
  3. rework the valve seat
1. is probably the most time-consuming and annoying method, as you have to reconcile deadlines  
2. very successful with a „good“ banjo bolt  
3. **nothing for beginners.**

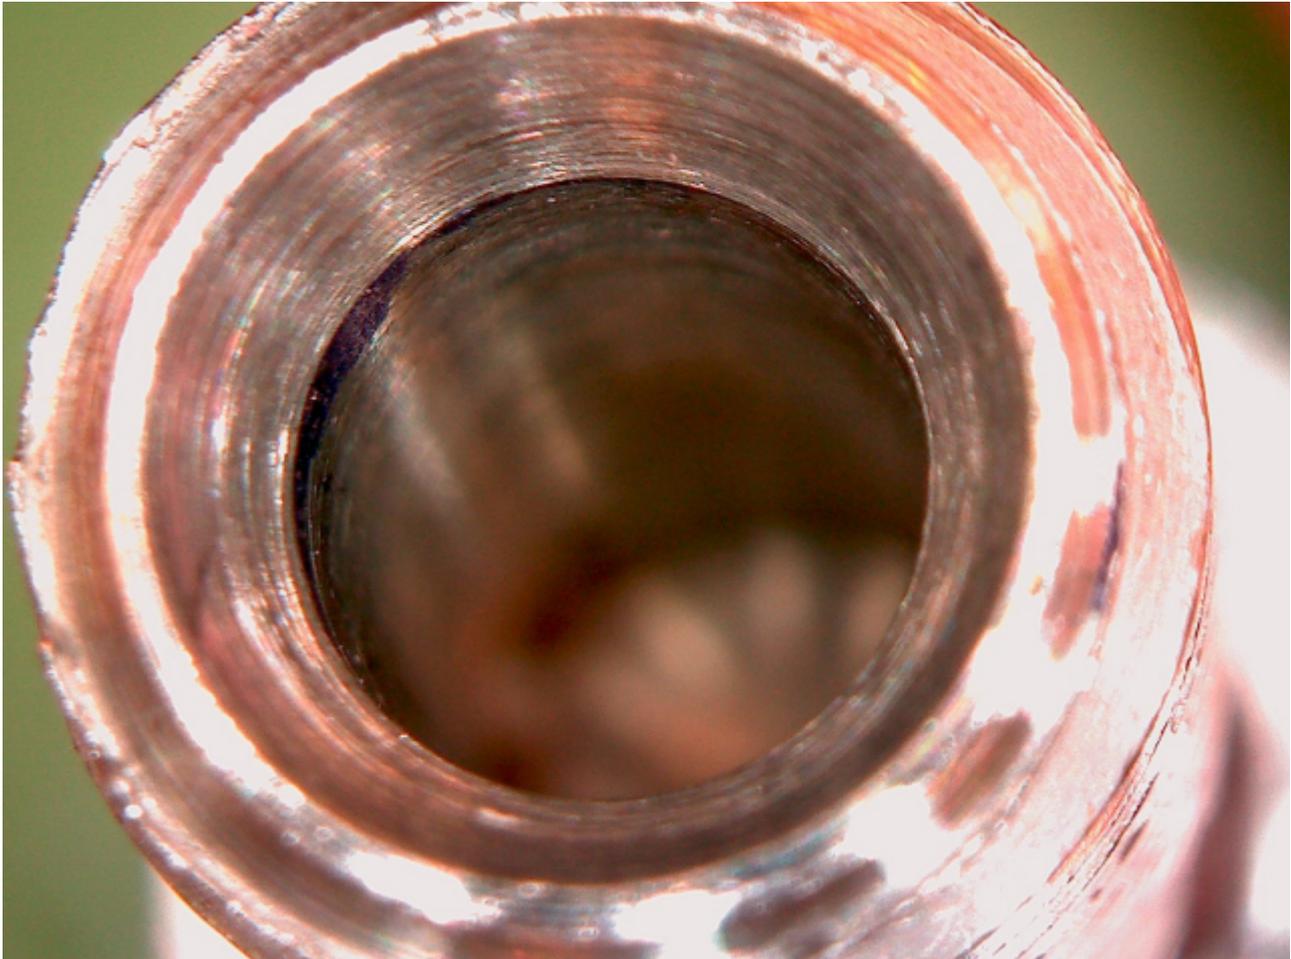
Unfortunately, the valve seat is not always designed precisely enough to be considered a valve seat, as the following image illustrates.

The image shows the conical valve seat in the banjo bolt. You can imagine that a leak is pre-programmed here.

However, I must point out that the picture is from an older version. The banjo bolts are now made of stainless steel and generally look better.

Place the banjo bolt with the bolt head on a stable surface (anvil, vice) and place the ball on the valve

Then place a cloth over it to keep the ball in place.

Now hit the ball with a 200g hammer with a targeted and balanced blow.
