# The check valve on the 914 turbocharger

... or why there is a pool of oil under the 914

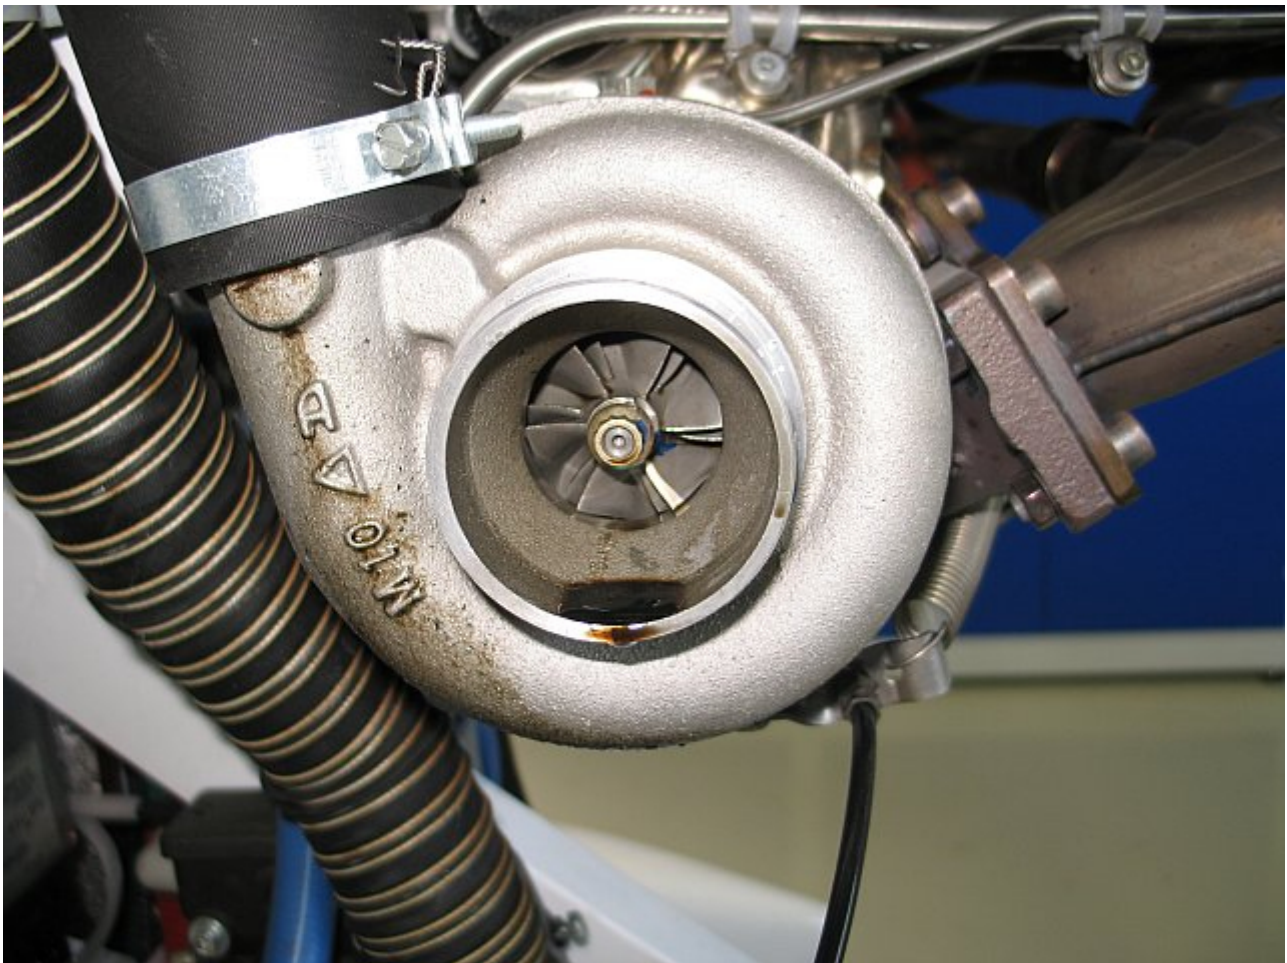
A pool of oil that shouldn't be there is smiling at you in the turbocharger.

If the non-return valve in the valve housing is not tight, the oil sump will fill up and then the turbine and compressor housing will also fill up.

If this is also full, the oil continues to run into the exhaust and into the compressor housing inlet. Here you can see the oil loss when oil drips from the intake hose.

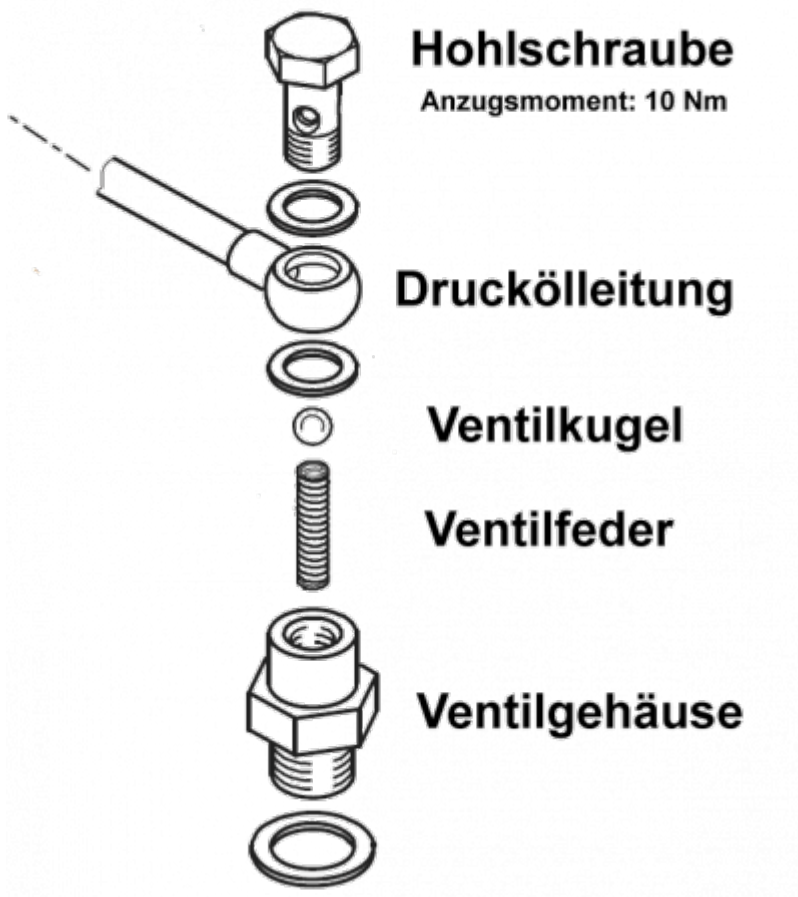
The valve is intended to ensure that no oil can run in from the direction of the oil pump.

To do this, the ball is pressed against the banjo bolt. During operation, the ball is lifted from the valve seat by the oil pressure and the oil can lubricate the turbocharger unhindered.

- The valve housing is mounted on top of the turbocharger.
- There is a compression spring in the valve housing
- which presses the ball above it
- against the banjo bolt.

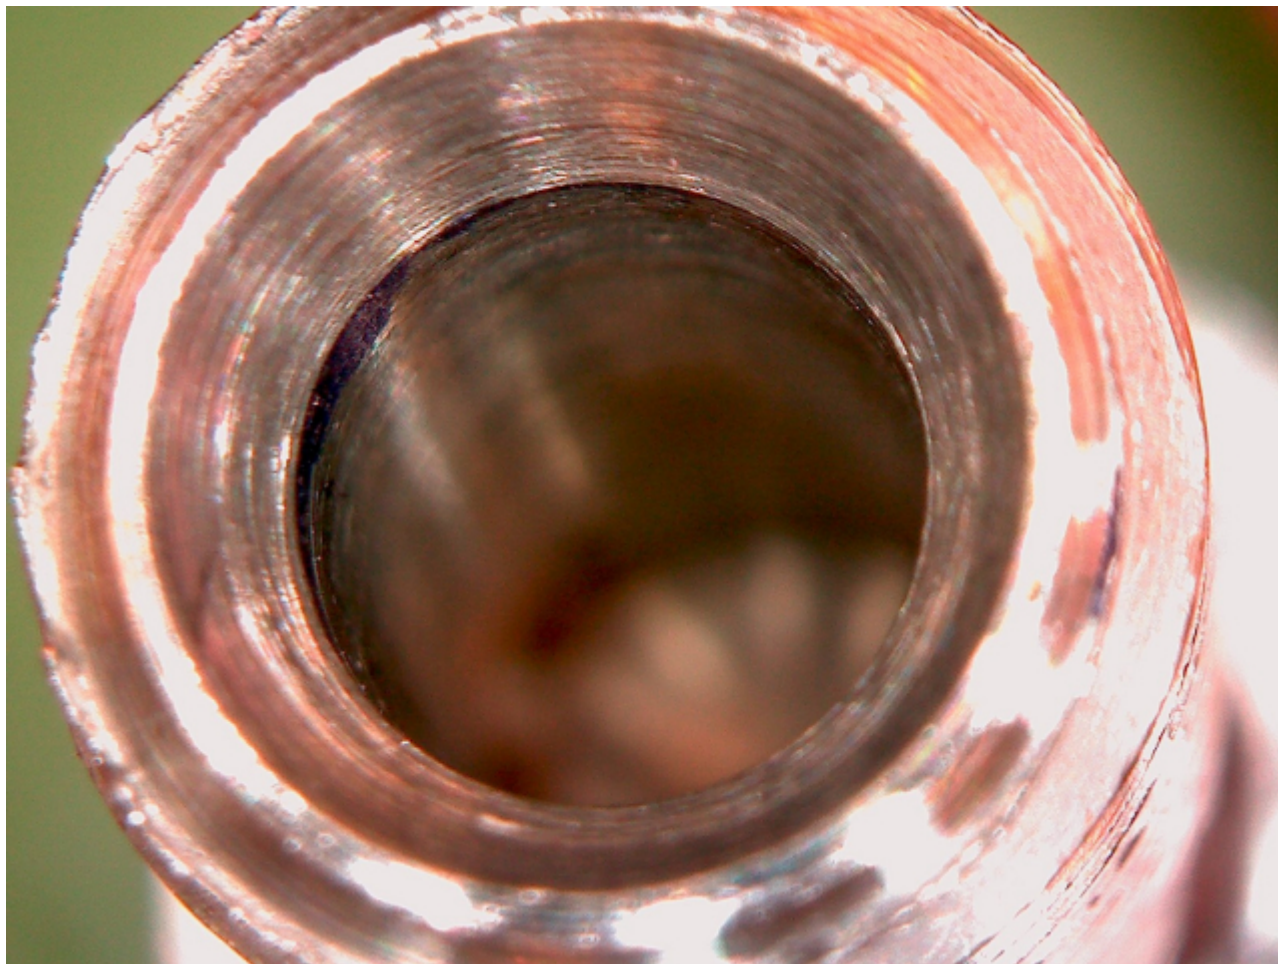
Unfortunately, the valve seat is not always designed precisely enough to be considered a valve seat, as the following image illustrates.

The image shows the conical valve seat in the banjo bolt. You can imagine that a leak is pre-programmed here.

However, I must point out that the picture is from an older version. The banjo bolts are now made of stainless steel and generally look better.

1. During the warranty period, get on your contractual partner's nerves until they have rectified the problem
  2. Fit a new banjo bolt (or have one fitted)
  3. rework the valve seat
- 
1. is probably the most time-consuming and annoying method, as you have to reconcile deadlines
  2. very successful with a „good“ banjo bolt
  3. **nothing for beginners.**

Place the banjo bolt with the bolt head on a stable surface (anvil, vice) and place the ball on the valve

Now hit the ball with a 200g hammer with a targeted and balanced blow.

Now you should see a nice, smooth valve seat in the banjo bolt under the microscope and have permanent peace of mind after assembly.
