# oval inlet valve seats

... and a possible cause

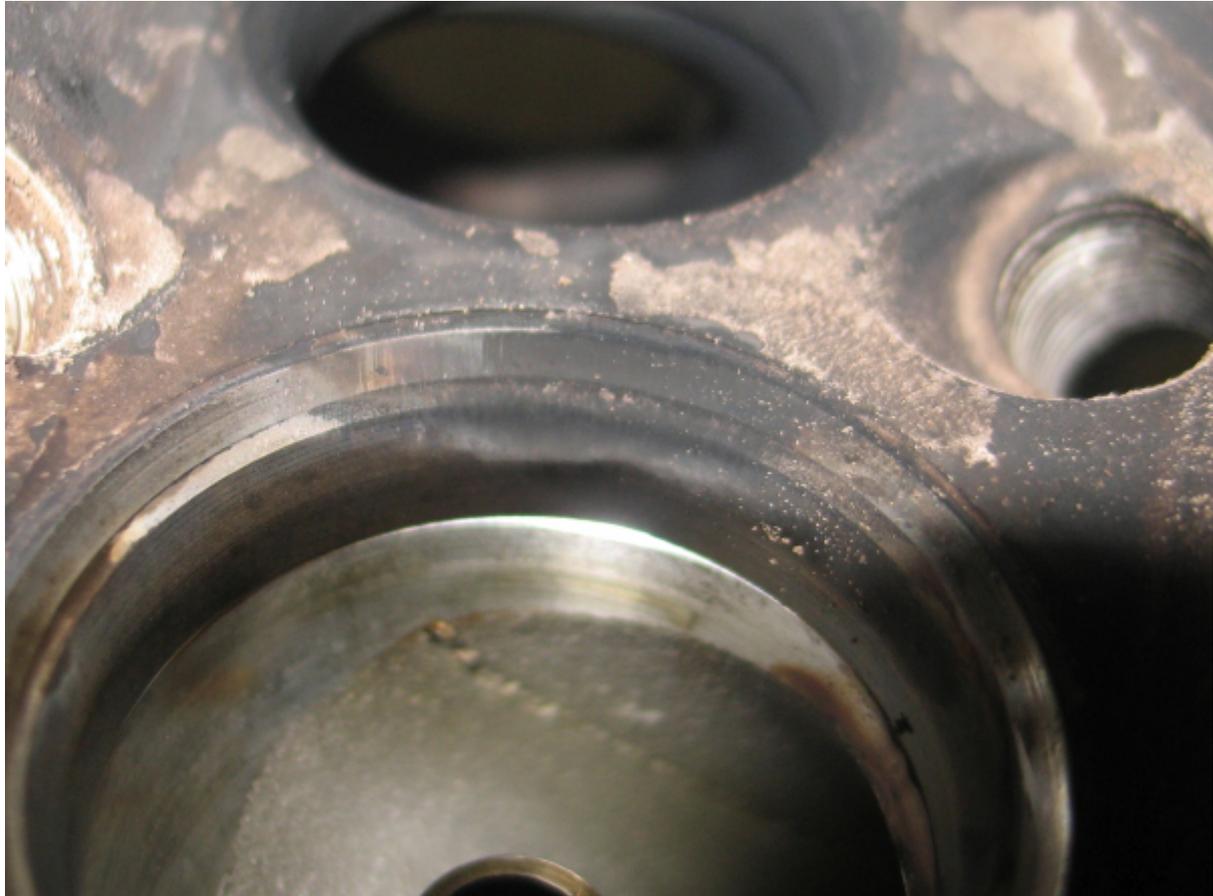
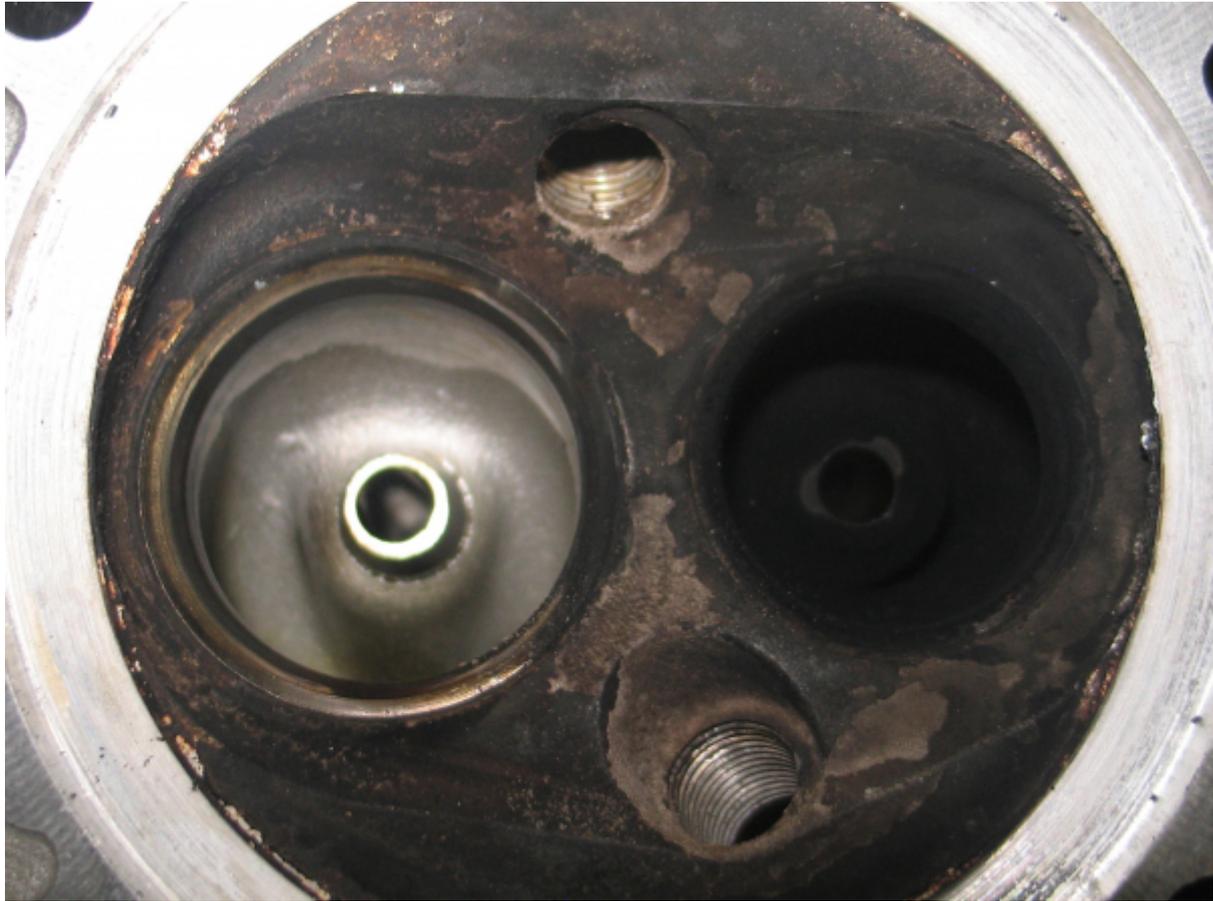
What is certain is that the most common cause of increased pressure loss is ovality of the inlet valve

Unfortunately, this is usually due to the installation situation.

The engine is constantly working at the thermal upper operating limit and the operator may still have difficulty making adjustments.

Here we can clearly see a black area on the inlet valve seat. The valve is no longer working properly there and the combustion gases are escaping. Here we have the measured pressure loss.

The running time of the engine was approx. 400 hours, the pressure loss was 18%.

In the last example, you still have the option of grinding in the valve to make it tight again. The cylinder head in the first two pictures can only be repaired by re-milling the valve seat.

\*\*So - if the pressure loss reaches double figures during engine maintenance, remove the head and carry out the necessary repair.

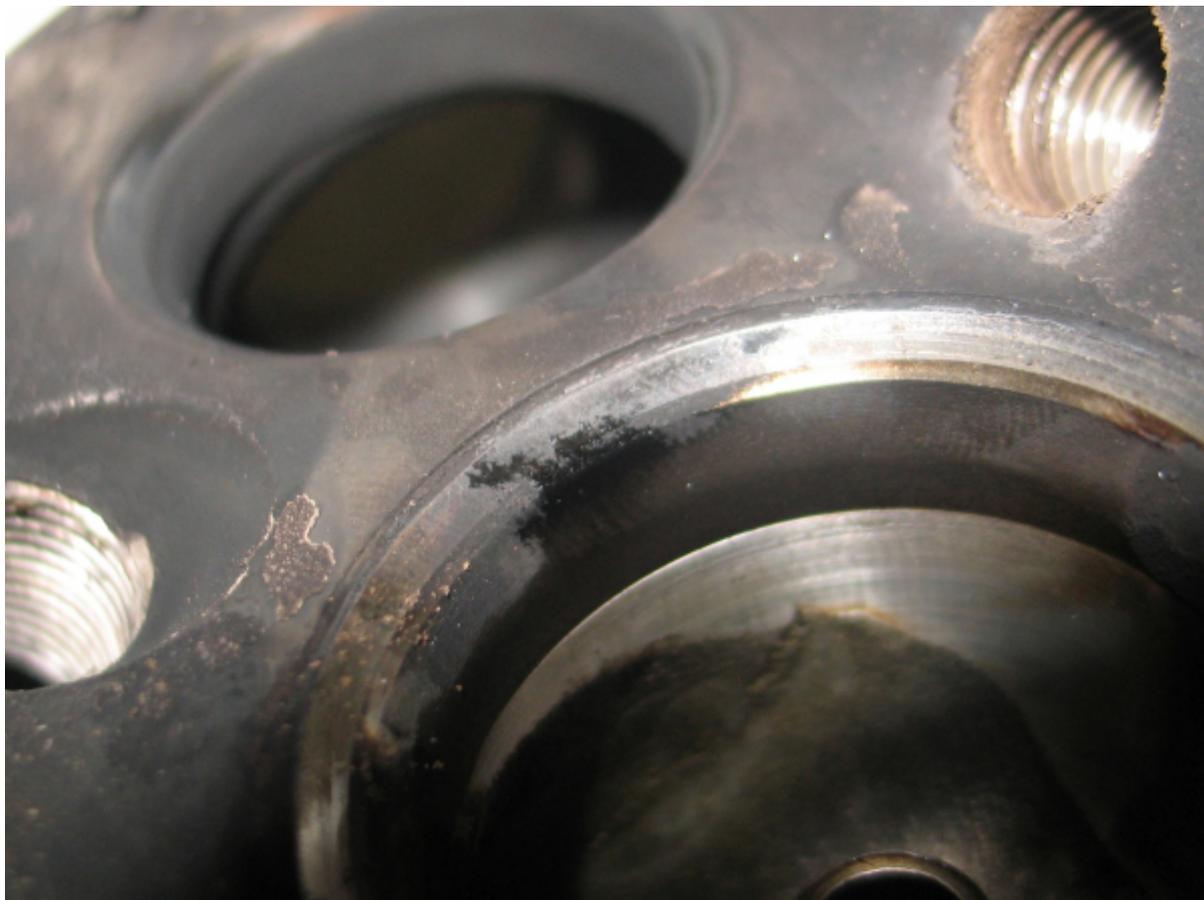
An example with a measured pressure loss of 10%.  
The black area on the valve seat is clearly visible. It doesn't look too bad yet, but the ovality is on the rise.  
As you can imagine, it is not only the valve seat that suffers, but also the valve's inability to dissipate heat.
