oval inlet valve seats

... and a possible cause

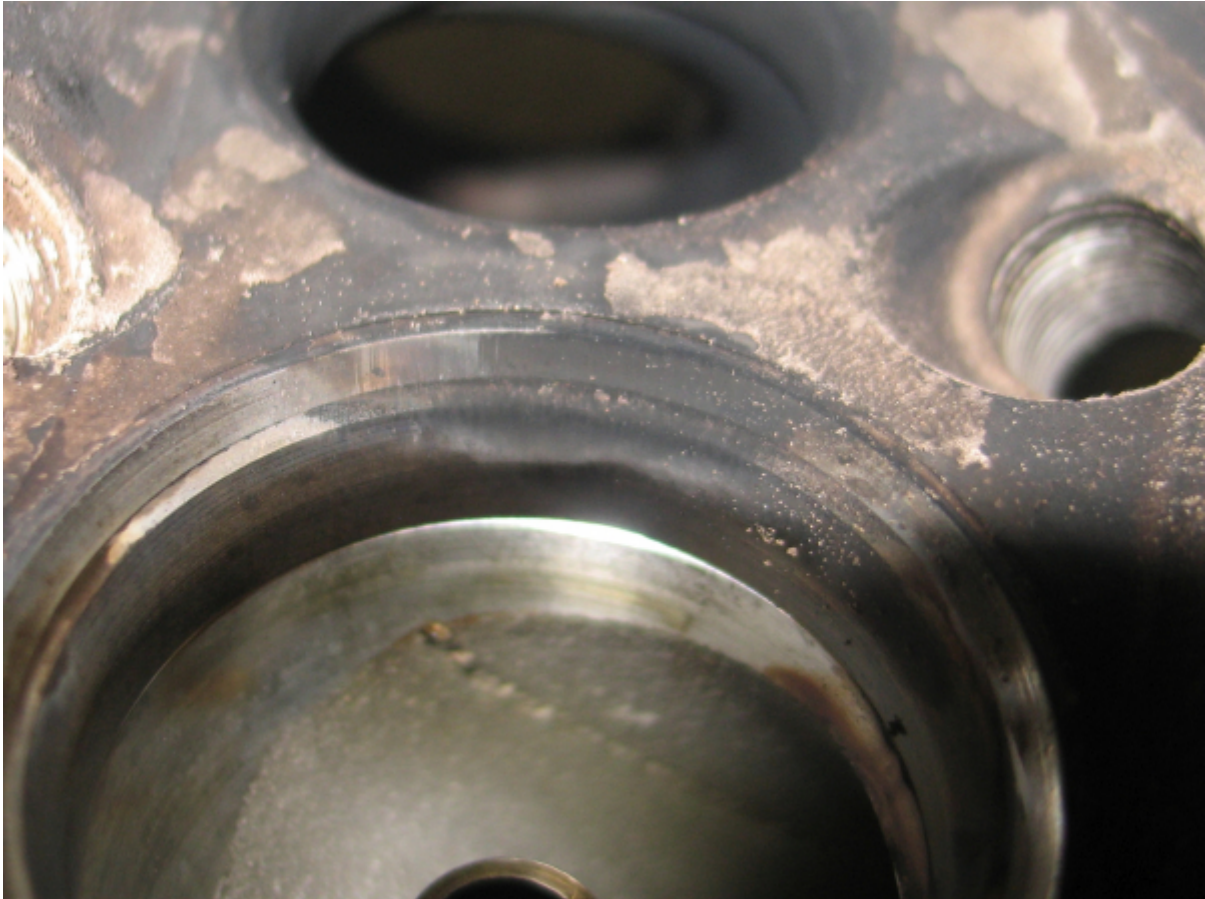
Unfortunately, this is usually due to the installation situation.

The engine is constantly working at the thermal upper operating limit and the operator may still have difficulty making adjustments.

Here we can clearly see a black area on the inlet valve seat. The valve is no longer working properly there and the combustion gases are escaping. Here we have the measured pressure loss.

The running time of the engine was approx. 400 hours, the pressure loss was 18%.

In the last example, you still have the option of grinding in the valve to make it tight again. The cylinder head in the first two pictures can only be repaired by re-milling the valve seat.

**So - if the pressure loss reaches double figures during engine maintenance, remove the head and carry out the necessary repair.

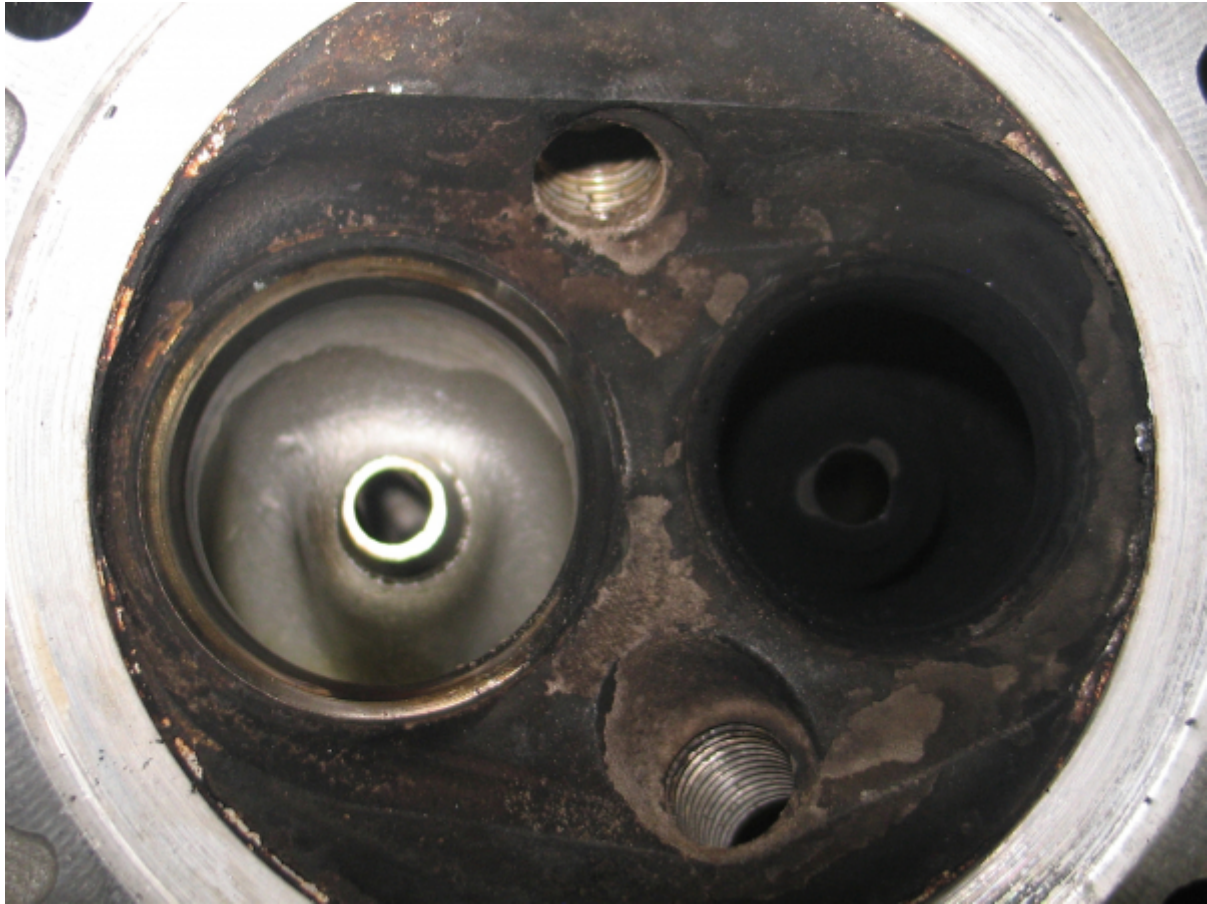
From another perspective:

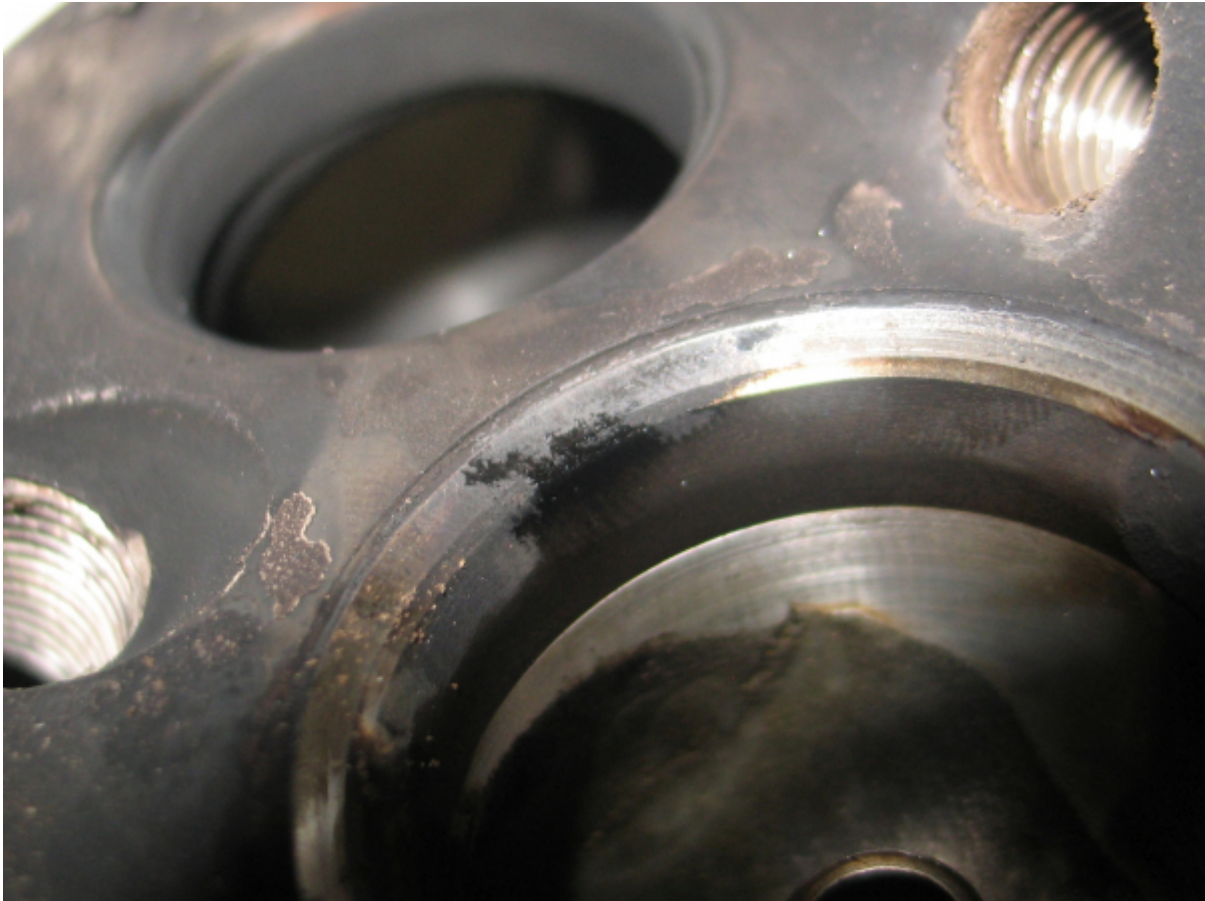
An example with a measured pressure loss of 10%.

The black area on the valve seat is clearly visible. It doesn't look too bad yet, but the ovality is on the rise.

As you can imagine, it is not only the valve seat that suffers, but also the valve's inability to dissipate heat.
