oval inlet valve seats

... and a possible cause

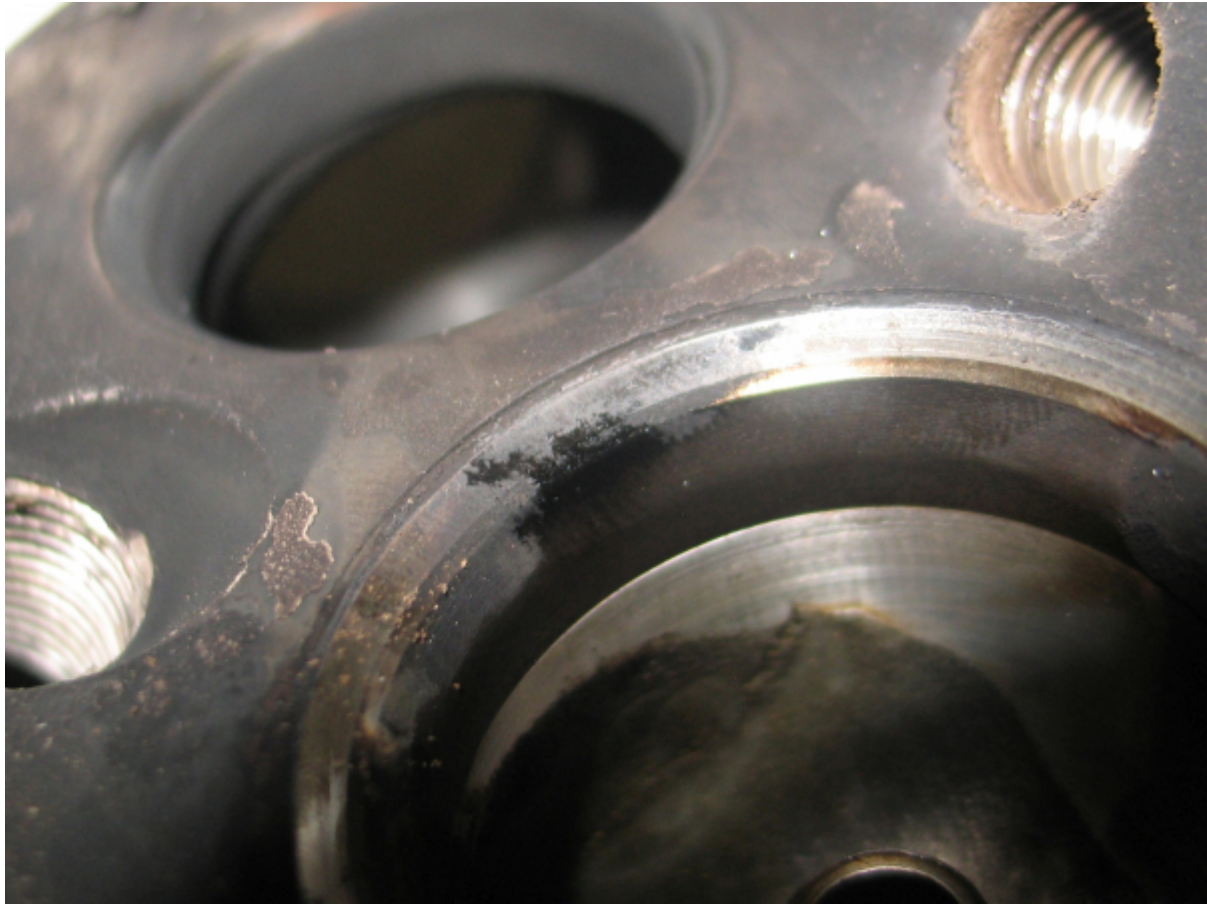
An example with a measured pressure loss of 10%.

The black area on the valve seat is clearly visible. It doesn't look too bad yet, but the ovality is on the rise.

As you can imagine, it is not only the valve seat that suffers, but also the valve's inability to dissipate heat.

In the last example, you still have the option of grinding in the valve to make it tight again. The cylinder head in the first two pictures can only be repaired by re-milling the valve seat.
