The turbo switch on the 914

... or what is the mystical devil thing actually there for?

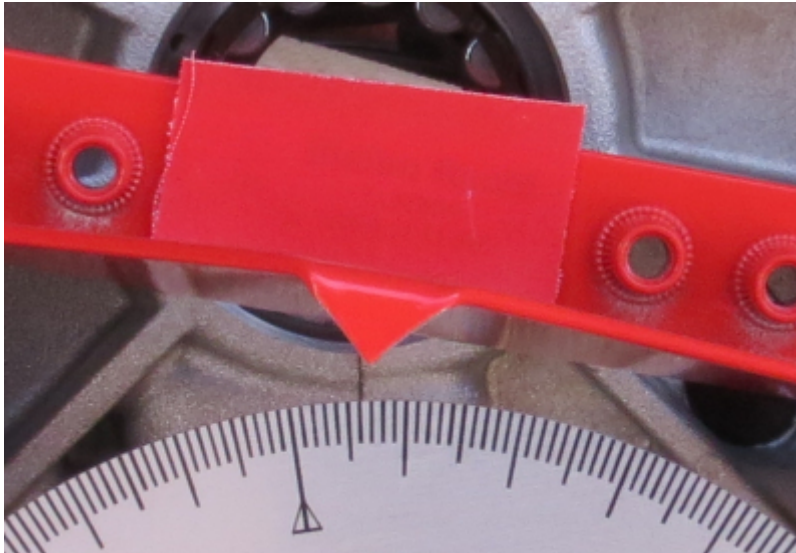
Turn the piston to the piston stopper at cylinder 2 and read the position on the degree disk.

Here you can clearly see that the crankshaft between the two measured cylinders is twisted by approx. 6° and needs to be replaced.

A very clear recommendation is to seal the switch and include its inspection in the checklist.

**If the seal is damaged, do not take the flight.
read out the operating parameters of the TCU
and check for an overboost.**
