The turbo switch on the 914

... or what is the mystical devil thing actually there for?

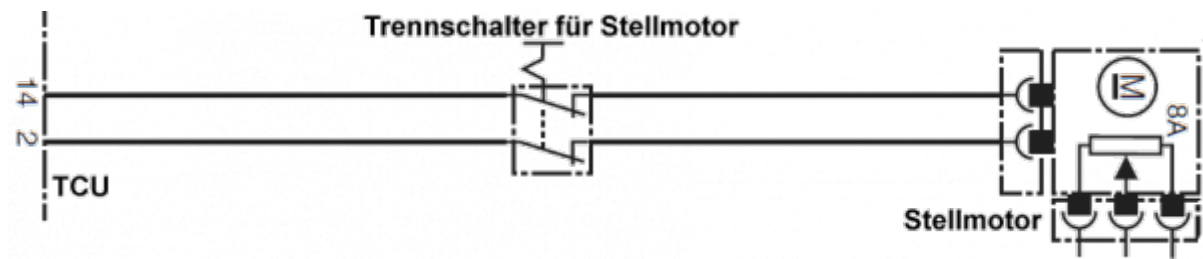
Disconnect switch for servomotor

The isolating switch is used to briefly switch off the servomotor if the boost pressure regulator oscillates.
A stable operating state should then be established after a short control time.

The circuit diagram now shows exactly what the switch actually switches.
The technical background is not explained in the aircraft operating manuals, but only a dubious procedure is specified.

The power supply to the servo that actuates the wastegate flap in the turbocharger is interrupted. This means that the flap does not move any more after the switch is pressed. Now it depends on how far the flap is closed and how much throttle is applied. If the flap is almost closed and the power setting is high, this can lead to overboost (more than 1550 mbar airbox pressure), which may cause the crankshaft to twist.

A very clear recommendation is to seal the switch and include its inspection in the checklist.

**If the seal is damaged, do not take the flight.
read out the operating parameters of the TCU
and check for an overboost.**

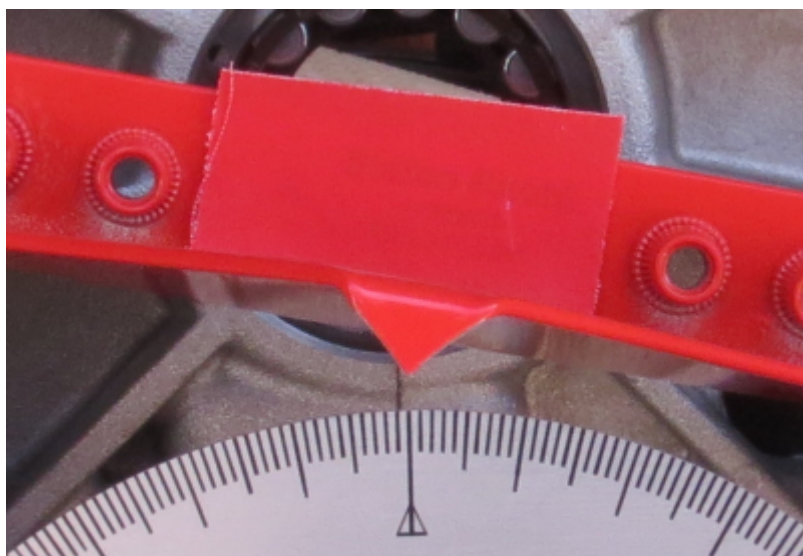
Piston turned to the piston stopper at cylinder 1 and the degree disk set to 0°.

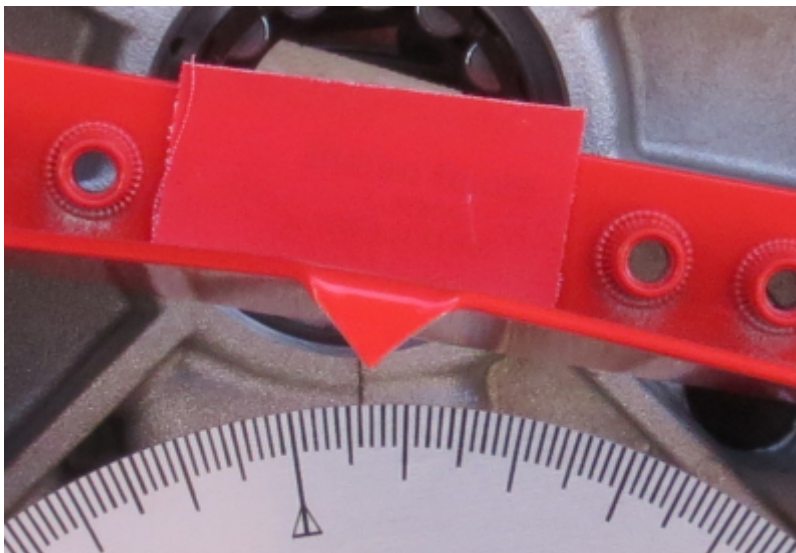
Turn the piston to the piston stopper at cylinder 2 and read the position on the degree disk.

Here you can clearly see that the crankshaft between the two measured cylinders is twisted by approx. 6° and needs to be replaced.
