# The turbo switch on the 914

... or what is the mystical devil thing actually there for?

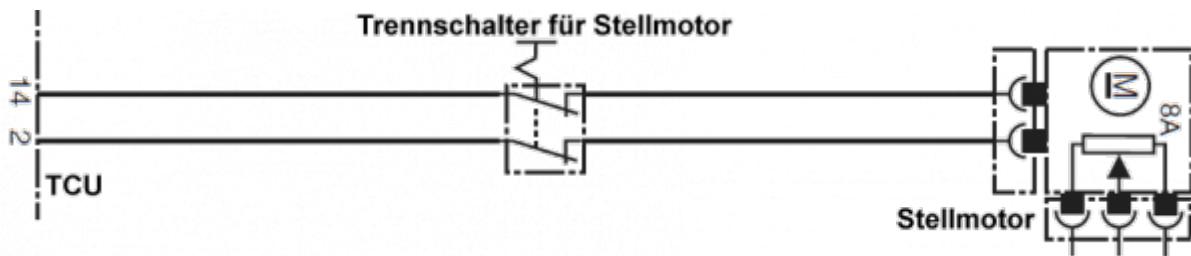
#### Disconnect switch for servomotor

The isolating switch is used to briefly switch off the servomotor if the boost pressure regulator oscillates.

A stable operating state should then be established after a short control time.

The circuit diagram now shows exactly what the switch actually switches. The technical background is not explained in the aircraft operating manuals, but only a dubious procedure is specified.

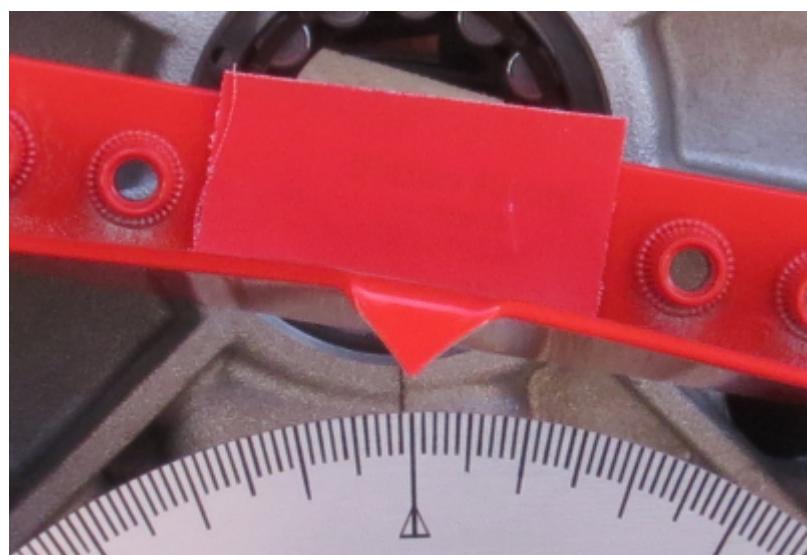
Piston turned to the piston stopper at cylinder 1 and the degree disk set to 0°.

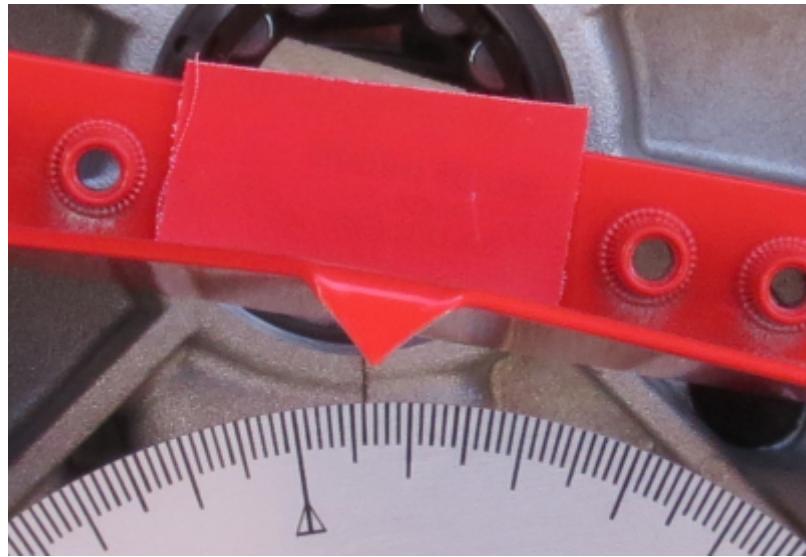
The power supply to the servo that actuates the wastegate flap in the turbocharger is interrupted. This means that the flap does not move any more after the switch is pressed. Now it depends on how far the flap is closed and how much throttle is applied. If the flap is almost closed and the power setting is high, this can lead to overboost (more than 1550 mbar airbox pressure), which may cause the crankshaft to twist.

Turn the piston to the piston stopper at cylinder 2 and read the position on the degree disk.

Here you can clearly see that the crankshaft between the two measured cylinders is twisted by approx. 6° and needs to be replaced.

A very clear recommendation is to seal the switch and include its inspection in the checklist.
