The transition holes

.... That's why I'm only reporting here on my experiences with modifying the Bing's on a 912 ULS with 100 hp.

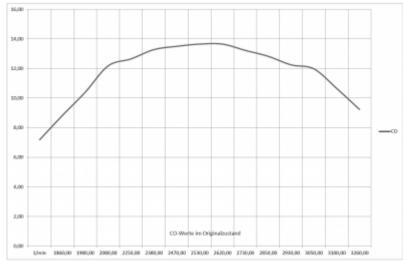
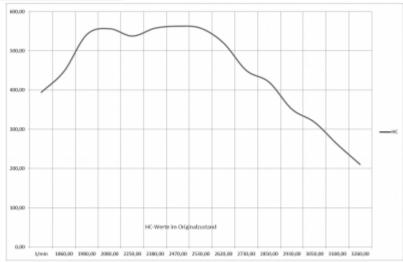
Original

This is why we have the following exhaust gas values (values determined on the test bench with overhauled carburetors) for the Bing's in their original condition (left CO - right HC): click to enlarge

At almost 14% CO and 550 ppm HC, the engine is already running very close to the "stall limit".

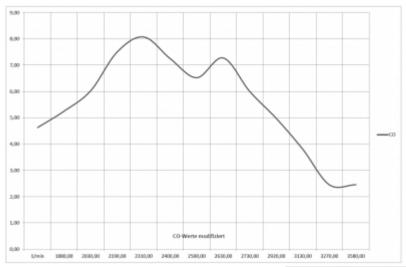
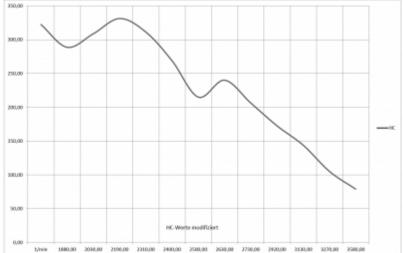
Subsequent test runs with extensive exhaust gas measurements and also tests with sudden throttling in every operating state then resulted in the following pictures:

.... looks great, I thought to myself and looked for a test pilot

Since I was able to gain some experience with carburetors during my almost 30 years as a motorcycle mechanic, I have now sealed the transition bores on a set of used Bing's.

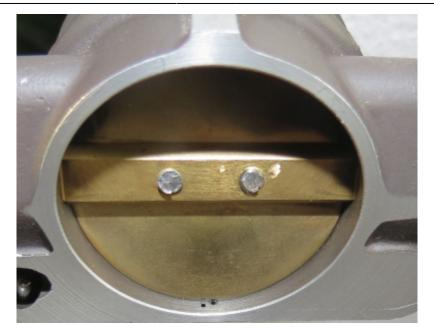
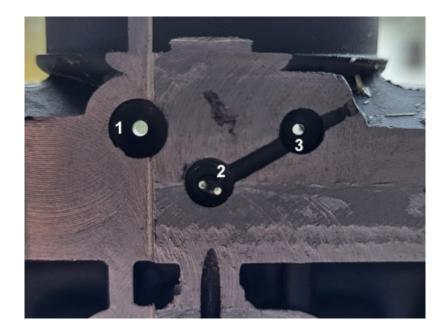
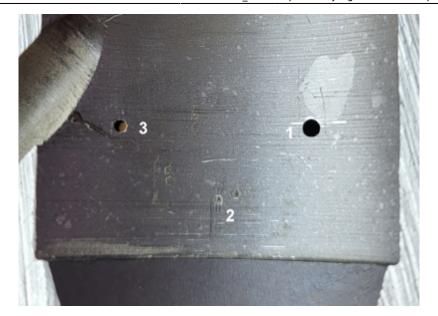
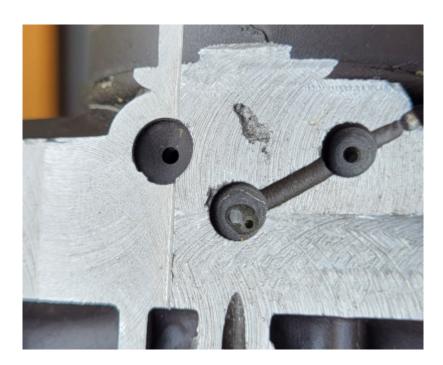
Picture story

1=Synchronization connection **2**=Transition holes **3**=Hole for idle mixture adjustment screw and outlet of the idle mixture in operation

- removed the float chamber from the carburetors
- removed the idle jets and mixture screws
- flooded the holes of the idle jets with brake cleaner and blew them out
- so that the idle system is dry and grease-free -
- a little 2K-Stabilit Express 1)
- and glue the transition holes.
- When gluing, make sure that not too much adhesive gets into the transition holes, otherwise the channel in the carburetor will be closed. The carburetor can then only be saved with considerable effort.
- The excess glue is simply cut off with a scalpel in the Venturi tube with the throttle valve open while it is still not fully cured.

If the transition holes have been sealed, the basic setting of the idle mixture screws is approx. 2.0 to 2.5 turns.
