# the hoses of the float chamber ventilation

... on the 914 and their pitfalls.

## On the Rotax 914 it looks like this:

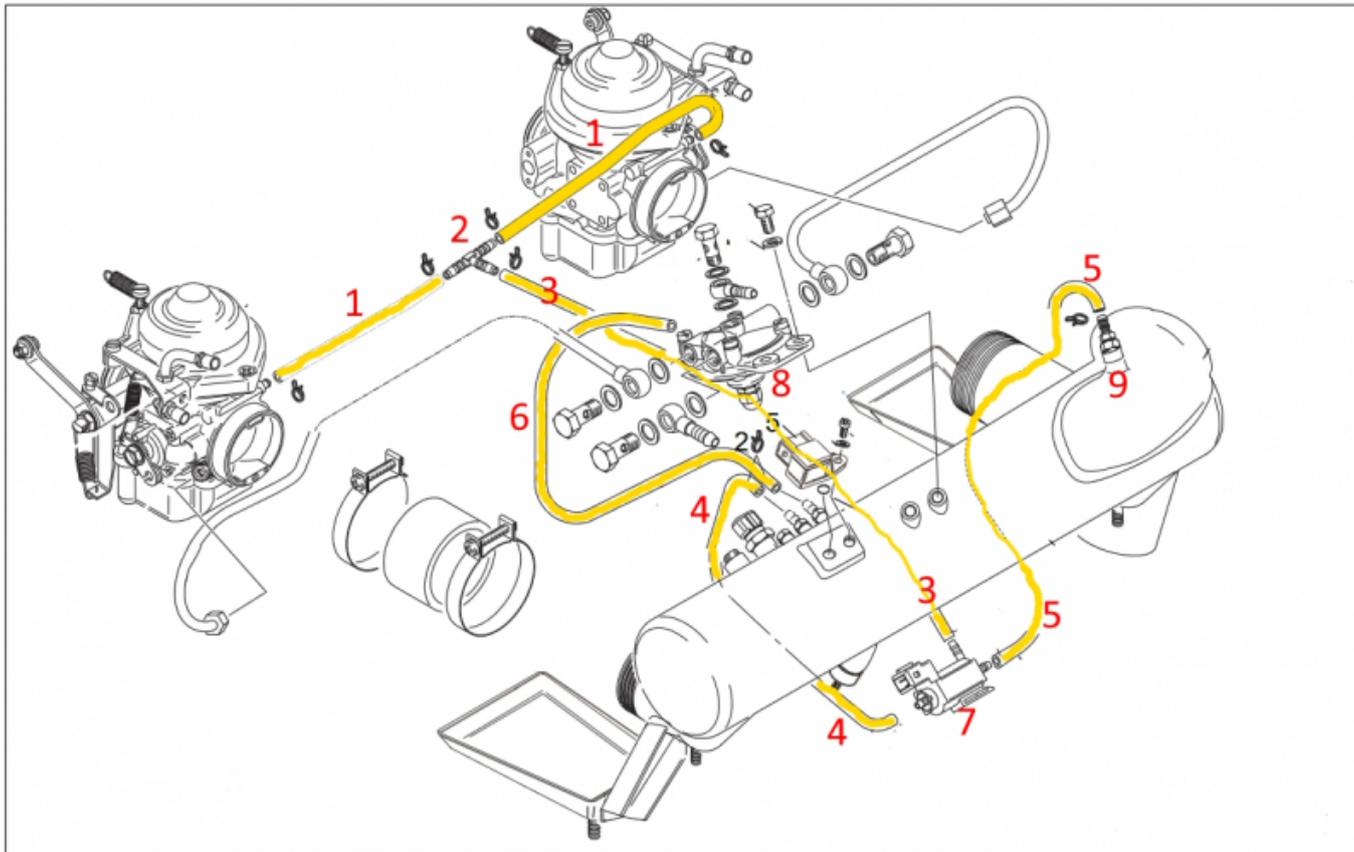
1)

A hose(1) is fitted to each float chamber ventilation, which leads via a T-piece(2) into the individual hose(3) to the 3-way valve(7). If the airbox pressure is below 1280 mbar, the hose(4) leads from the 3-way valve to the middle of the airbox.

If the airbox pressure now rises above 1280 mbar, the 3-way valve switches over. As a result, the pressure for the float chamber ventilation is now removed via the hose(5) from a pitot tube(9) in the air flow of the air pressed into the airbox by the turbocharger.

Due to the position, design and setting of the pitot tube, the pressure in the float chamber is increased by 10 mbar. This means significant greasing at a power setting of 115%, i.e. starting power.

We also have the hose (6) that leads from the center of the airbox to the fuel pressure regulator. The fuel pressure regulator regulates the fuel pressure to 250 mbar via the airbox pressure.

## **Crack in hoses 1, 3 and 4**

## **Crack in the hose 5**

## **Crack in the hose 6**

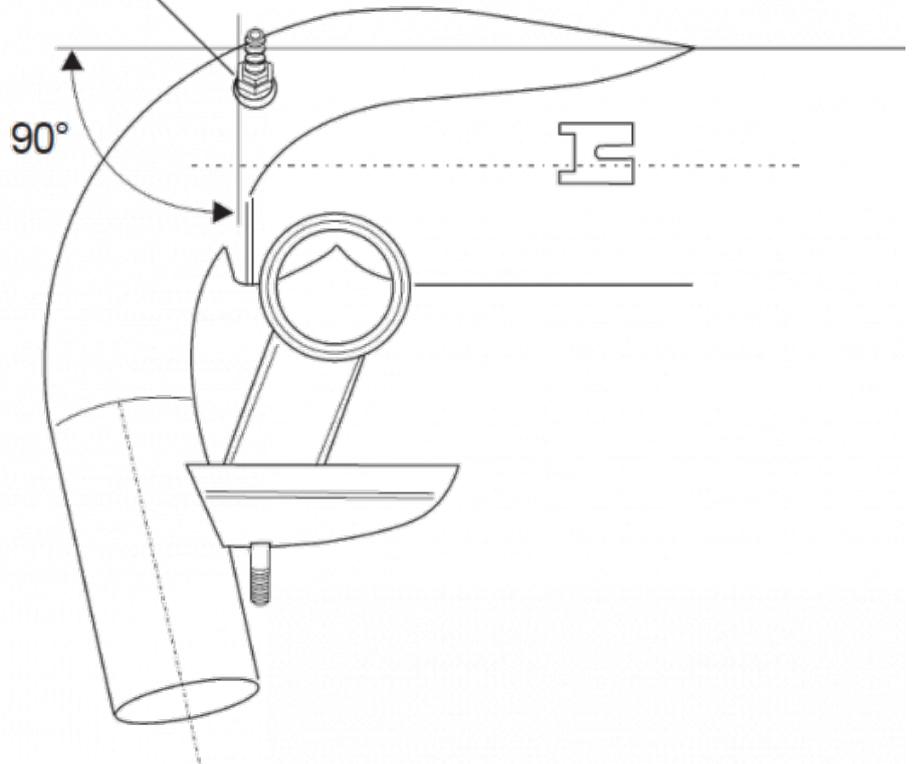
### Position of the enrichment jet: counter sinking on the hexagon

The pitot tube has a hole that is directed into the airflow that is fed from the turbocharger to the airbox.

Incorrect adjustment can lead to engine damage due to leaning.  
If the pitot tube is twisted, there is a basic setting as shown in the following illustration.

An exact setting is only possible on the engine test bench and is carried out after a repair during the test run.

This requires an exhaust gas measurement at starting power.

The lock nut of the pitot tube is marked in color with locking paint.
