# ... always black spark plugs

... or why the spark plug pattern on a Rotax carburetor engine is usually a fata morgana...

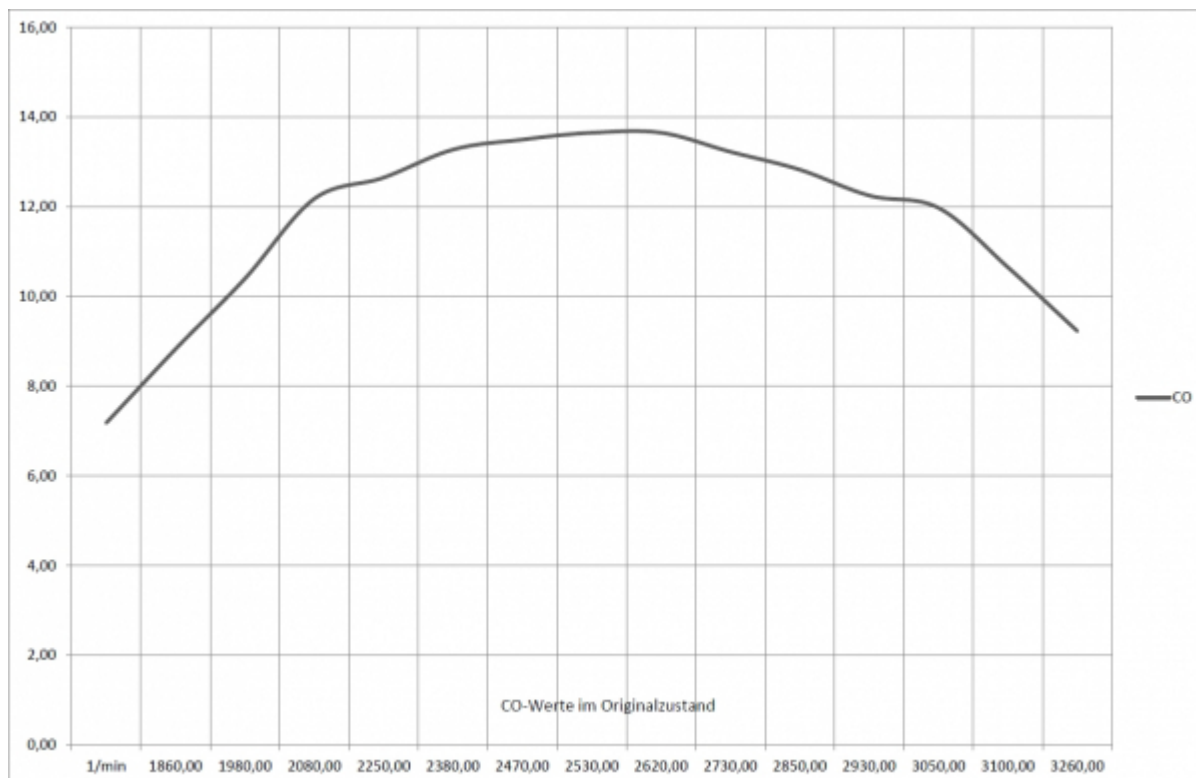
What is the reason for this? Let's first take a look at a graph that illustrates the CO content of the engine in the low to medium speed range:

If you now look at the speed range in which you roll to the parking area, it becomes clear that the spark plugs must be black.

With a CO content of approximately 14%, we are in a range where the engine is still just able to process the fuel „poured in“.

So we have to run the engine for several minutes in a range where the exhaust gas values are reasonably „normal“ before switching off.

In the lower to medium speed range, the engine runs too rich for a reasonable spark plug pattern and in the upper range, the differences in the exhaust gas values of the individual cylinders are too large\....
