the leakage hole on the igniter housing

... mostly well hidden holes and their meaning

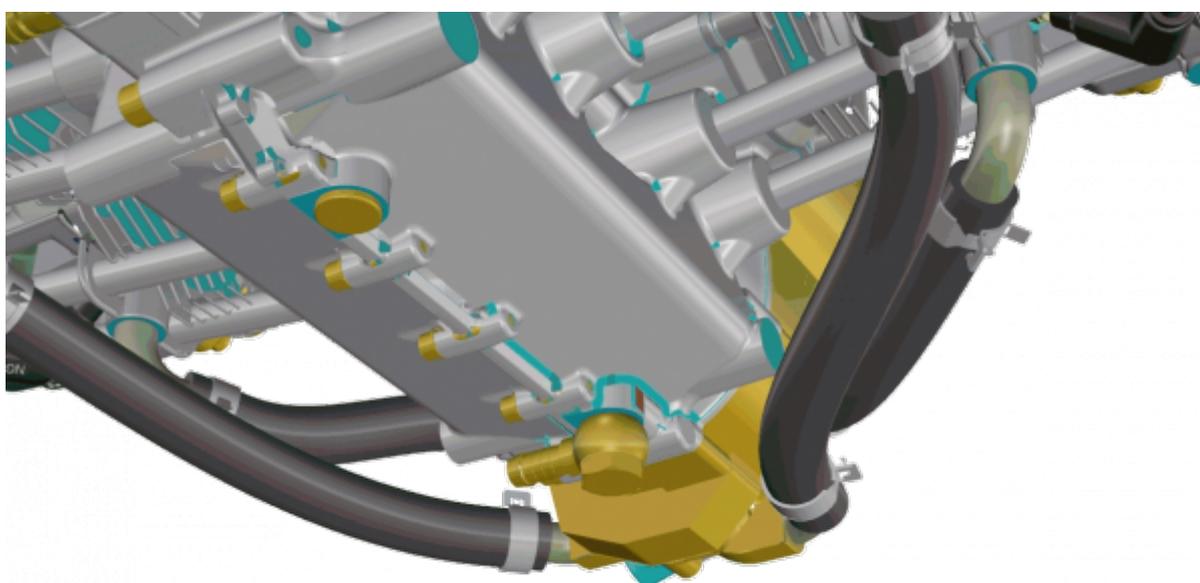
During an engine check, you will come across the following item in the checklist:

Carry out visual inspection of leakage bore at the base of the water pump for signs of leakage.	X		X						12-20-00 Leakage check	
---	---	--	---	--	--	--	--	--	------------------------------	--

This is one of the points where the search begins because you have never seen the holes before ...

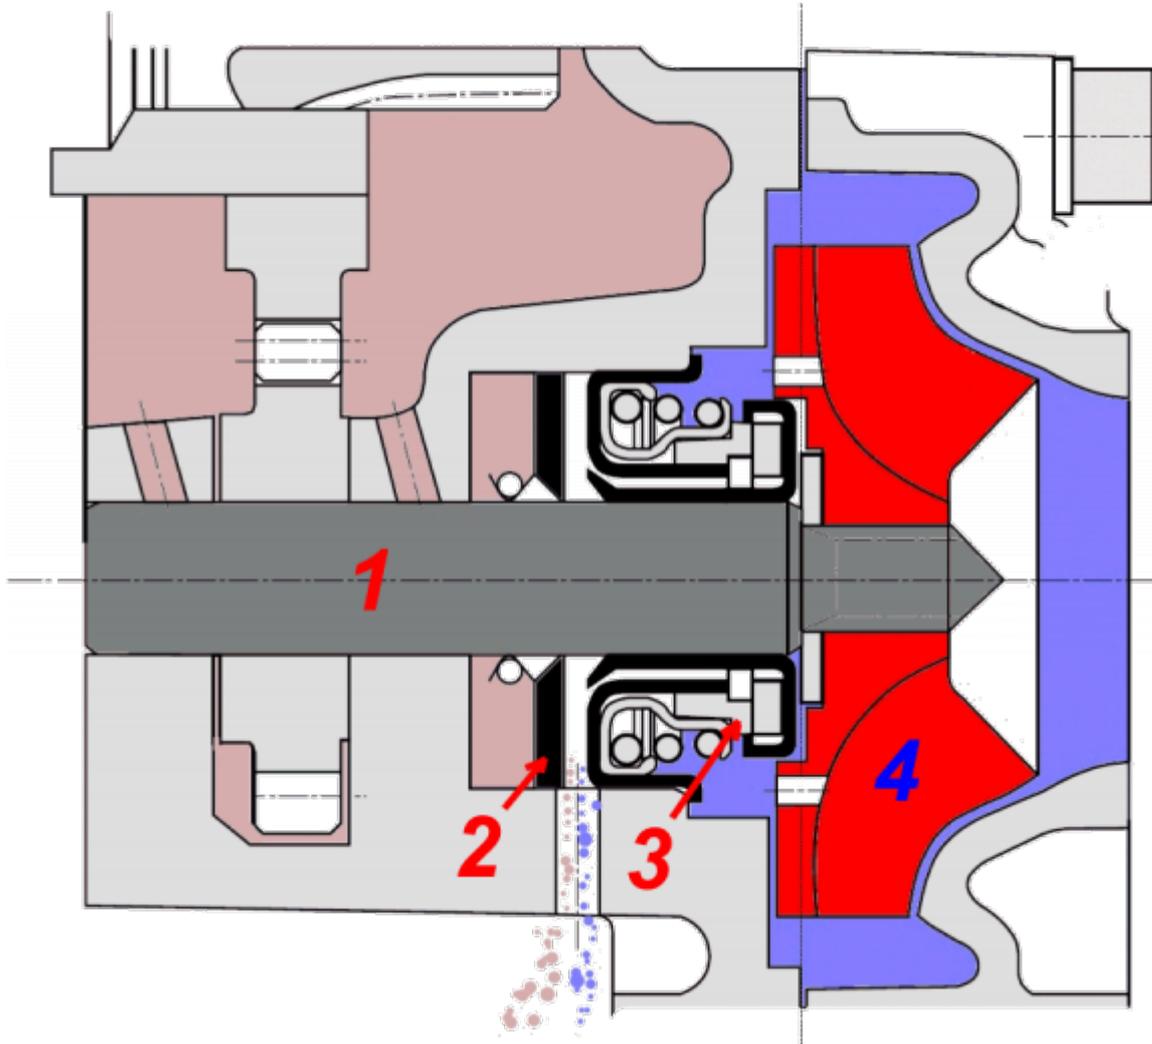
Here is the cross-section through the water pump with the following components

- 1. Water pump shaft
- 2. Shaft seal ring
- 3. Mechanical seal
- 4. Pump impeller

The leakage hole is located between numbers 2 and 3.
A fluid leak is shown here with light red and light blue dots.

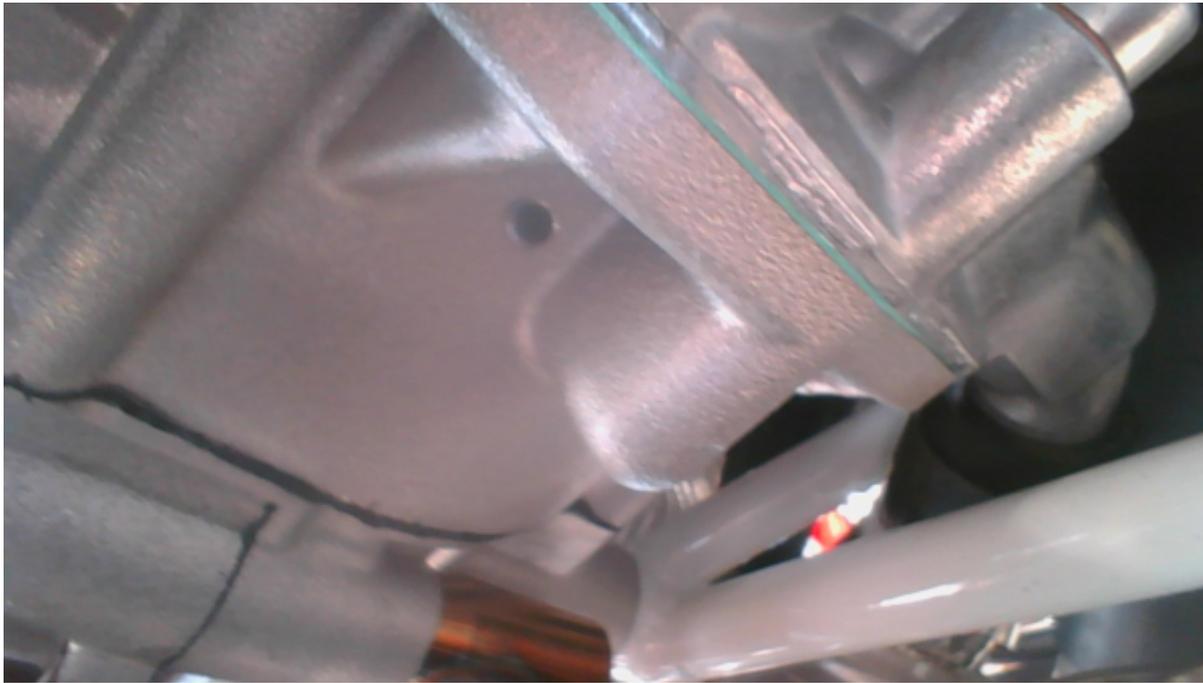
one of the drill holes
The green water pump seal can be clearly seen in the top right-hand corner and the engine mount further in the background

The leakage holes are actually not that difficult to find. They are located at the bottom of the engine, where the water hoses to cylinders 1 and 2 are connected to the

water pump housing. The water pump housing is mounted on the igniter housing. The only problem is that the silencer usually sits underneath and thus greatly obstructs the view.
