Lubrication of the hollow propeller shaft

... how the propeller shaft and the longitudinal gearing are lubricated without contact.

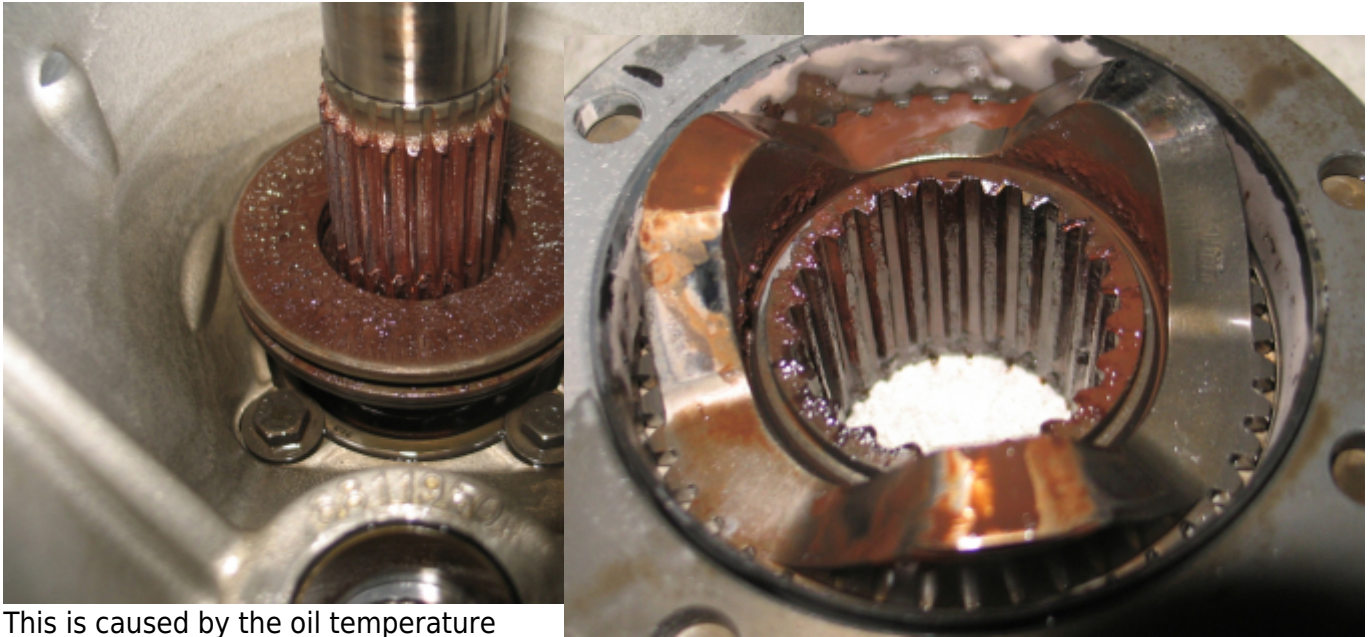
If we have a so-called „cold runner“, **the gearbox may look like this after disassembly:**

cruel pictures

This is caused by the oil temperature being too low during operation, resulting in an increased build-up of condensation in the engine and the formation of rust on various parts after the engine has been switched off. The crankshaft and propeller shaft are particularly affected. If the crankshaft starts to rust a little on the crank webs, this does not interfere with operation. The propeller shaft looks like the one in the pictures.

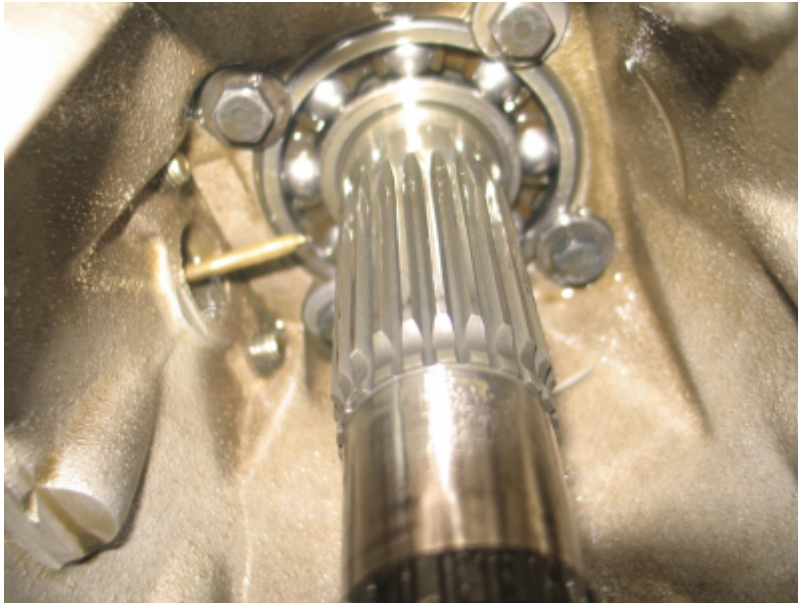
My idea was to realize the lubrication without contact.

After extensive consultation, Edi turned a suitable sleeve and I made a spray nozzle, which was mounted near the hole for the fuel pump and fed from the pressure line connection for the hydraulic governor.

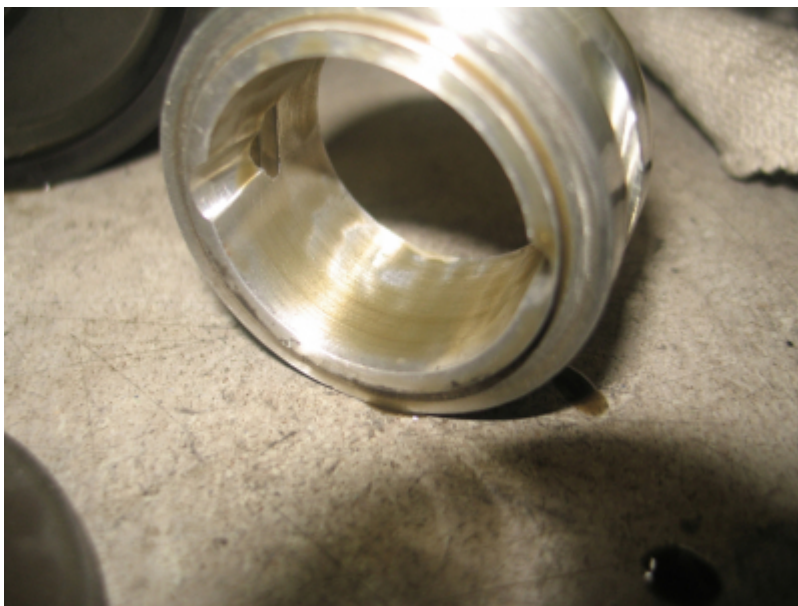
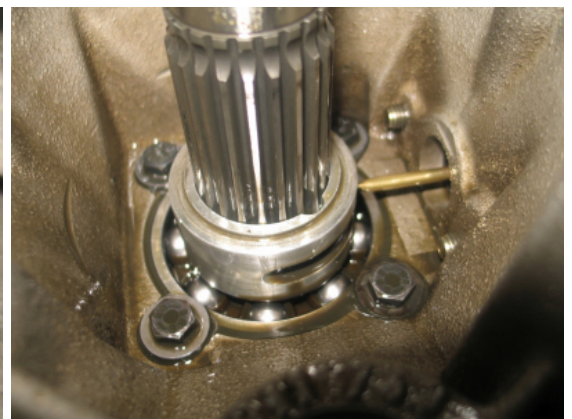
A smoking colleague had to blow into the connection to adjust the oil jet.

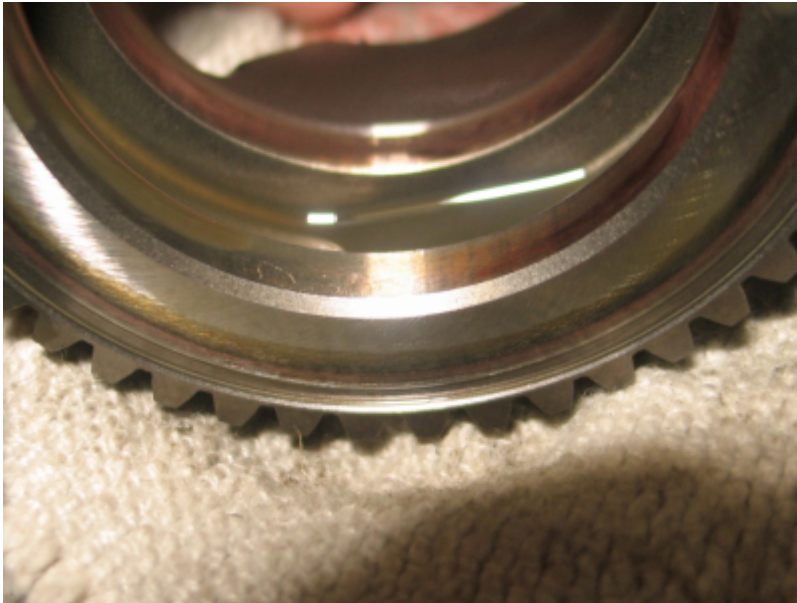
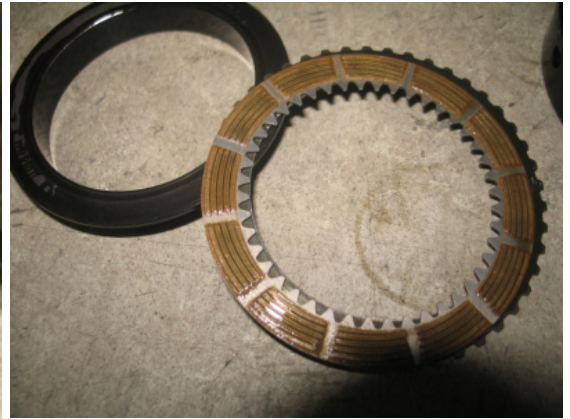
The gearbox was completely dry, i.e. degreased with brake cleaner, mounted on a 912iS injector and a test run of 5 minutes was carried out.

This is what the components looked like after disassembly.

Even in the slipping clutch, the friction plates were wet with engine oil.

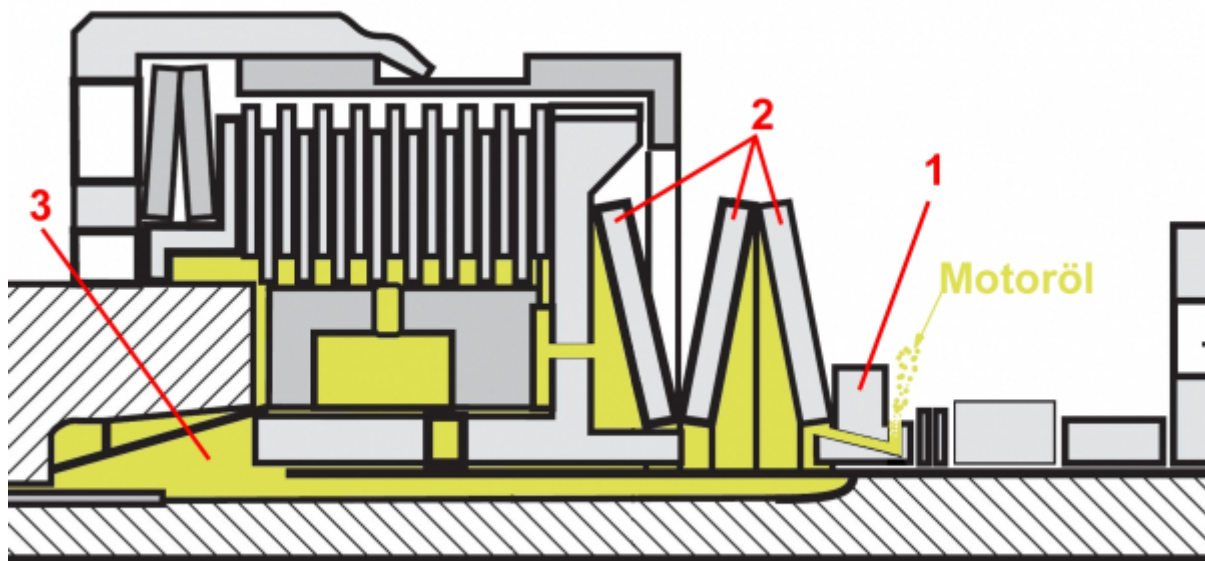
the principle of lubrication

The engine oil that enters the slotted stepped sleeve(1) through the spray nozzle is conveyed towards the slipping clutch via the disk springs(2) by the centrifugal force generated by the rotating propeller shaft and fills the entire cavity(3) next to the propeller shaft. In addition to the well-lubricated longitudinal gearing and the slipping clutch, we also have the effect that the disk springs hardly wear at the contact surfaces and the claw ramps are better lubricated.

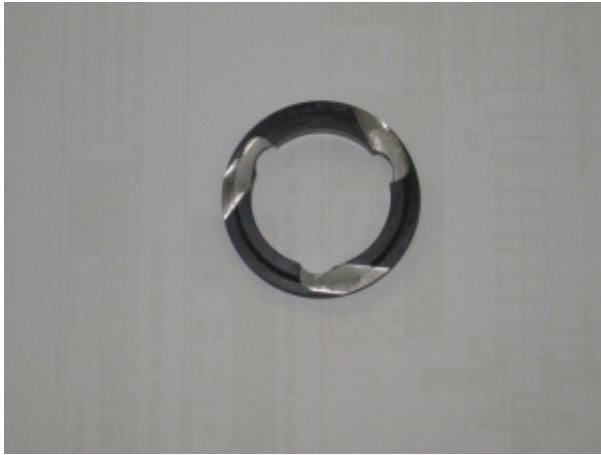
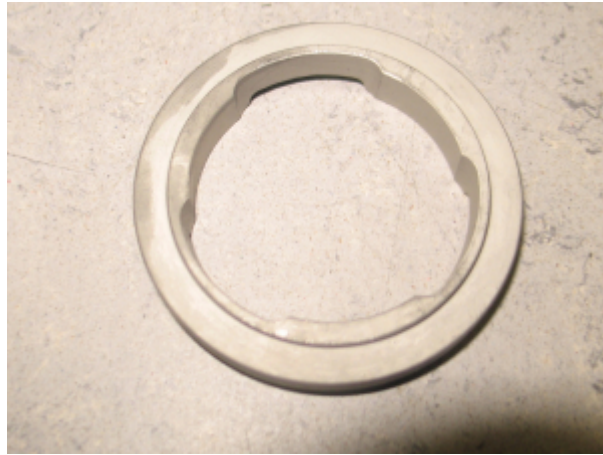
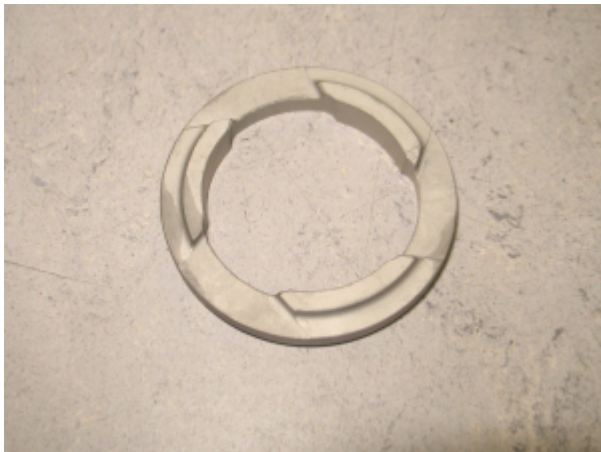
1st picture: Prototype of the stepped sleeve - 2nd and 3rd picture: The final shape.

Rotax finally brought the project to series maturity and designed the stepped sleeve accordingly.

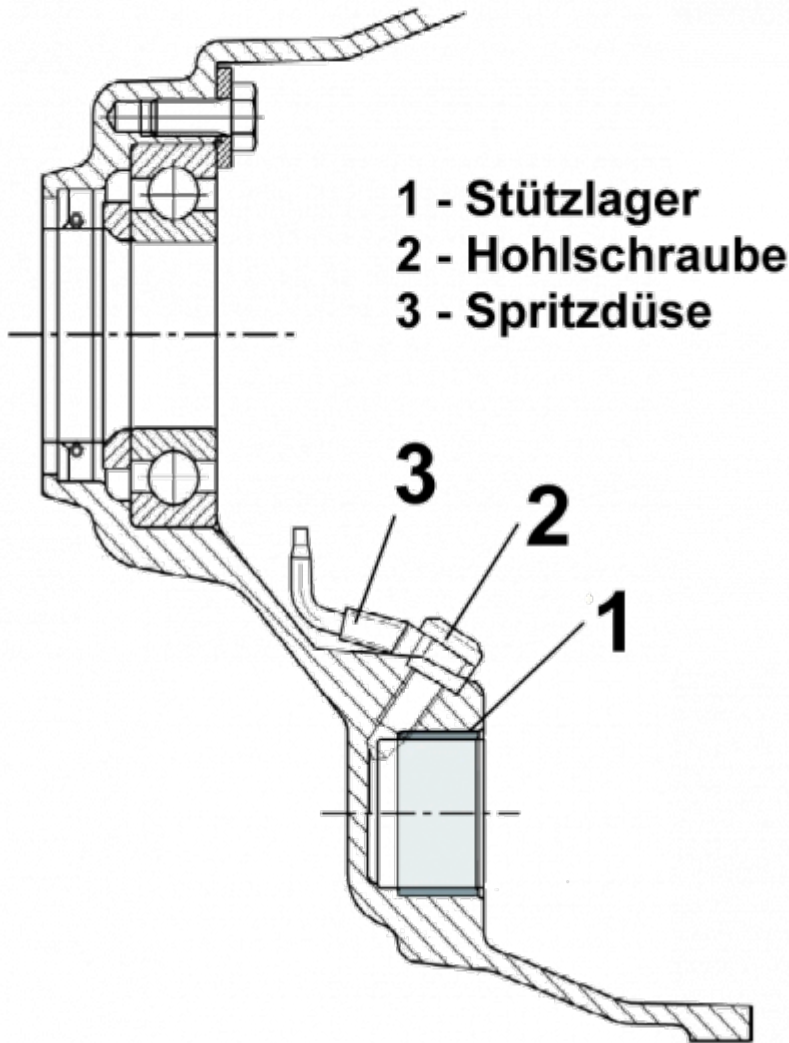
In addition, the gearbox housing was fitted with a spray nozzle that is fed by the crankshaft support bearing in the gearbox housing. The oil pressure of the crankshaft lubrication was utilized here.

1. crank shaft bearing
2. banjo bolt
3. spray nozzle

The new gearbox housing now has the spare part number

811957 for the 912 and 914 carburetor engines

811959 for the 912iS injection engine

This also indicates whether the gearbox is equipped with the lubrication system.
