the hoses of the float chamber ventilation

... on the 914 and their pitfalls.

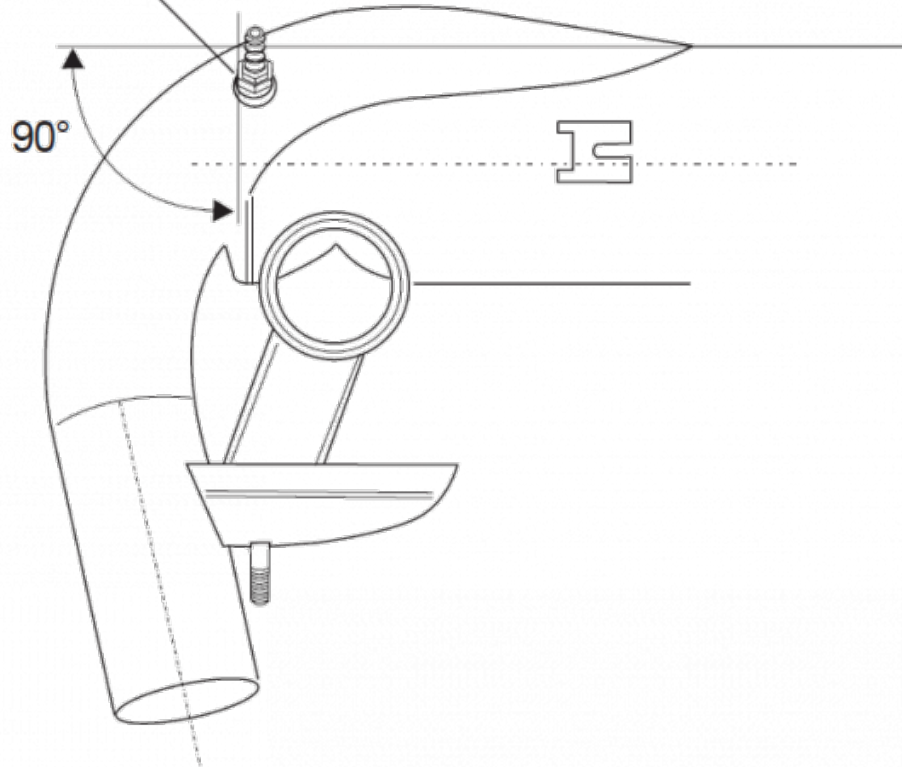
If the pitot tube is twisted, there is a basic setting as shown in the following illustration.

Position of the enrichment jet: counter sinking on the hexagon

The pitot tube has a hole that is directed into the airflow that is fed from the turbocharger to the airbox.

An exact setting is only possible on the engine test bench and is carried out after a repair during the test run.

The lock nut of the pitot tube is marked in color with locking paint.
