the hoses of the float chamber ventilation

... on the 914 and their pitfalls.

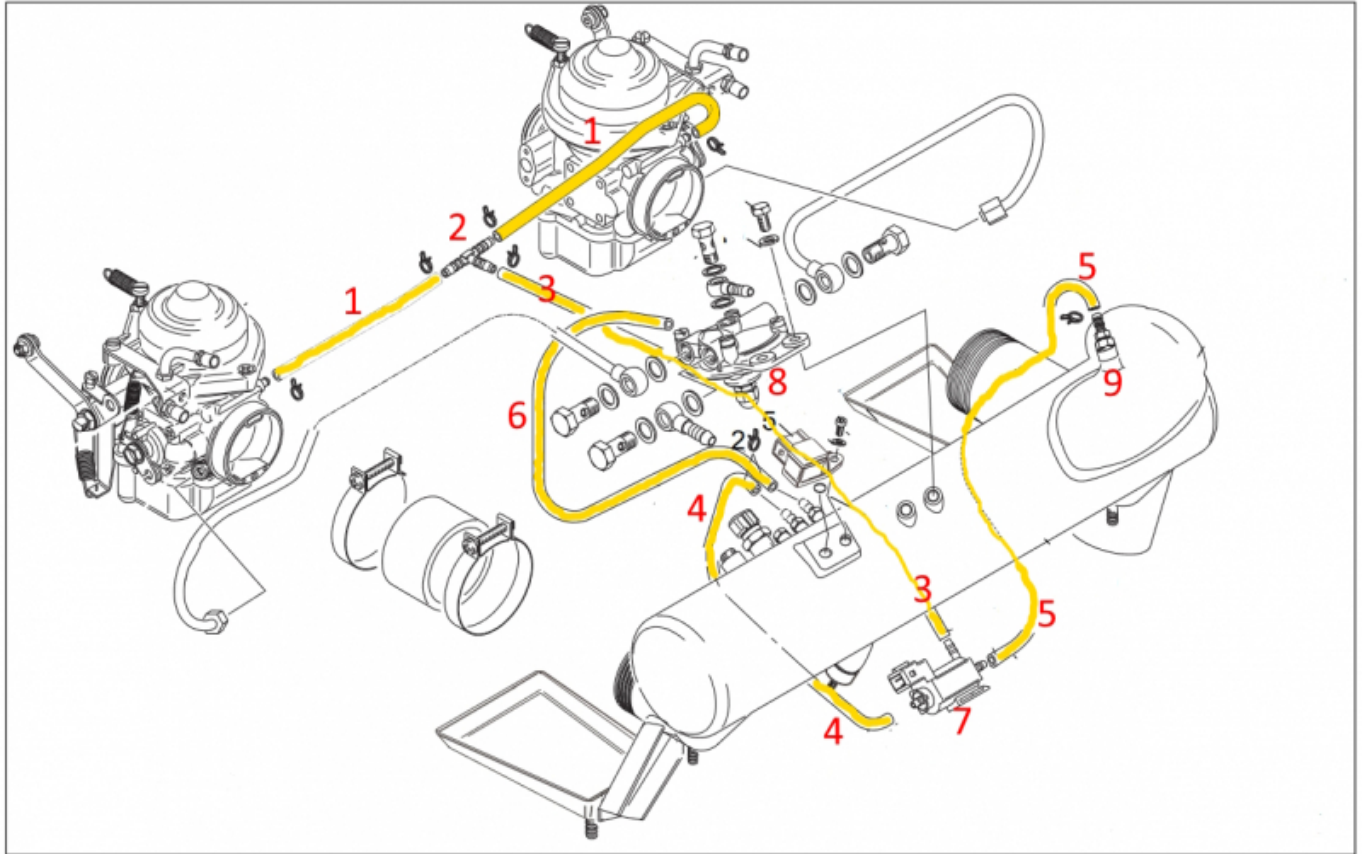
1)

A hose(1) is fitted to each float chamber ventilation, which leads via a T-piece(2) into the individual hose(3) to the 3-way valve(7). If the airbox pressure is below 1280 mbar, the hose(4) leads from the 3-way valve to the middle of the airbox.

If the airbox pressure now rises above 1280 mbar, the 3-way valve switches over. As a result, the pressure for the float chamber ventilation is now removed via the hose(5) from a pitot tube(9) in the air flow of the air pressed into the airbox by the turbocharger.

Due to the position, design and setting of the pitot tube, the pressure in the float chamber is increased by 10 mbar. This means significant greasing at a power setting of 115%, i.e. starting power.

We also have the hose (6) that leads from the center of the airbox to the fuel pressure regulator. The fuel pressure regulator regulates the fuel pressure to 250 mbar via the airbox pressure.

Crack in hoses 1, 3 and 4

Crack in the hose 5

Crack in the hose 6

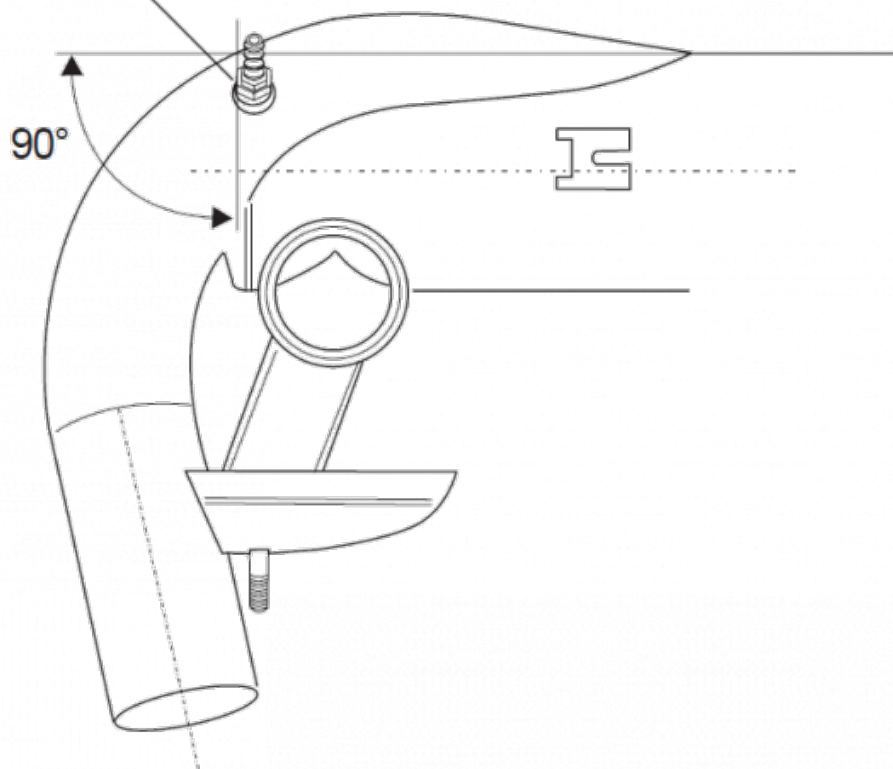
If the pitot tube is twisted, there is a basic setting as shown in the following illustration.

Position of the enrichment jet:
counter sinking on the hexagon

The pitot tube has a hole that is directed into the airflow that is fed from the turbocharger to the airbox.

An exact setting is only possible on the engine test bench and is carried out after a repair during the test run.

This requires an exhaust gas measurement at starting power.

The lock nut of the pitot tube is marked in color with locking paint.
