The cooling run of the turbocharger

.... and what happens if you don't comply with it

From:
https://kleinjung.de/rotax/ - **Ralle's ROTAX FAQ**

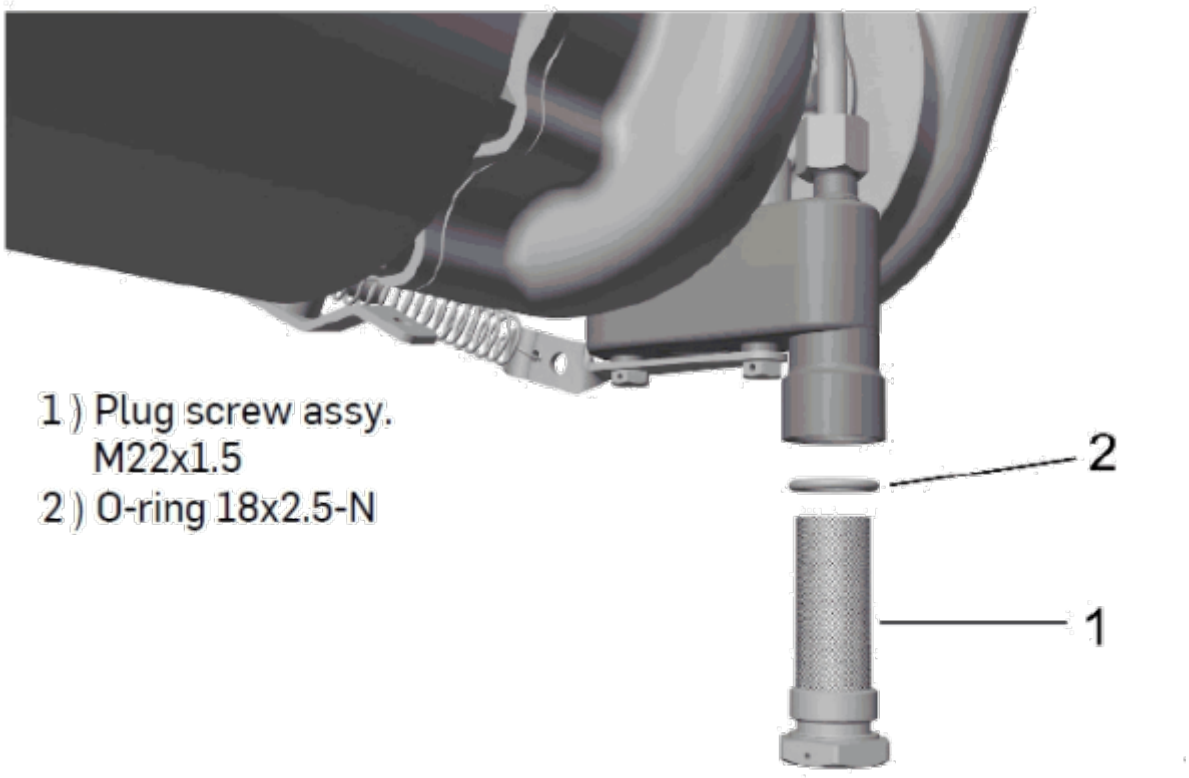
We measured the temperature of the center section and were amazed at how cool it stays.
We fitted the sensor to the oil inlet of the center section of a Turbo-Dimona as a replacement for the copper seal that is fitted under the valve housing.

We had just 120°C in flight after 5 minutes of take-off power. After landing and the cooling run approx. 100°C .

The temperature rose to approx. 130°C after parking.

However, these are temperatures that do not lead to carbonization.
Consequently, carbon formation only takes place on the shaft in the area of the turbine wheel.
