The turbo switch on the 914

… or what is the mystical devil thing actually there for?
Quite a few people have had to buy a new crankshaft to operate the switch.

From:
https://kleinjung.de/rotax/ - **Ralle's ROTAX FAQ**

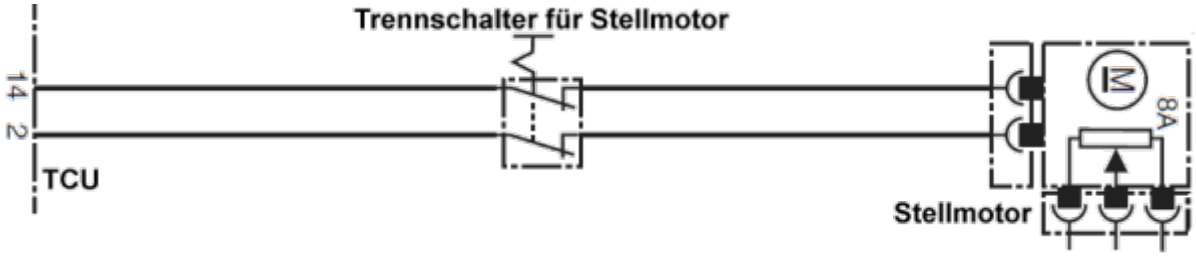
Orange caution lamp of TCU is not blinking	
Possible cause	**Remedy**
Pressure control is not possible.	Limited flying operation. Switch off servo motor for a moment (max. 5 sec).
	After a short regulating time operation should stabilize.

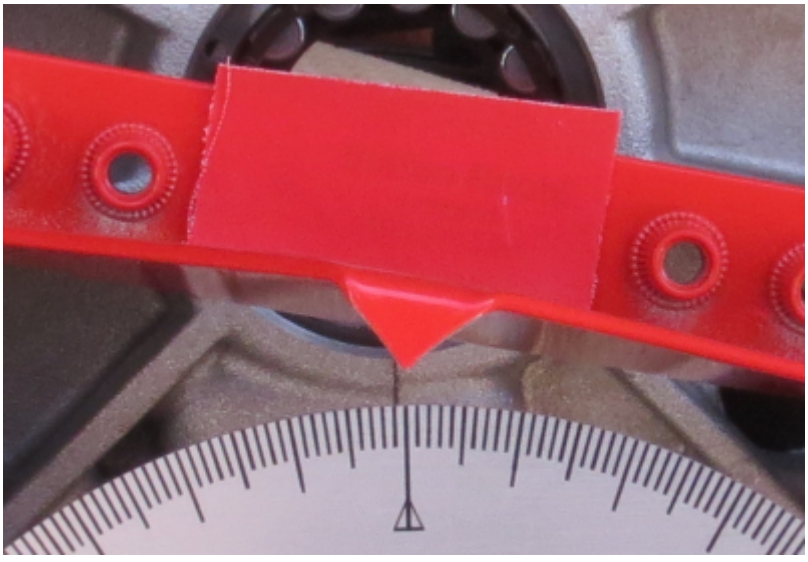
Piston turned to the piston stopper at cylinder 1 and the degree disk set to 0°.

Here you can clearly see that the crankshaft between the two measured cylinders is twisted by approx. 6° and needs to be replaced.

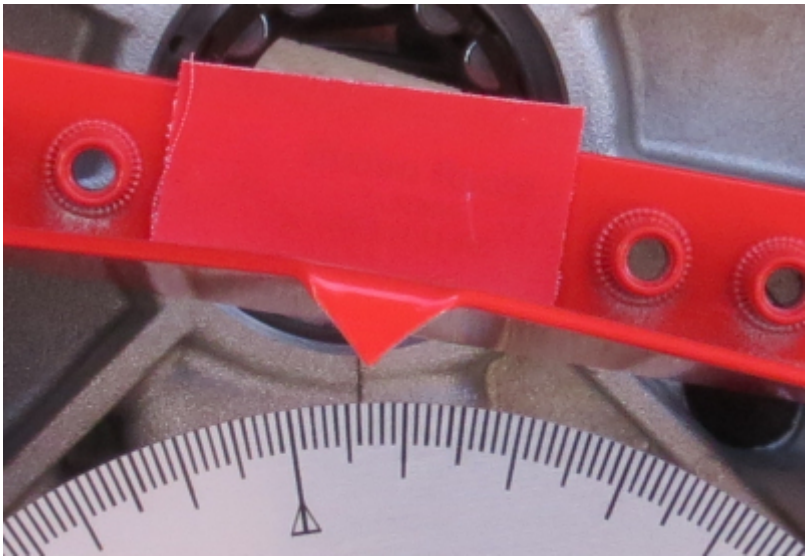
The power supply to the servo that actuates the wastegate flap in the turbocharger is interrupted.
This means that the flap does not move any more after the switch is pressed.
Now it depends on how far the flap is closed and how much throttle is applied.
If the flap is almost closed and the power setting is high, this can lead to overboost (more than 1550 mbar airbox pressure), which may cause the crankshaft to twist.

Turn the piston to the piston stopper at cylinder 2 and read the position on the degree disk.

A very clear recommendation is to seal the switch and include its inspection in the checklist.
If the seal is damaged, do not take the flight.
read out the operating parameters of the TCU
and check for an overboost.
