# The check valve on the 914 turbocharger

... or why there is a pool of oil under the 914

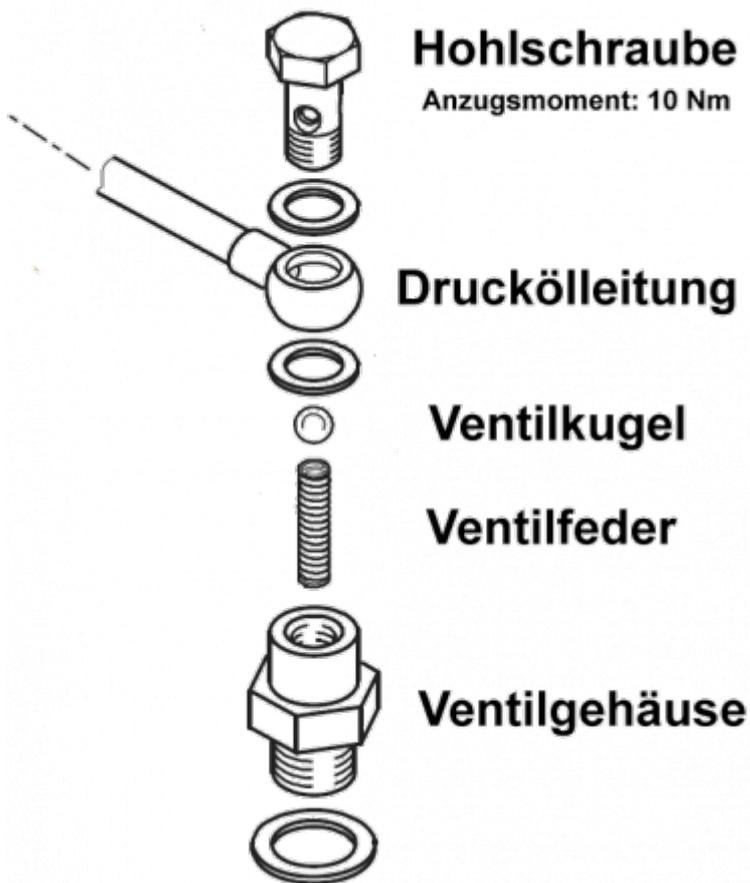
If the non-return valve in the valve housing is not tight, the oil sump will fill up and then the turbine and compressor housing will also fill up.

To do this, the ball is pressed against the banjo bolt. During operation, the ball is lifted from the valve seat by the oil pressure and the oil can lubricate the turbocharger unhindered.

- The valve housing is mounted on top of the turbocharger.
- There is a compression spring in the valve housing
- which presses the ball above it
- against the banjo bolt.
