The transition holes

.... That's why I'm only reporting here on my experiences with modifying the Bing's on a 912 ULS with 100 hp.

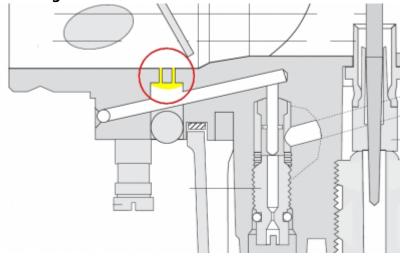
Picture story

1=Synchronization connection **2**=Transition holes **3**=Hole for idle mixture adjustment screw and outlet of the idle mixture in operation
