Rotax 914 log file analysis

RECORDING - 14:35:09 - 15:01:37

DATE	START - END	RECORDING TIME
21.10.	**14:35:09 - 15:01:37**	**26:28 min**

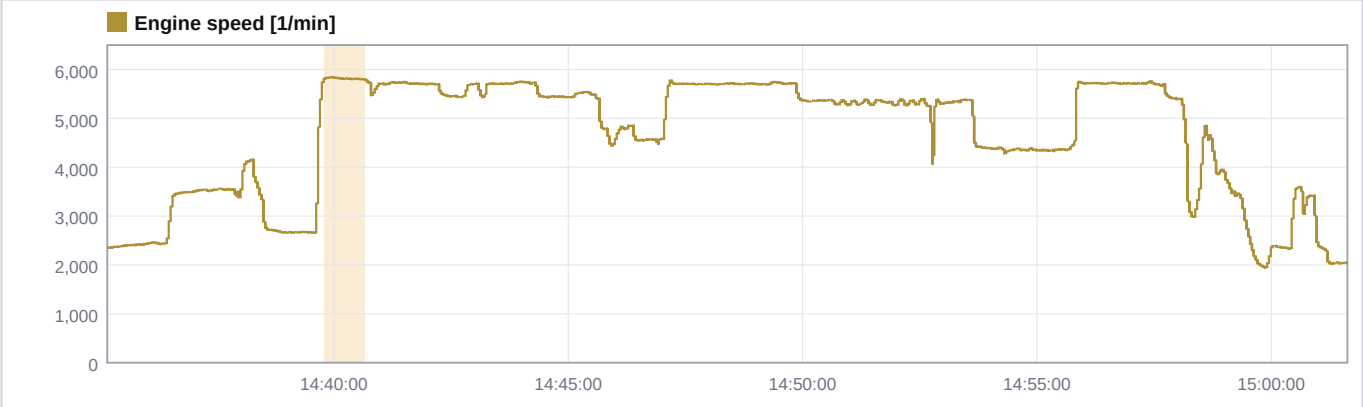
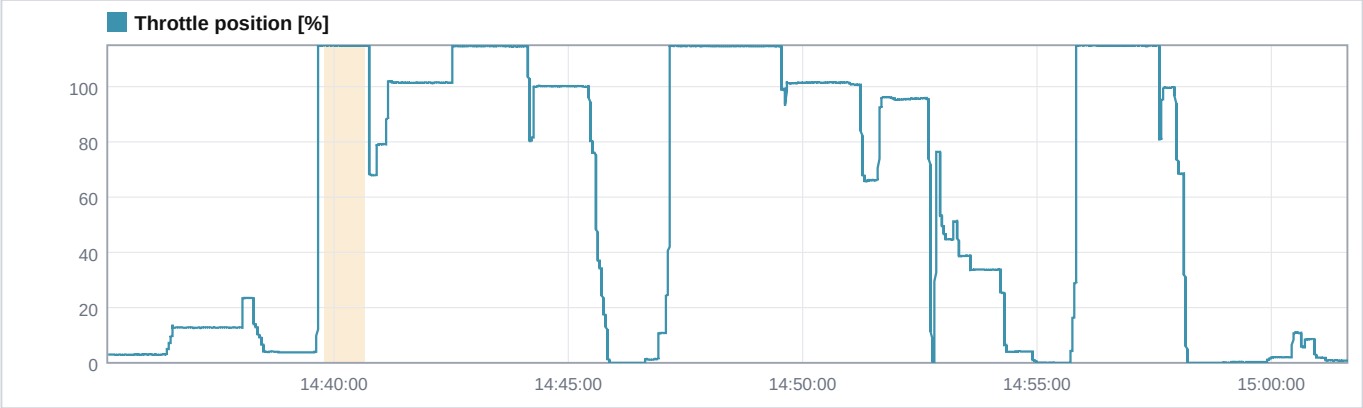
Caution: TCU transition range (108-110 %)

The throttle range between 108 % and 110 % must be avoided and passed through quickly when opening and closing the throttle, as unstable boost control and controller oscillations can occur in this range.

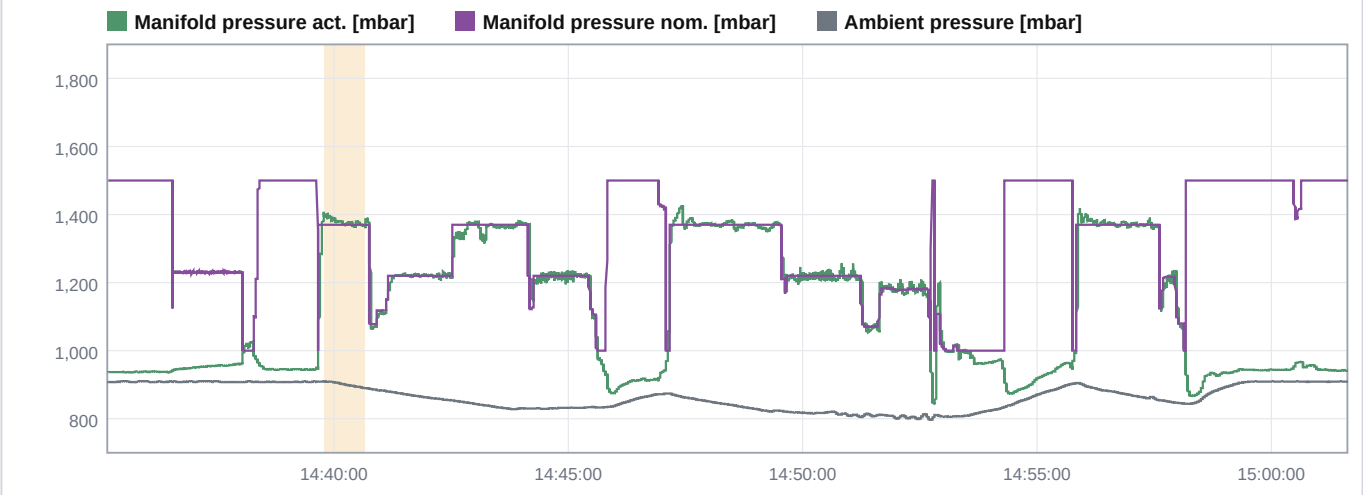
CHANNELS

CHANNEL	MIN	MAX		MAX. AT
Engine speed	1,940 (798)	**5,839 (2,403)**	1/min (Prop.)	14:39:57
Throttle position		**115.0**	%	14:39:40
Ambient pressure	797	**910**	mbar	14:39:47
Manifold pressure act.	842 (24.9)	**1,426 (42.1)**	mbar (inHg)	14:47:24
Manifold pressure nom.	1,000 (29.5)	**1,500 (44.3)**	mbar (inHg)	14:35:09
Servo position	56.3	**101.3**	%	14:42:31
Airbox temperature	19.9	**83.3**	°C	14:44:07
Height above start	27	**3,546**	ft	14:52:43

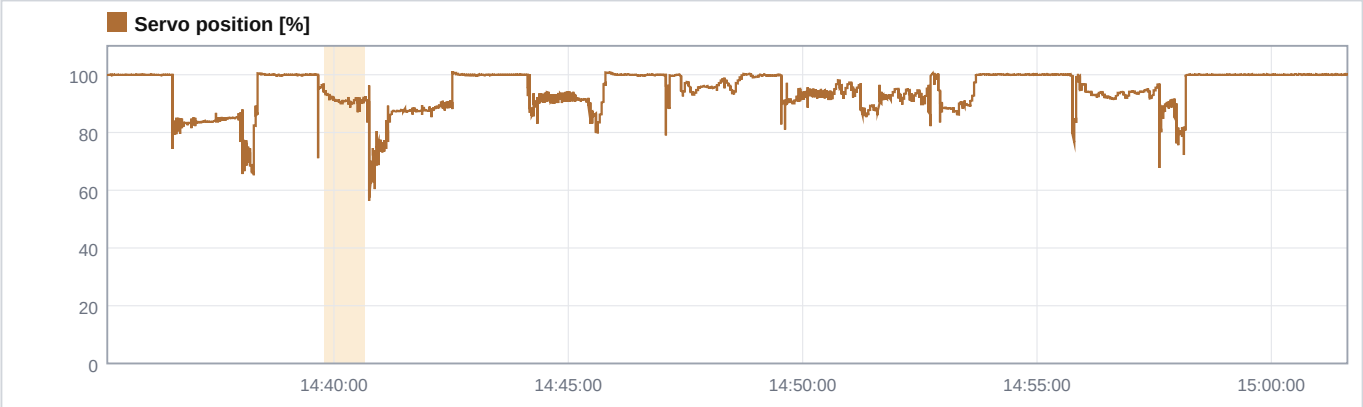
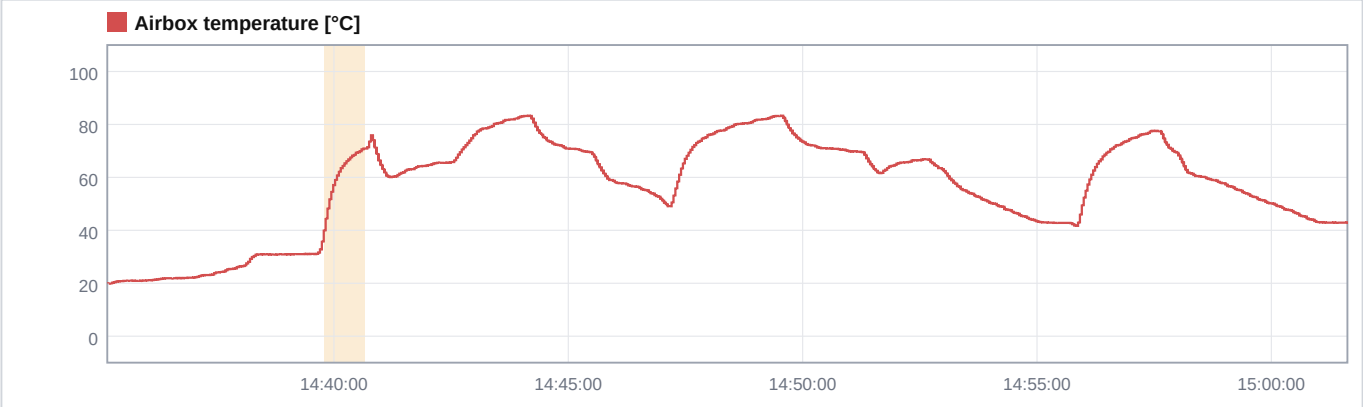
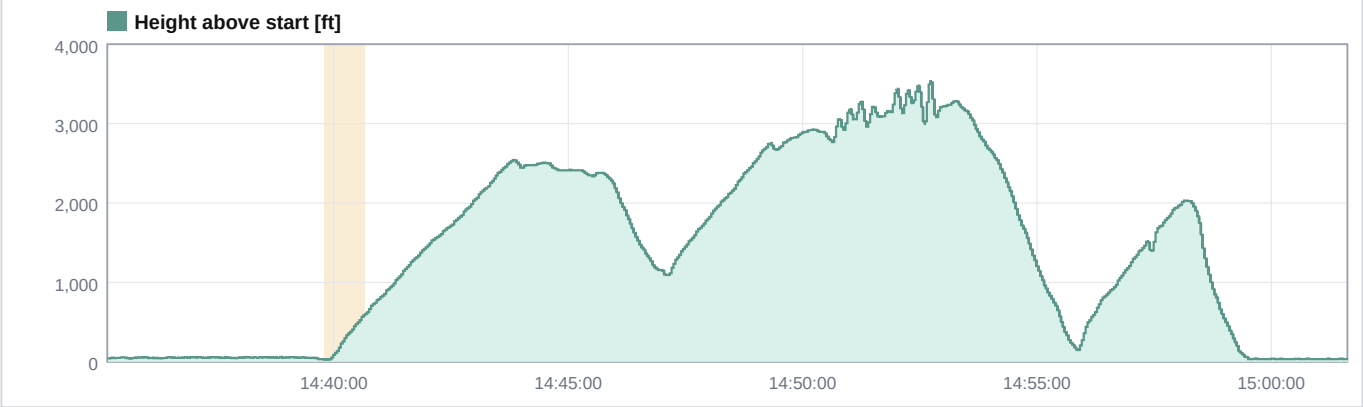
CHARTS - 14:35:09 - 15:01:37

Height above start: calculated from the ambient pressure (ISA standard atmosphere) relative to the pressure at the beginning of the recording. Field elevation and current air pressure (QNH) are not contained in the log file, so the height starts at 50 ft.

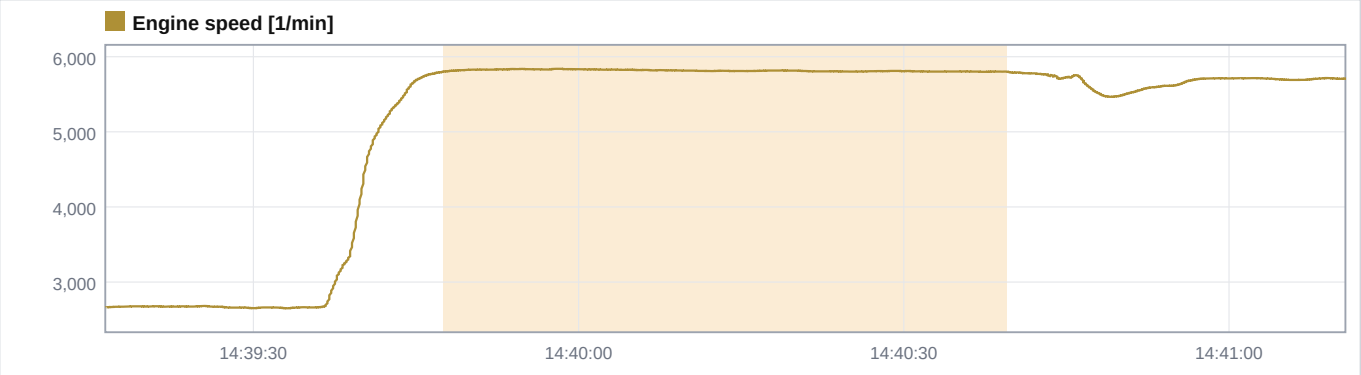
RATING - DETAILS

14:39:47 5800 up to max. 6200 rpm (Prop. 2,387 - 2,551) for max. 1 minute (max. 5,839 1/min (Prop. 2,403), 51.2 s)
