how to block the crankshaft correctly with the blocking screw

... and how to avoid dismantling the engine

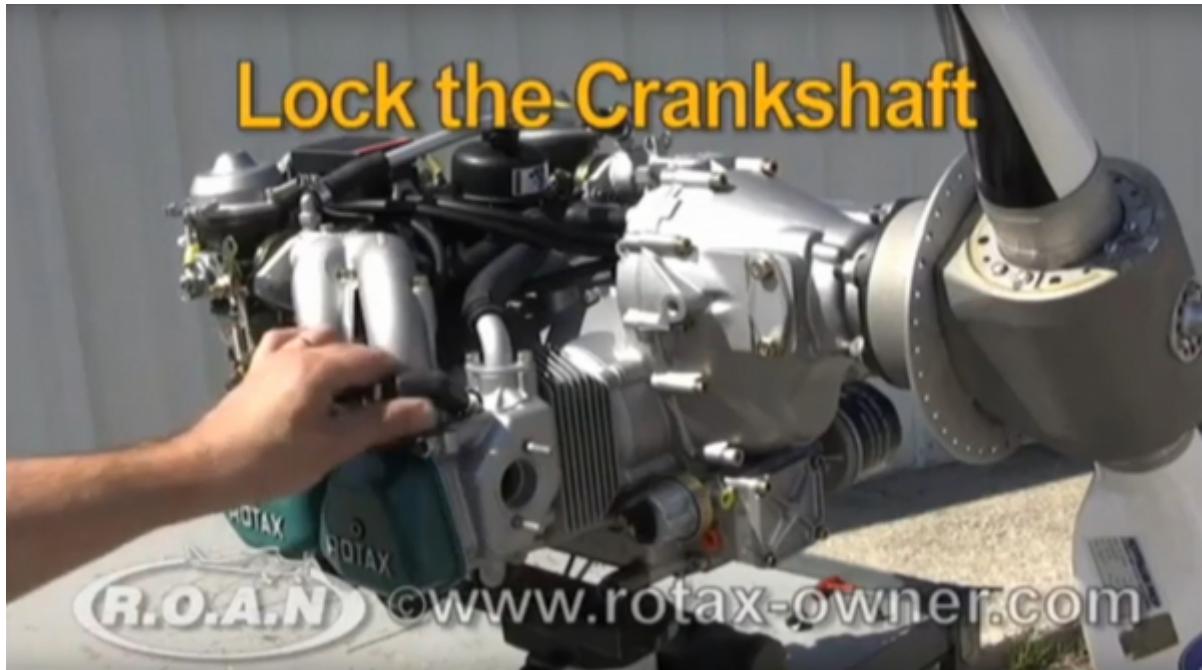
If it is necessary to **lock the crankshaft**, I recommend watching the following video from rotaxowner.com carefully. It is perfectly explained here:

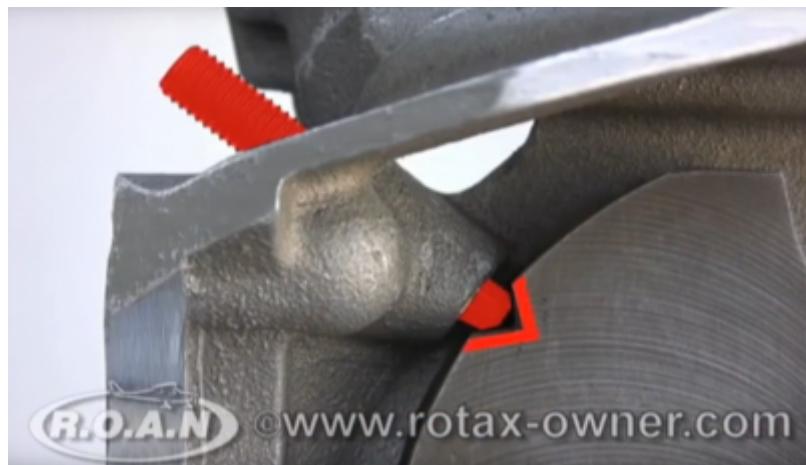
This picture clearly shows how the blocking pin should be positioned

If the locking pin is not screwed correctly into the notch in the crank web, it may protrude into the engine housing next to the crank web when the drive wheel nut is loosened or tightened. As the distance between the threaded end of the hole for the locking pin in the housing and the crank web is greater than when the pin is properly seated in the notch in the crank web, we have a longer lever here. This may cause the end of the locking pin to bend in the crankcase.

There is no tightening torque for the locking pin.

I recommend tightening it here with approx. **12 Nm - 15 Nm**. You could also say **hand-tight**.

If you now think that the locking pin is seated correctly, there is another good **control option**. Turn the locking pin out again 1/2 to 3/4 turns. Now place a finger on the locking pin and turn the propeller back and forth as far as it will go.

Of course, it should lock again in both directions after a very small angle.

At the same time, you should feel with your finger that the locking pin is moved back and forth a little when the notch in the crank arm touches the pin.
