how to block the crankshaft correctly with the blocking screw

... and how to avoid dismantling the engine

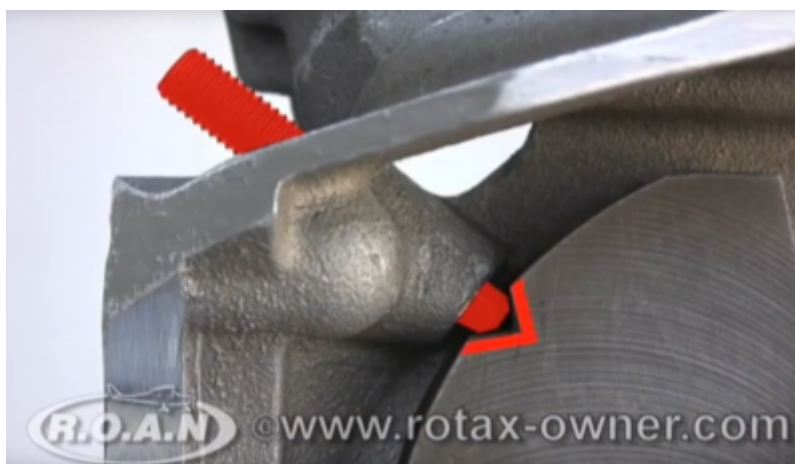
This picture clearly shows how the blocking pin should be positioned

If the locking pin is not screwed correctly into the notch in the crank web, it may protrude into the engine housing next to the crank web when the drive wheel nut is loosened or tightened. As the distance between the threaded end of the hole for the locking pin in the housing and the crank web is greater than when the pin is properly seated in the notch in the crank web, we have a longer lever here. This may cause the end of the locking pin to bend in the crankcase.

There is no tightening torque for the locking pin.
I recommend tightening it here with approx. **12 Nm - 15 Nm**. You could also say **hand-tight**.

If you now think that the locking pin is seated correctly, there is another good **control option**. Turn the locking pin out again 1/2 to 3/4 turns. Now place a finger on the locking pin and turn the propeller back and forth as far as it will go.

At the same time, you should feel with your finger that the locking pin is moved back and forth a little when the notch in the crank arm touches the pin.
