how to block the crankshaft correctly with the blocking screw

... and how to avoid dismantling the engine

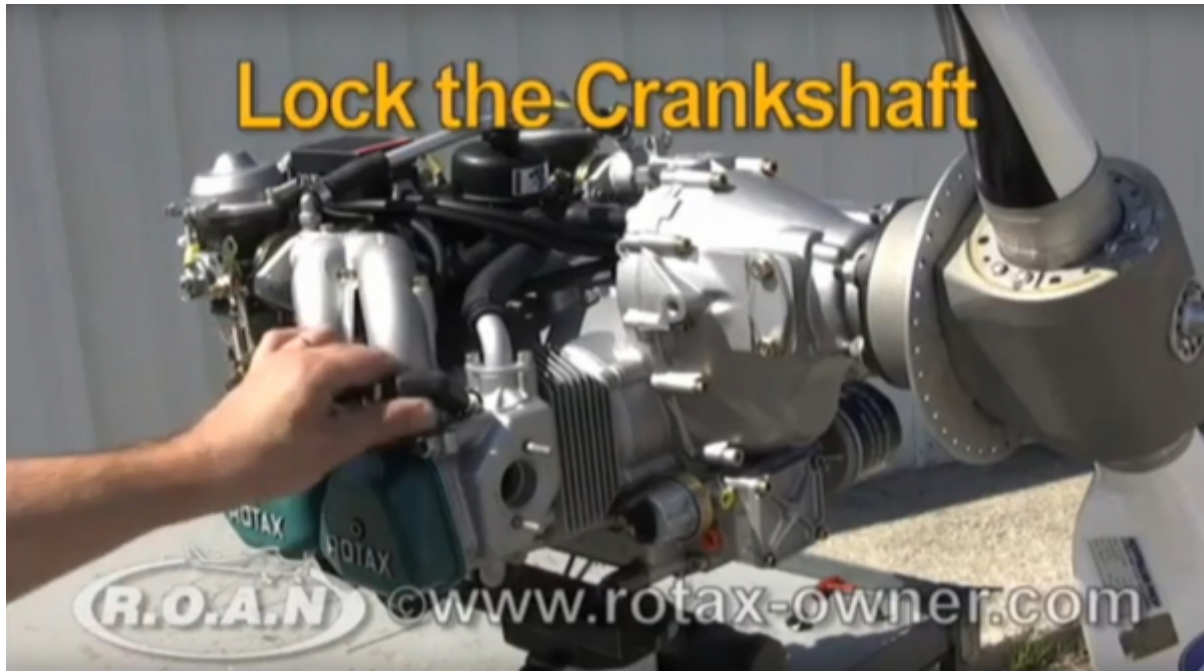
If it is necessary to **lock the crankshaft**, I recommend watching the following video from [rotaxowner.com](https://kleinjung.de/rotax/) carefully. It is perfectly explained here:

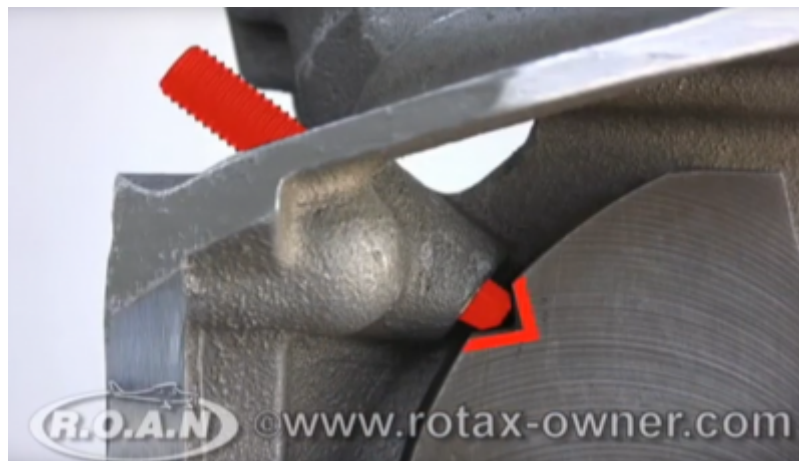
This picture clearly shows how the blocking pin should be positioned

If the locking pin is not screwed correctly into the notch in the crank web, it may protrude into the engine housing next to the crank web when the drive wheel nut is loosened or tightened. As the distance between the threaded end of the hole for the locking pin in the housing and the crank web is greater than when the pin is properly seated in the notch in the crank web, we have a longer lever here. This may cause the end of the locking pin to bend in the crankcase.

There is no tightening torque for the locking pin.

I recommend tightening it here with approx. **12 Nm - 15 Nm**. You could also say **hand-tight**.

If you now think that the locking pin is seated correctly, there is another good **control option**.

Turn the locking pin out again 1/2 to 3/4 turns. Now place a finger on the locking pin and turn the propeller back and forth as far as it will go.

Of course, it should lock again in both directions after a very small angle.

At the same time, you should feel with your finger that the locking pin is moved back and forth a little when the notch in the crank arm touches the pin.

If this is the case, finally turn it **hand-tight** and you can now safely do what you have set out to do.
