Permanent oil pressure fluctuations during operation

... when the needle trembles or the numbers do not come to rest

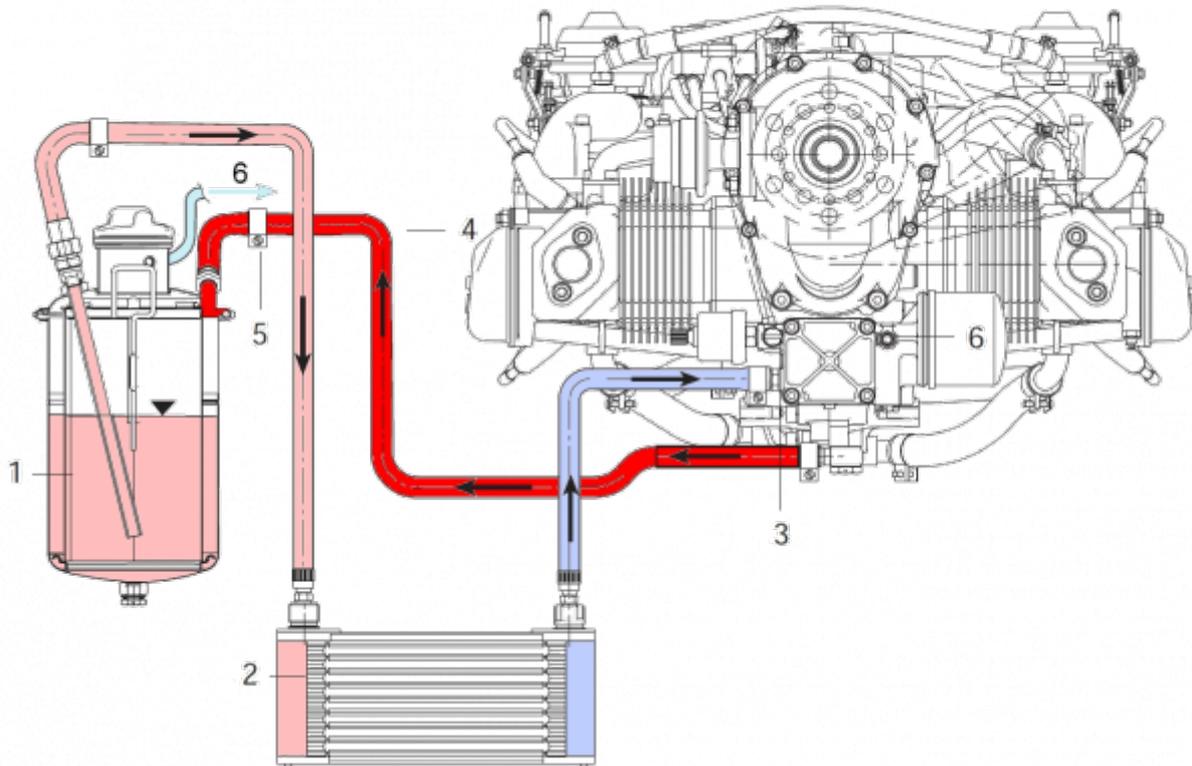
The oil system

Let's first look at the dry sump lubrication system used on the Rotax.

In contrast to wet sump lubrication, in which the engine oil is stored in the engine block, usually below the crankshaft in the oil pan, this requires a separate oil reservoir(1). We are all familiar with this, as this is where the engine oil is topped up if necessary.

In a standard dry sump lubrication system, a double oil pump is used to return the engine oil dripping into the crankcase after the lubrication process to the oil tank.

In the Rotax, this was realized much more simply and, above all, much more easily by using the [Blow-By-Gas](#) that is always present in the combustion engine to return the engine oil. For this purpose, the engine does not have an extra crankcase ventilation system, but the „misused“ oil return line(4). The crankcase ventilation then takes place at the oil reservoir(6). Proof of this process is the „burping“ from the oil reservoir when the engine is turned over by hand to check the oil level.

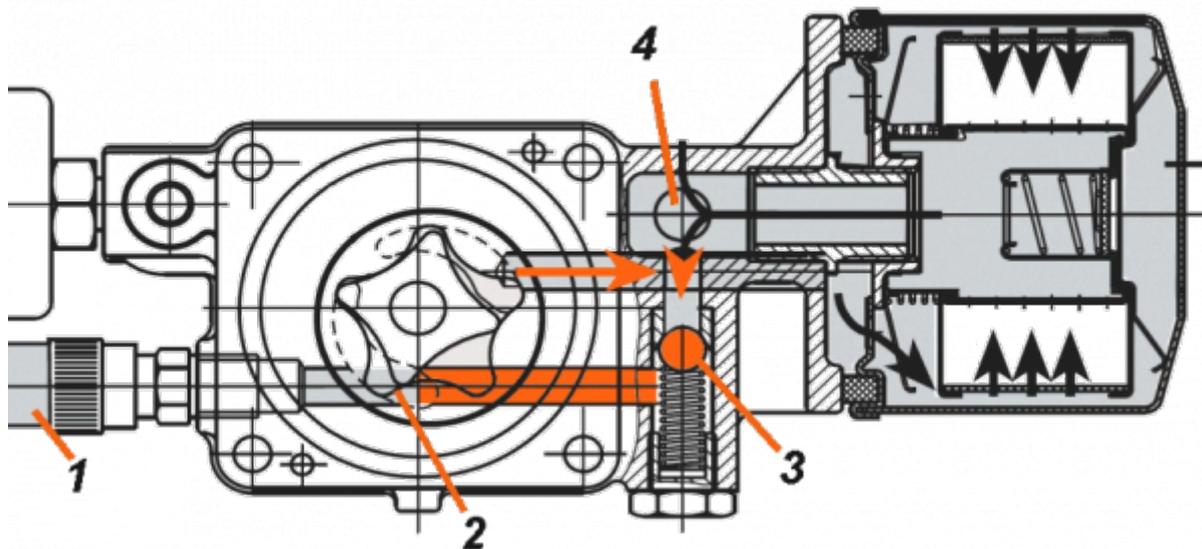
1. Here is the oil supply line connected to the oil pump
2. Here is the inlet to the intake side of the trochoid in the oil pump
3. the oil pressure control valve
4. the oil channel for engine lubrication and the oil pump outlet

Basically, such an oil pump, whether a gear pump or a [Eatonenpumpe](#), has a very high delivery pressure.

This must be reduced/regulated and this is achieved by the oil pressure control valve. The excess oil „regulated“ by the control valve is usually discharged into the engine oil pan.

Here, the oil is fed directly back into the oil supply through the channel shown in red.

This has two advantages: 1. the amount of oil to be drawn in by the pump is considerably reduced, as only the oil required for lubrication has to be drawn in and 2. it reduces the amount of oil that has to be returned to the oil reservoir, which could potentially be difficult with the blow-by gas.

The oil return channel after the oil pressure control valve is absolutely the same as the oil inlet from the oil reservoir. This means that when oil is regulated away from the valve, it flows exactly opposite the oil coming from the oil reservoir.

Depending on the oil temperature, delivery rate and pressure of the oil pump and the elasticity of the oil hoses, this can lead to resonances in the entire oil circuit. How the condition is caused is not yet entirely clear to me, but is probably caused by the control behavior of the oil pressure control valve. As I have already written, the installation of the mushroom-shaped valve piston (857230) could possibly lead to an improvement.
