Replacing the float needle valve seat bushing

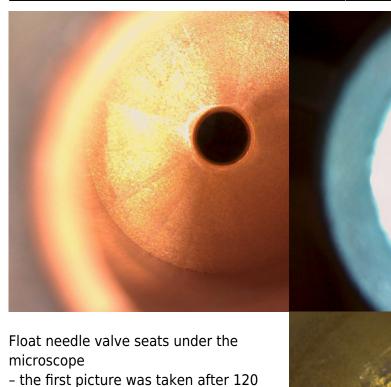
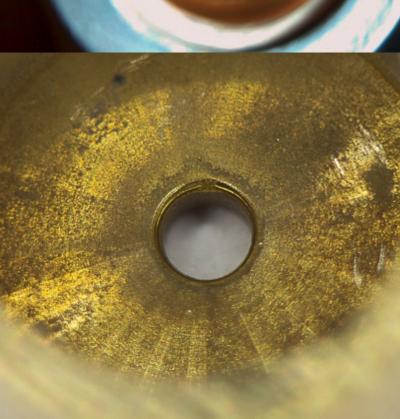
Anyone who was lucky enough to come across this post in the UL forum will perhaps remember similar pictures:

- the first picture was taken after 120 operating hours

The third picture is by © Steffen E. and is a very clear example as a supplement to his post in the UL forum.

The advice obtained from the trusted Rotax dealer is devastating: Replace carburetor - price = 4 digits.

But now you can resort to a repair method not approved by Rotax. **Replace the valve seat bushings**.
